CLEARWATER

Agenda

LONG CENTER
NATATORIUM

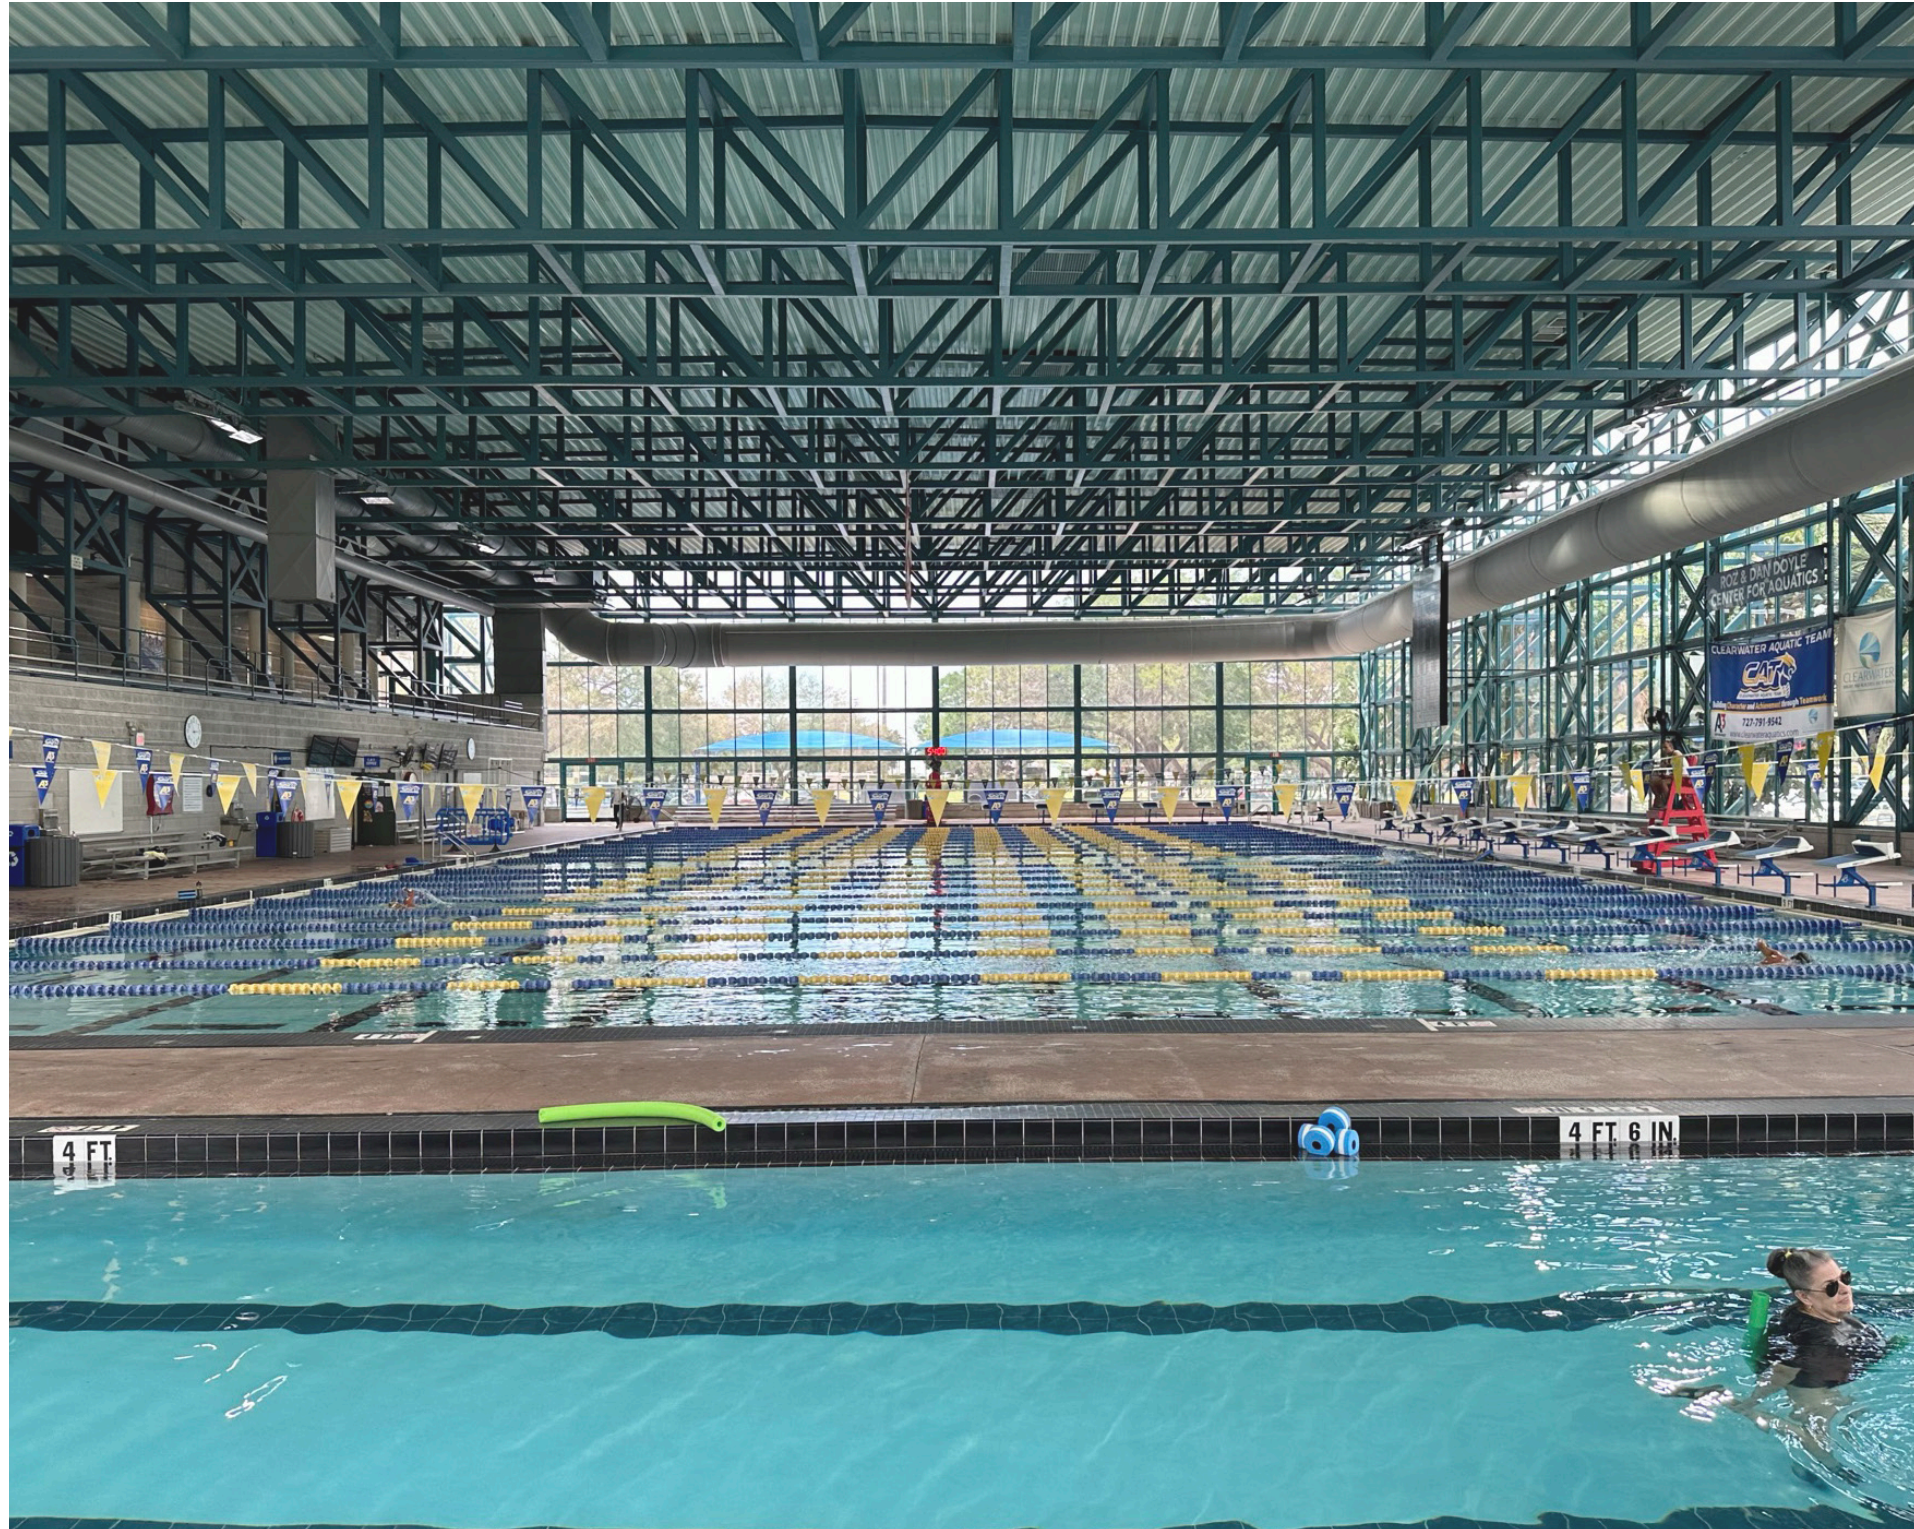
EXISTING CONDITIONS

- Existing natatorium built 1988
- Separated from existing building by fire wall.
- Two Pools
- Spectator seating at mezzanine
- Exposed structural steel
- Glass building envelope
- Low slope roof
- Dectron HVAC system

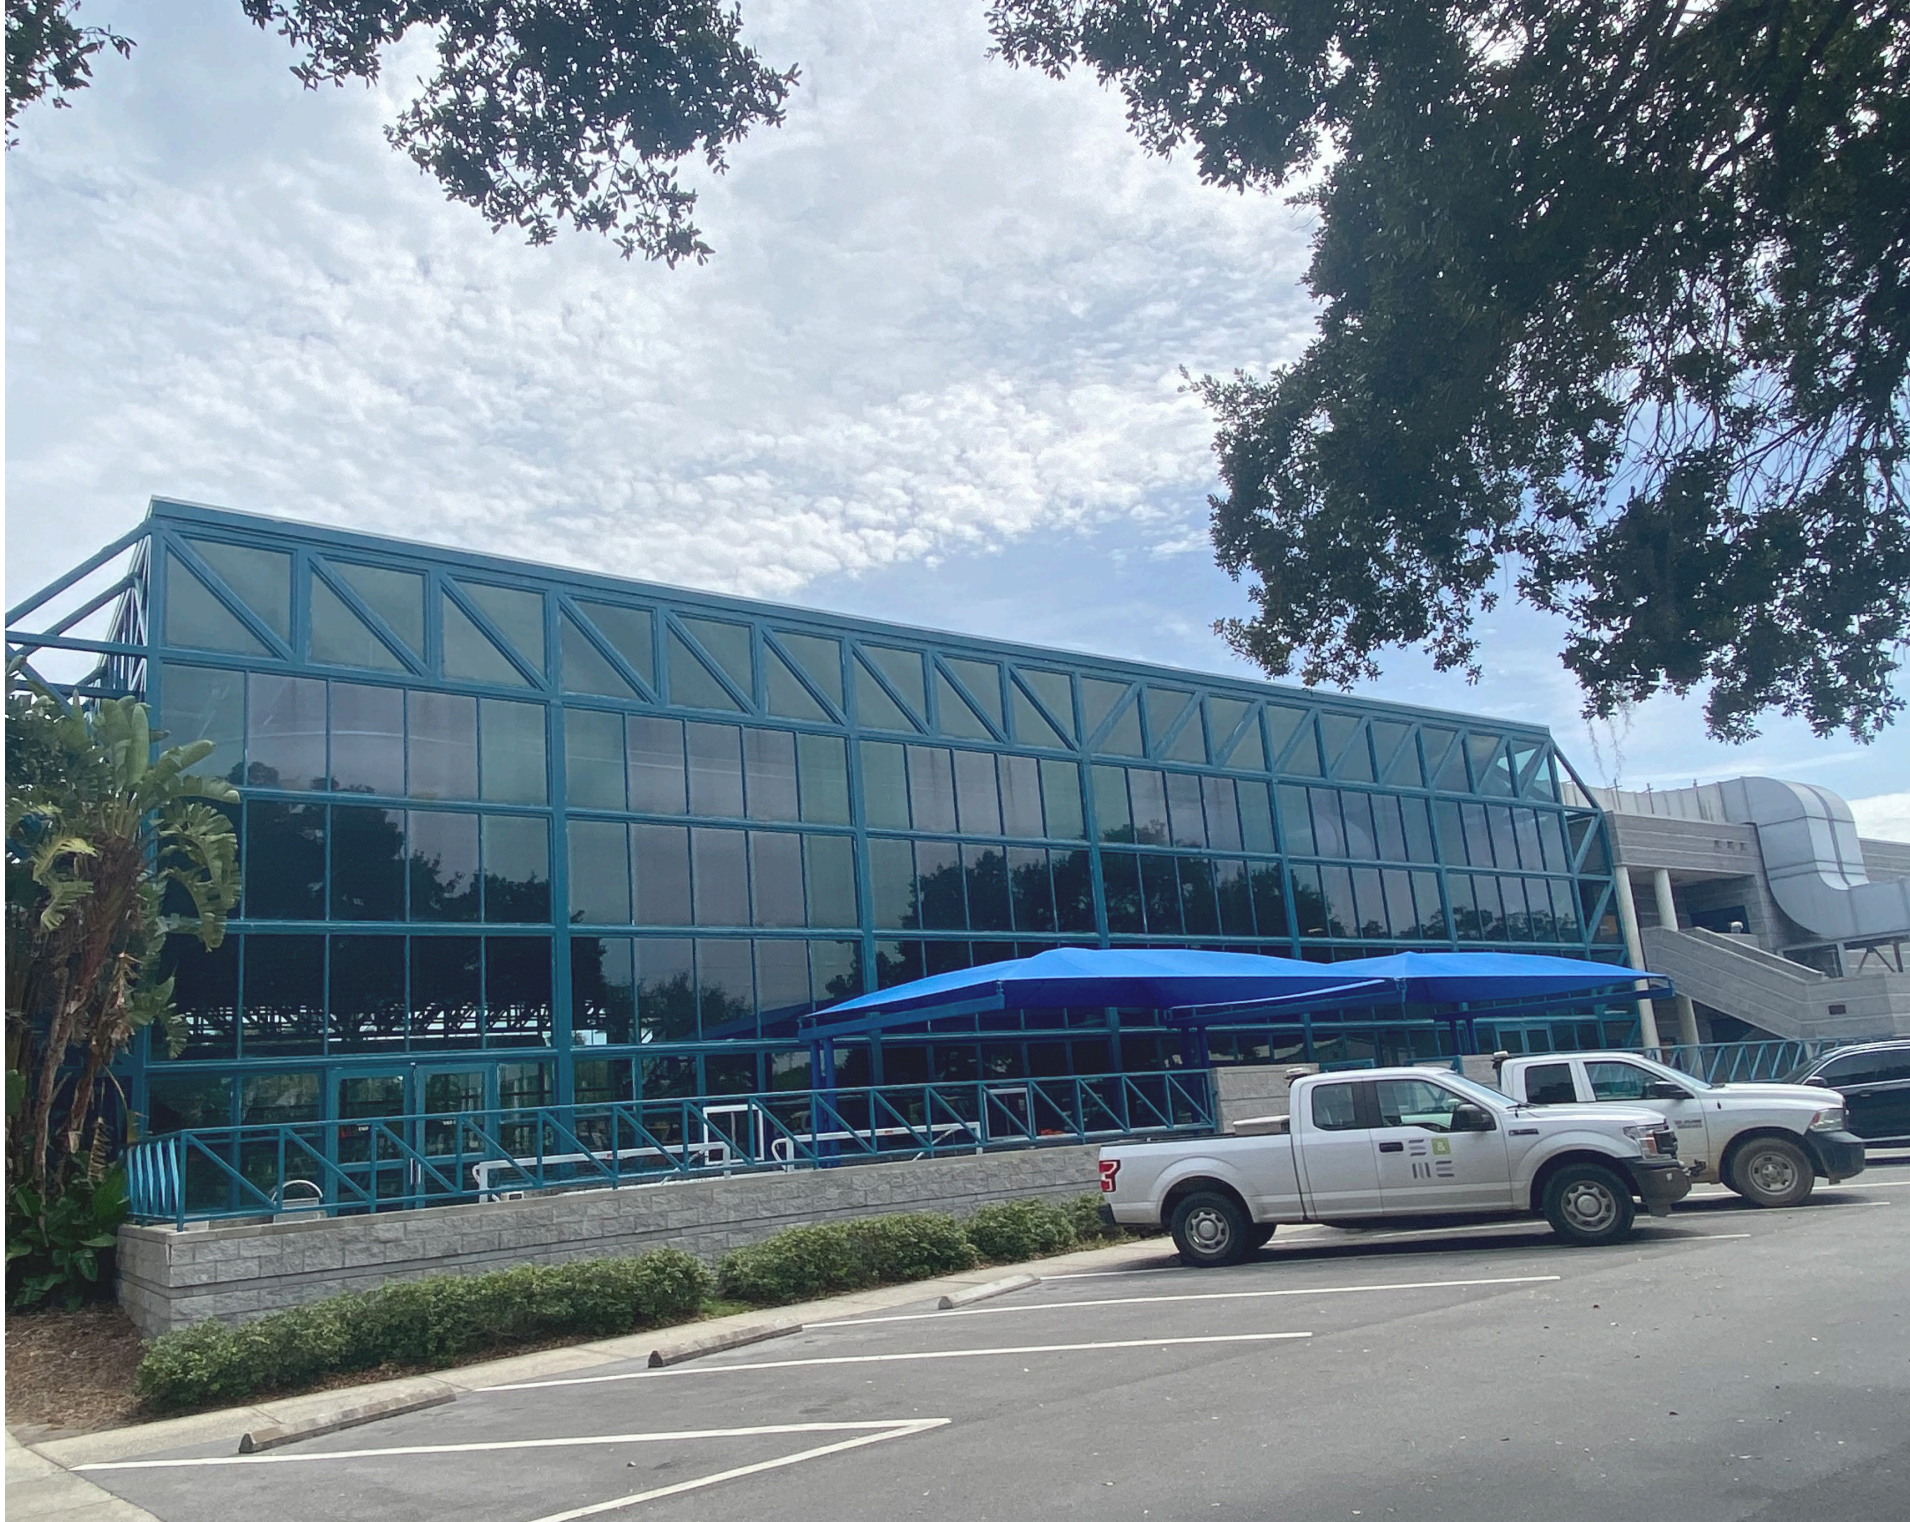
West Elevation

- Exposed steel structure facade
- Single pane glazing
- Shaded Sun Deck
- Dectron HVAC Unit (Background)

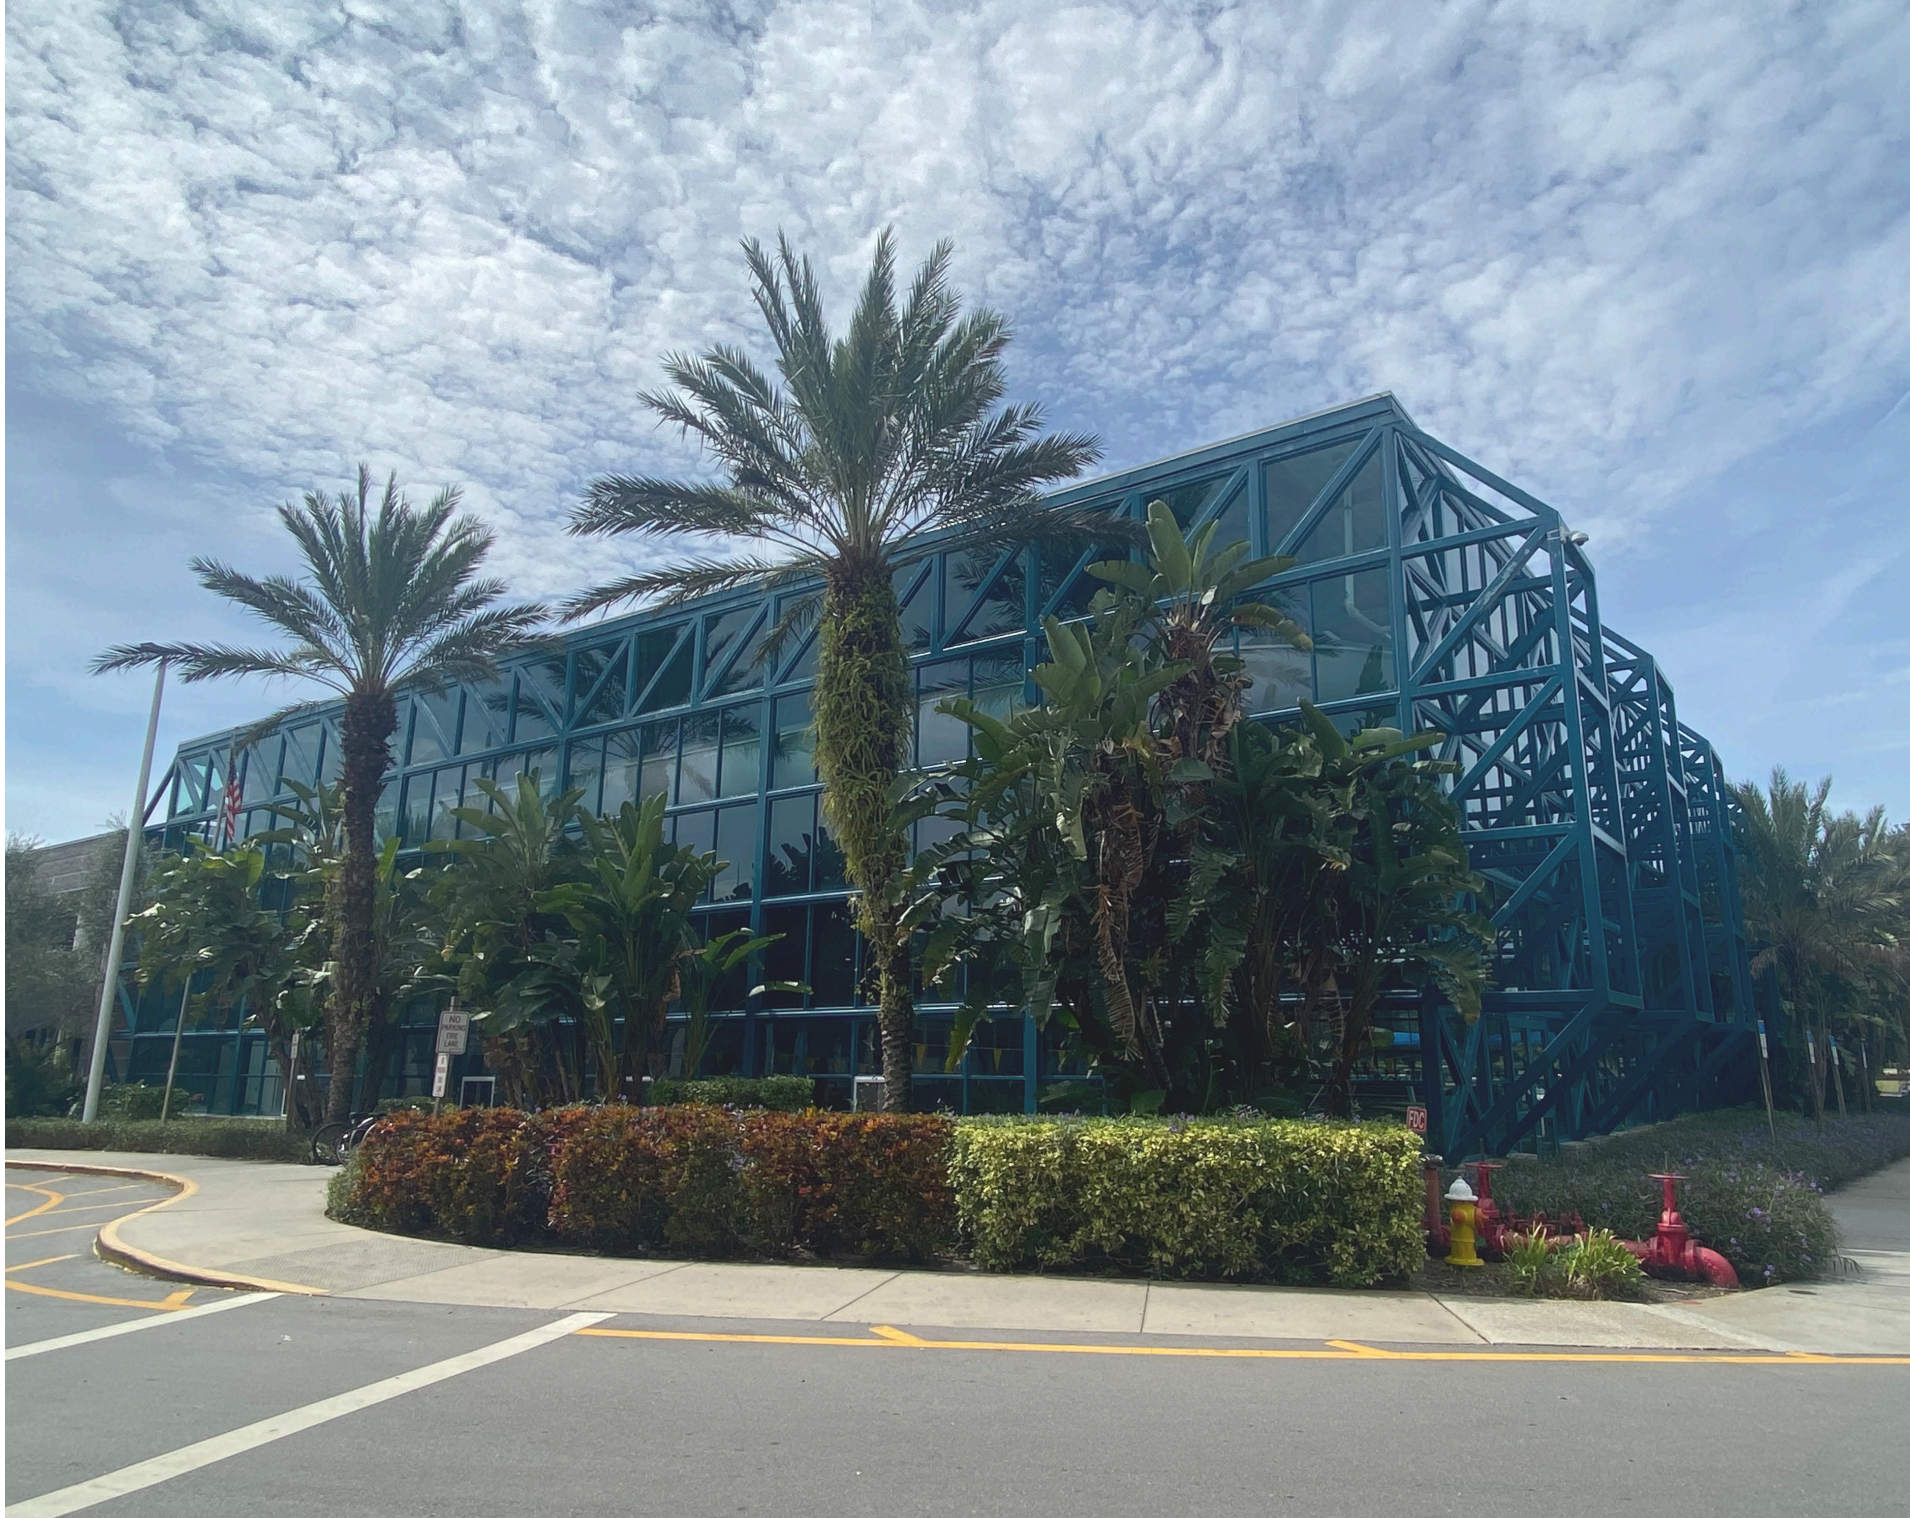
East Elevation

- Exposed steel structure facade
- Single pane glazing
- Manicured & matured planting

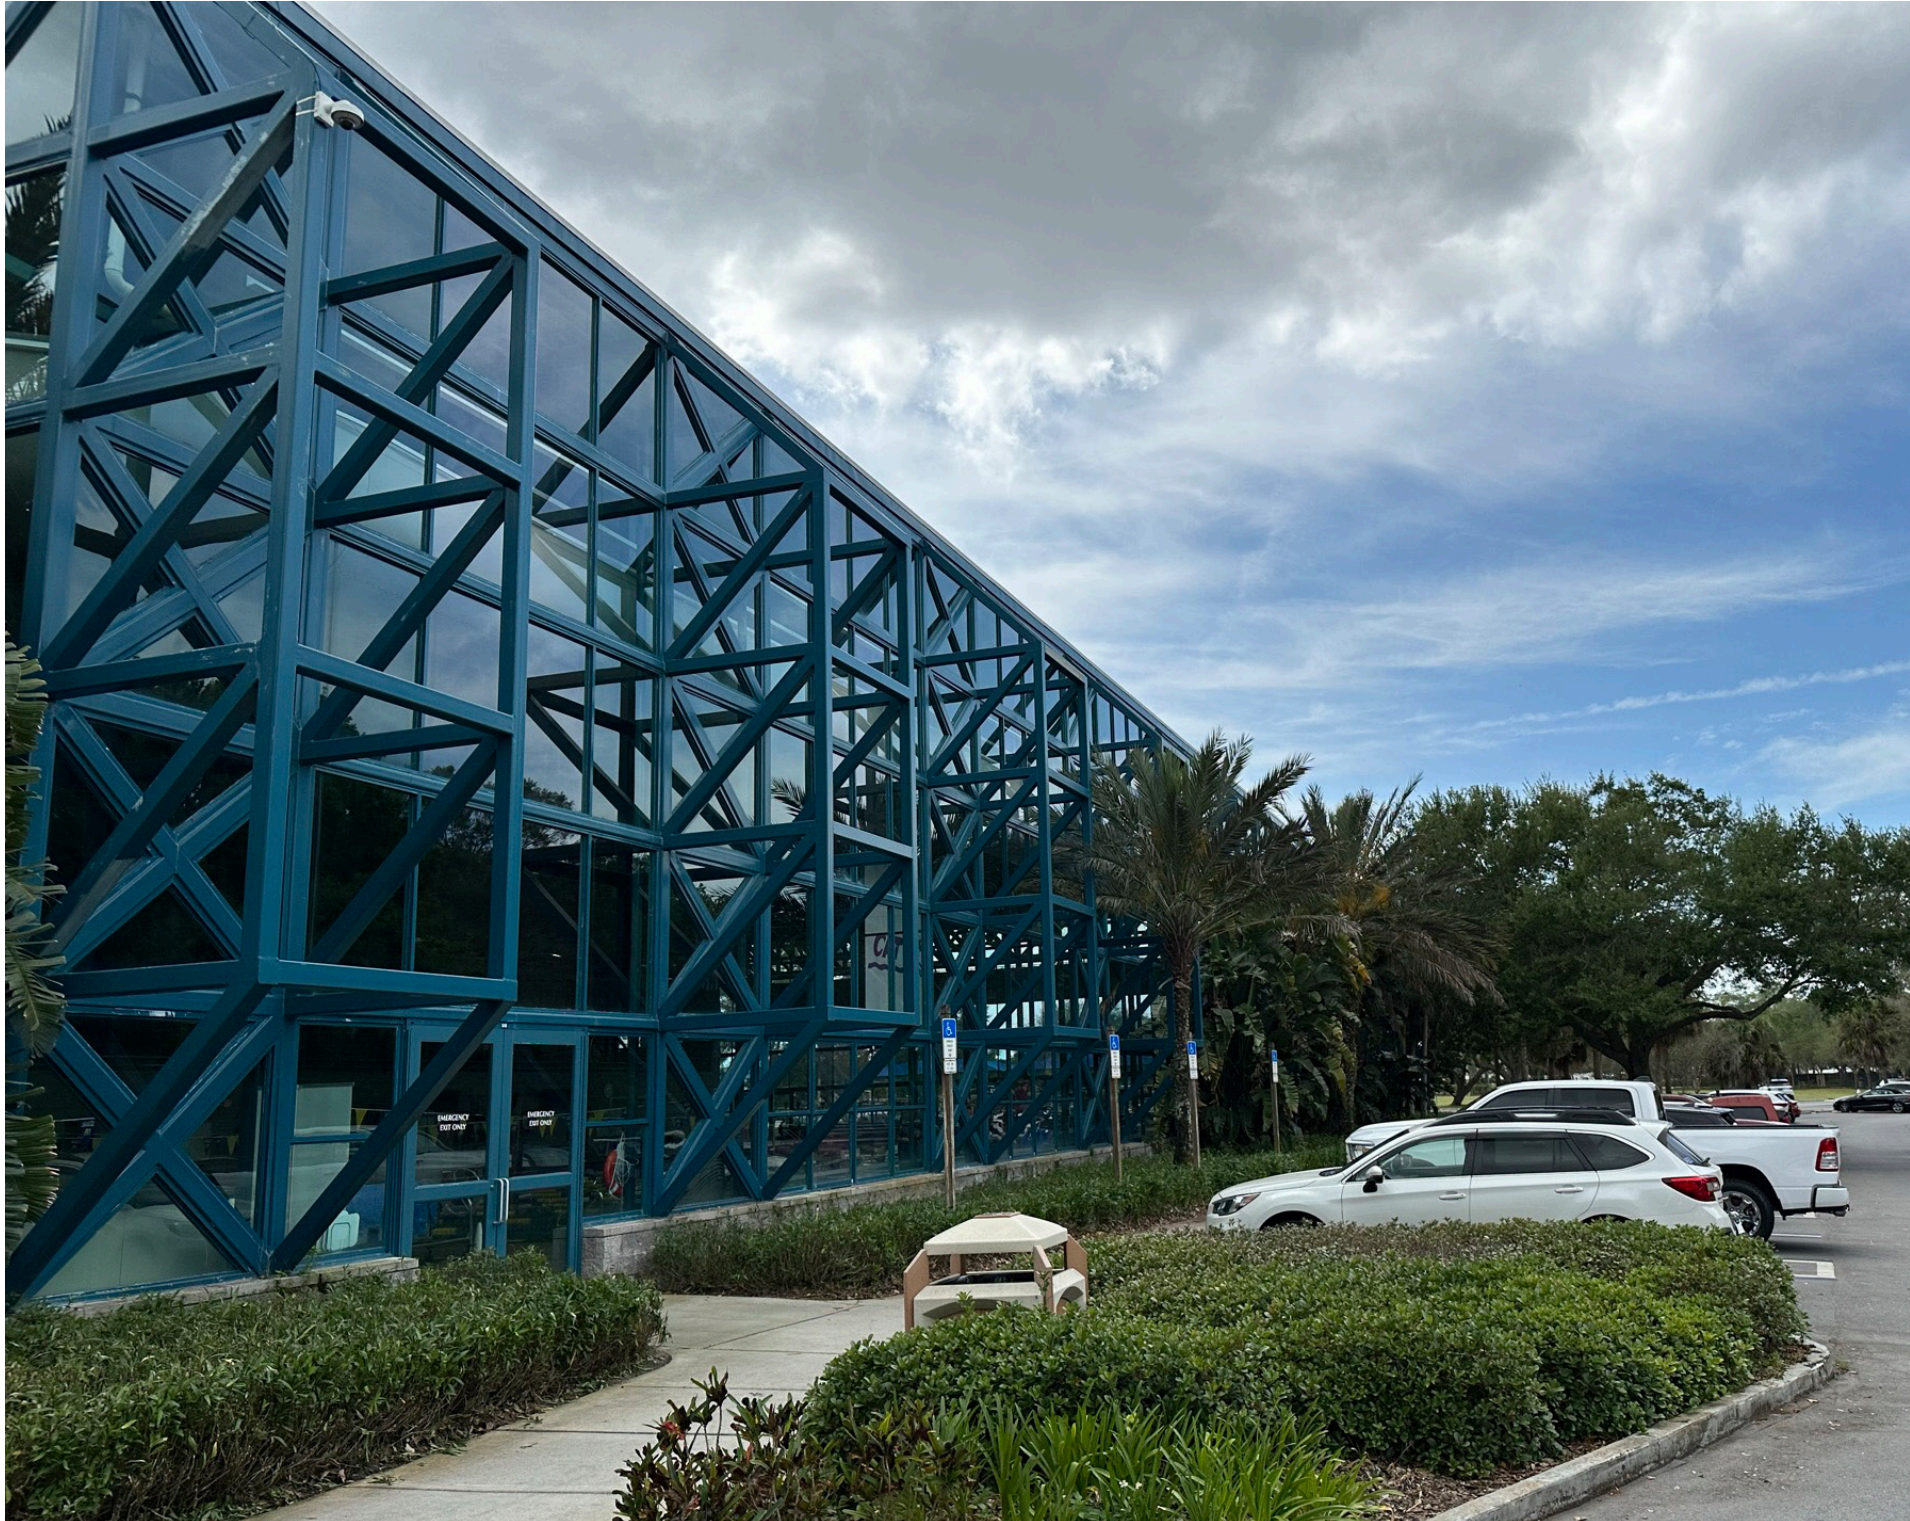
North Elevation

- Exposed steel structure facade
- Single pane glazing
- Manicured & matured planting

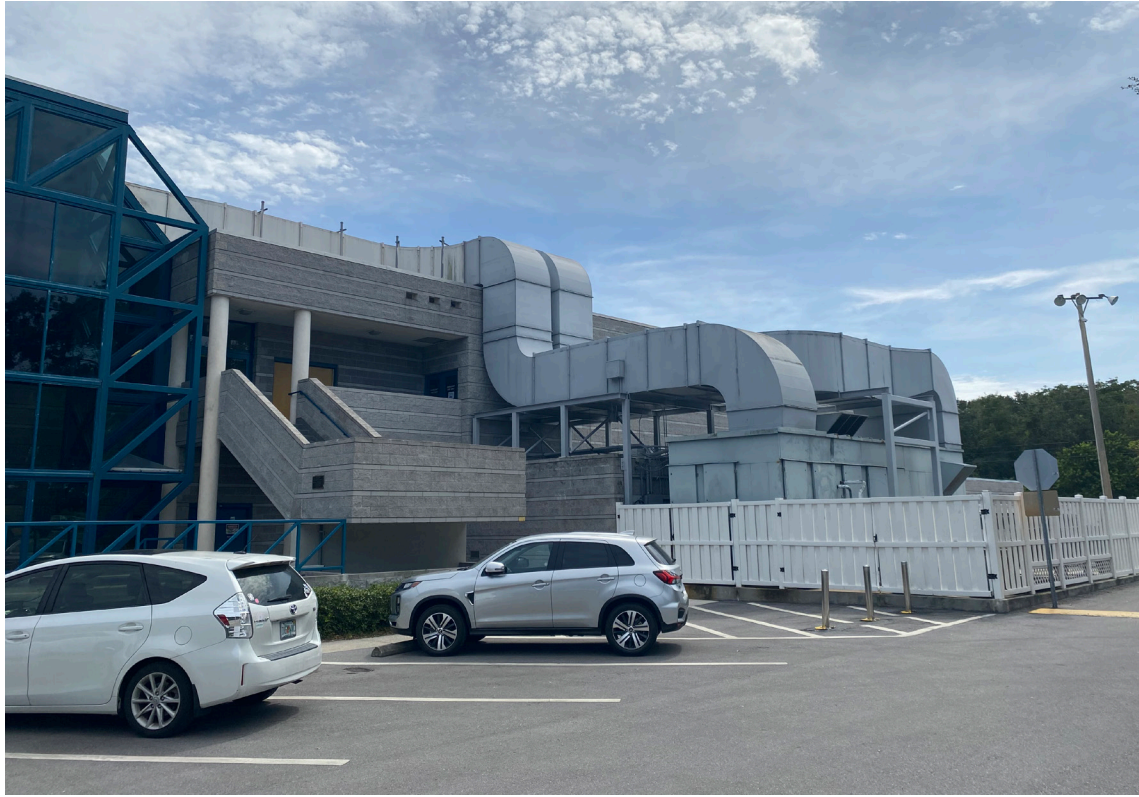
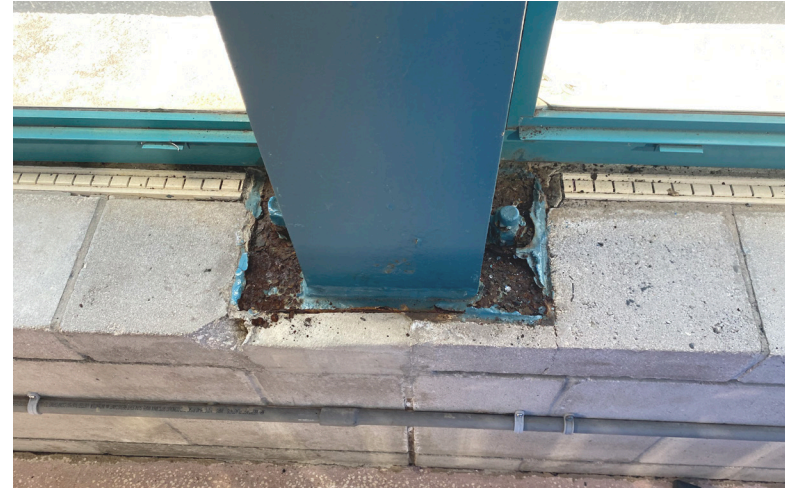
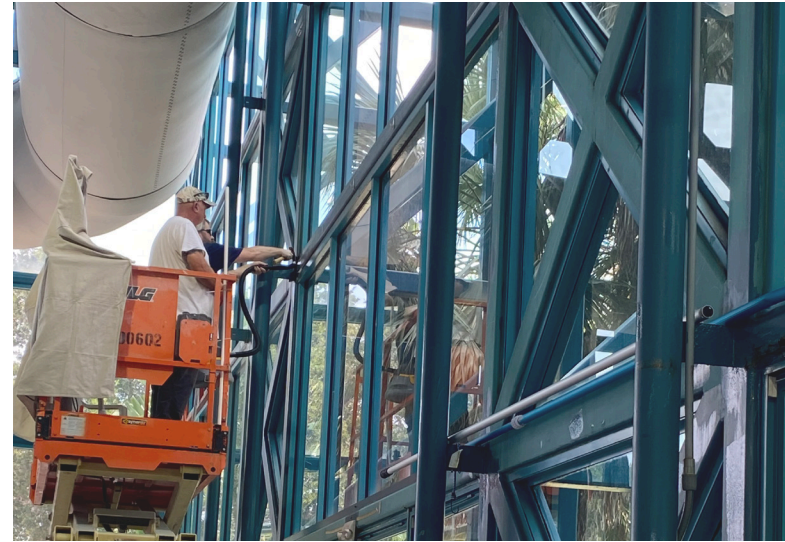
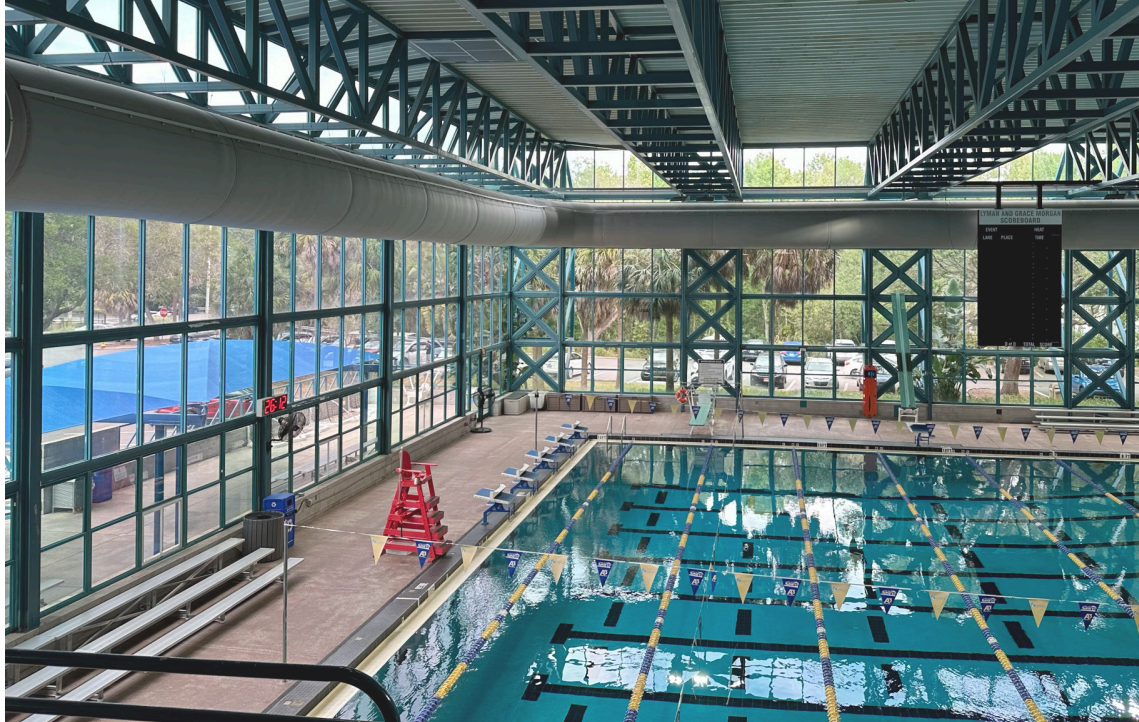
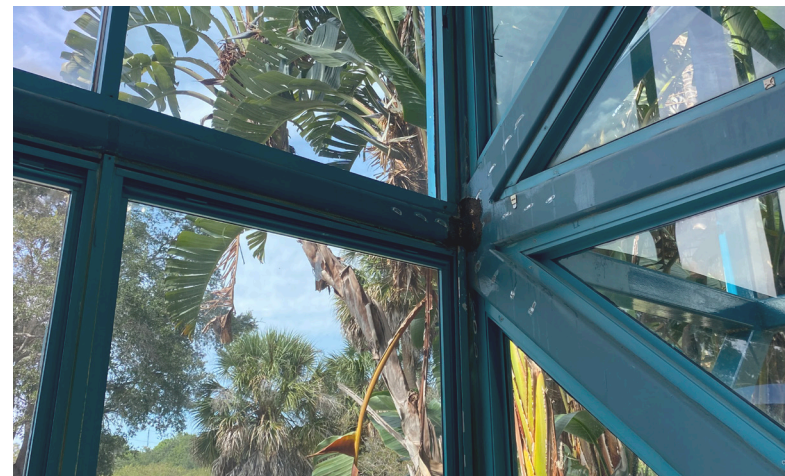
CURRENT ISSUES

- Dectron HVAC system beyond useful life span, unable to keep up with load demand.
- Solar heat gain
- Single pane non-impact fenestration system.
- Corrosive environment causing steel to rust.
- Roof system beyond usable life-span.
- Poor water filtration at pools
