# CITY OF CLEARWATER CLEARWATER POLICE DOCKING FACILITY INSPECTION AND DAMAGE ASSESSMENT

April 2026

**Prepared for:**  
The City of Clearwater

**FIRST LINE  
COASTAL**

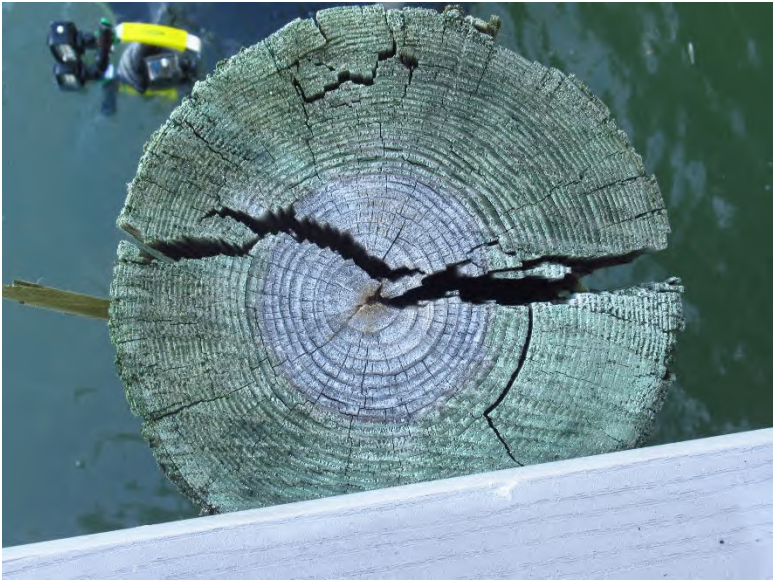
| <b>Figure 2</b> | | |

- **Splitting and Cracking:** Repeated wet and dry cycles have degraded the dock's timber members, reducing their structural density and causing deep splits and cracks. Maximal forcing during extreme weather events are likely to have accelerated damage. See figure 2 below.

| <b>Defect Type: Splitting</b> | | |
| <b>Issue:</b> Splitting is primarily caused by the cycle of repeated saltwater exposure and drying, causing a breakdown in the wood fibers. Maximal loading can cause extensive cracking, especially near hardware penetrations like this pile along Lift Slip 2. | | |

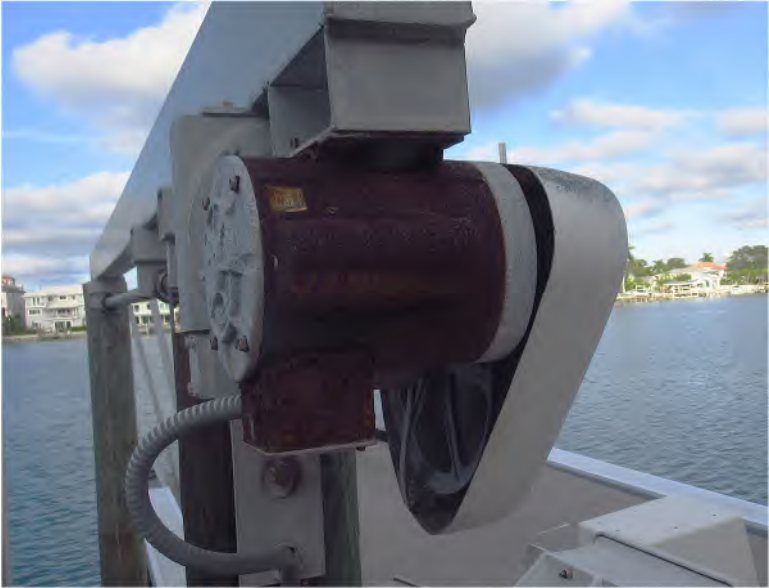
| <b>Figure 3</b> | | |

- **Oxidative Corrosion (rust):** Exposure to the marine environment has triggered widespread oxidation of metal hardware and components. Corrosive damage to electrical compounds is widespread. Observed severity ranges from surface pitting to component seizure. Given proximity to the Gulf and Clearwater Pass, above-water components likely encounter aerosolized sea spray (salt air) on a regular basis. Storm events lead to direct spray and even full submersion. See figure 3 below.

| <b>Defect Type: Rust/Corrosion</b> | | |
| <b>Issue:</b> Rust and corrosion is a common issue around water and is caused by oxidation within the metals. Direct exposure to salt water from splashing or submersion often leads to current leaks in electrical components like this lift motor at Lift Slip 2. | | |

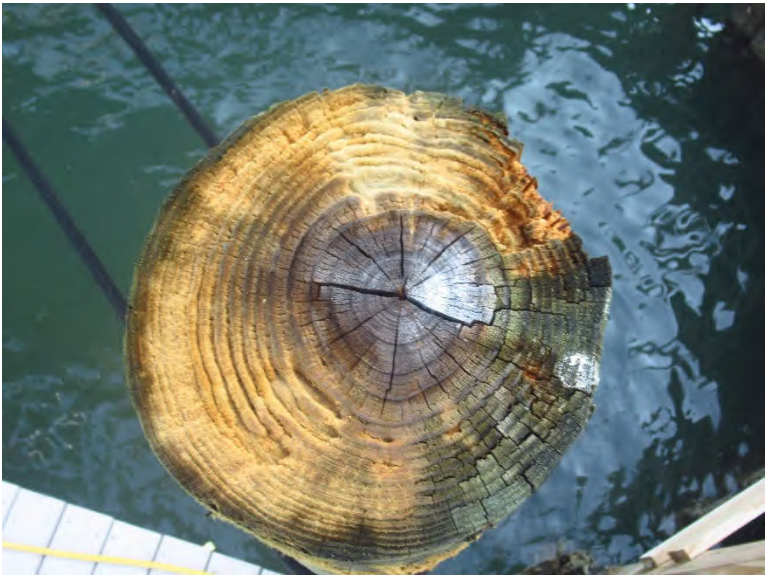
| <b>Figure 4</b> | | |

- **Dry Rot:** High-moisture conditions have promoted fungal growth, leading to degradations on timber structures. This reduces the load-bearing capacity of the wooden components. Dry rot is an anticipated wear with wood members in the marine environments. See figure 4 below.

| <b>Defect Type: Dry Rot</b> | | |
| <b>Issue:</b> Dry rot presents itself in moisture rich environments, like a piling on a dock, where fungi eat away at the wood. Preventative measures may include pile caps, coatings and wraps. | | |

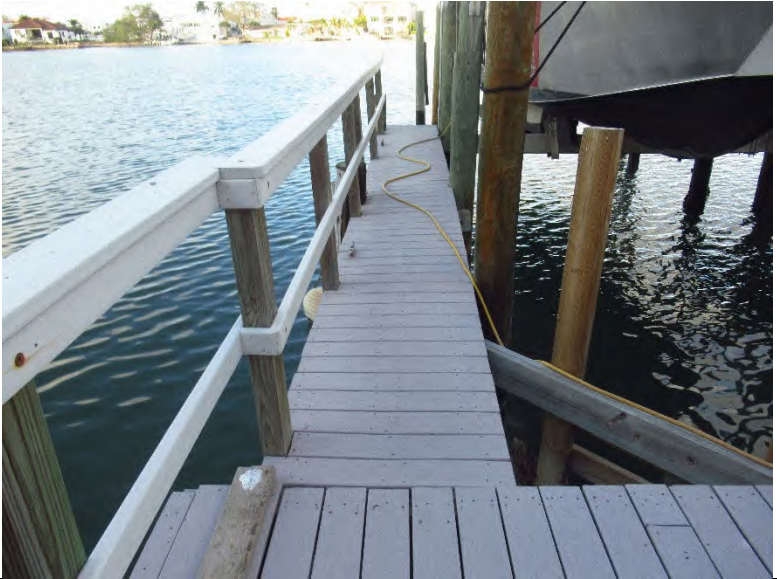
| <b>Figure 5</b> | | |

- **Instability:** Various stressors—including wave action, wind energy, and vessel impacts—have compromised the dock's rigidity. Evidence includes leaning pilings and movement in finger piers under minimal loads. The loading conditions which cause gradual instability are exacerbated in extreme weather events. See figure 5 below.

| <b>Defect Type: Instability</b> | | |
| <b>Issue:</b> General dock instability is noted at several primary facility elements. Finger pier 1 is notably unstable under minimal loads (like walking). Likely sources of damage include lateral loading, collision, and surge loading during storm events. | | |

**Finger Pier 1** – Post storm, the pier exhibits significant lateral instability. Evidence of impacts from movement of the Fire Boat are apparent. Pile splits and imminent failure of a cross member are present. Decking has been temporarily repaired but remains uneven. Overall stability of the pier is poor, but without signs of imminent failure.

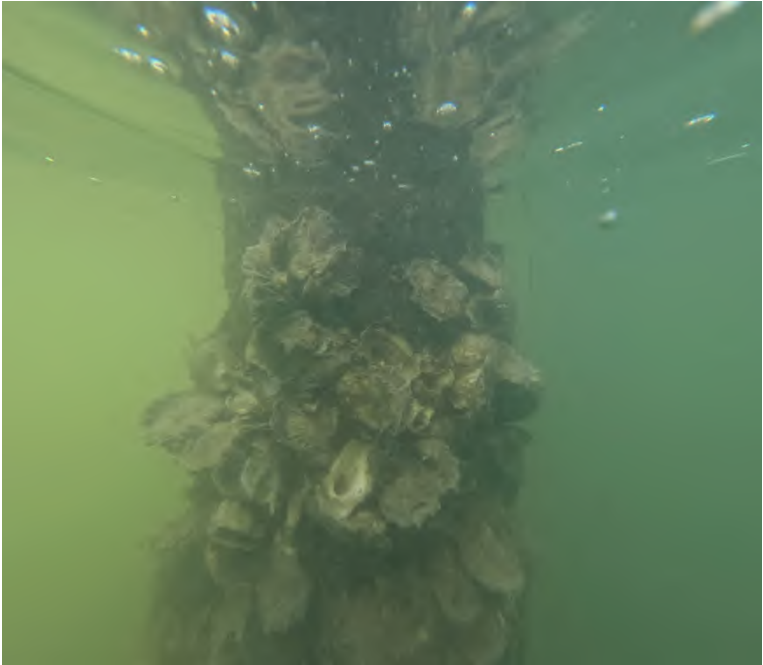
| <b>Figure 6</b> | | |

- **Biofouling:** Accumulation of algae, oysters, mussels, and tunicates are present at varying levels on all pilings, both on bare and wrapped piles. This increases the impact of stressors such as waves by increasing the surface area and their forcing against the member. These organisms also accelerate timber degradation. Marine growth is common for this region. See figure 6 below.

| <b>Defect Type: Biofouling</b> | | |
| <b>Issue:</b> Growth is inevitable in a marine environment. A common and effective preventative measure is a piling wrap. Occasional removal by scraping accessible pilings is advisable to extend pile life and reduce potential vessel damage. | | |

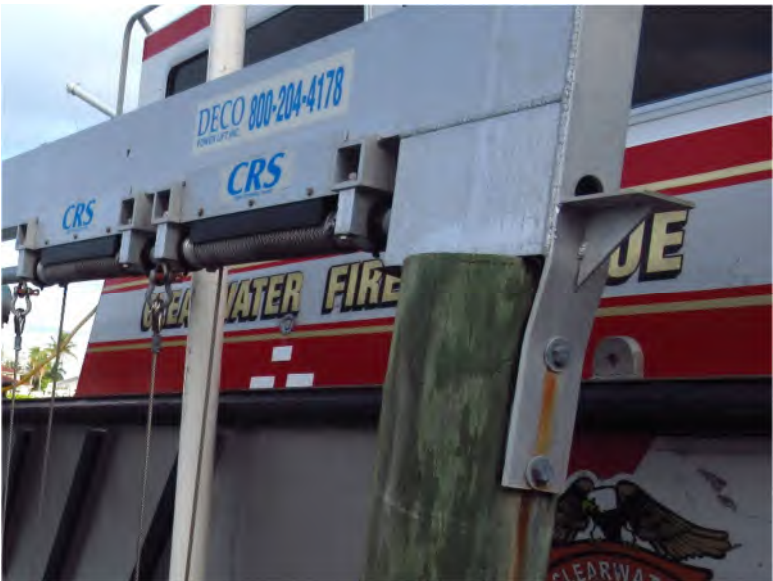
| <b>Figure 7</b> | | |

| <b>Defect Type: Hardware Damage</b> | | |
| <b>Issue:</b> Lateral load forcing is apparent at several locations and is likely the cause of wind and wave action during storm events. Deflection of hardware connections in the direction of wave forces are evident at Lift Slip 1. | | |

**Lift Slip 1** – Post storm, the lift has remained in operation. Movement of the Fire Boat during Helene has caused notable shifting of the western lift beam and deflection of mounting brackets. Minor shifting was also noted on the eastern beam. The flywheel cover is missing from a lift motor. Electrical components were exposed to seawater. The users of the slip report adequate operation with good stability. The risk rating for the deflected mounting beam brackets assigns a Very High priority to repair.

| Table 6 – Selective Individual Repairs to Existing | |
|---|---|
| Replace Lift 1 | \$ 53,494 |

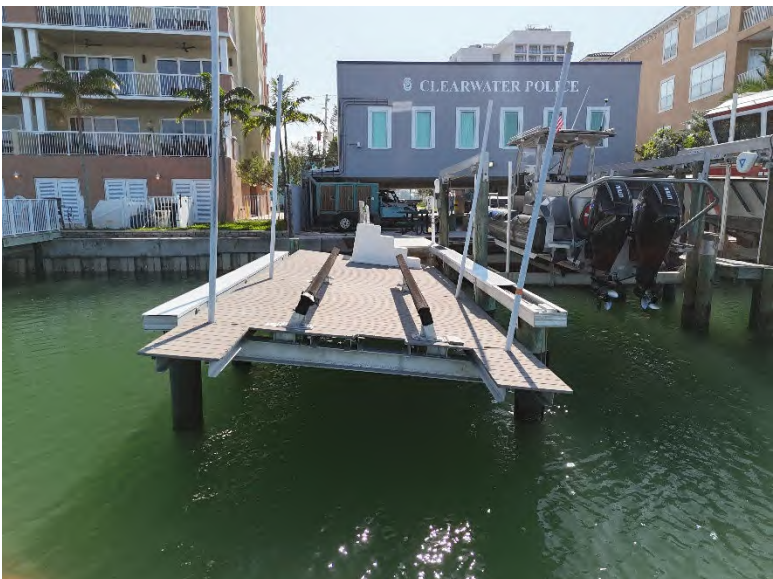
| <b>Defect Type: Mechanical Failure</b> | | |
| <b>Issue:</b> Mechanical failure has been encountered at several locations. Lift Slip 3 was removed from service following hurricane Helene and rests in a state of disrepair. The longevity of electrical components at the facility are of particular concern, as they have encountered varying levels of seawater intrusion during storms. | | |

**Lift Slip 3** – The lift was taken out of service following Helene and is non-operational. The hydraulic control box was fully submerged during Helene. Efforts to secure the lift have been unsuccessful due to failure of the hydraulic system, leaving an uneven platform that is non-operational and hazardous to users. Movement of the eastern pulley and lift housing was notable with deflection of mounting brackets and is likely attributable to wind loading during Milton. With consideration to the operational impacts of a loss of use for the Police Boat Lift, a risk rating of Very High is appropriate for priority repair.

| Table 6 – Selective Individual Repairs to Existing | |
|---|---|
| Replace Lift 3 | \$ 37,107 |

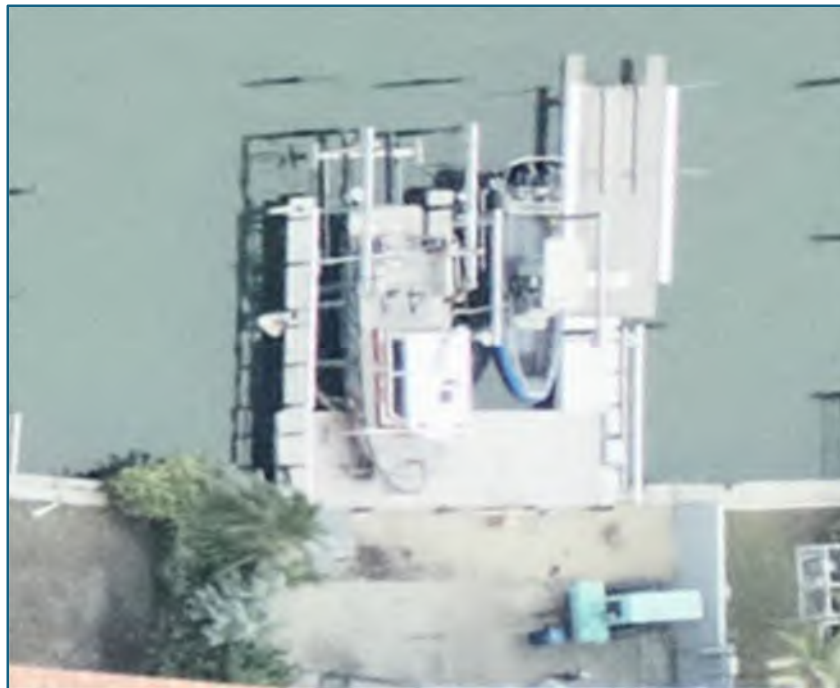
Figure 15: Post Storm (Helene) Imagery of Fire Vessel on Dock (NOAA NGS Emergency Response Imagery, 10/01/2024)

**Main Deck** – Evidence of lifting and cracking were observed during inspection. The deck also experienced collision and surge loading during Helene when the Fire Boat was floated onto it. Surface undulation and piling penetration of the planer deck surface indicates localized subsidence. Overall stability of the deck is moderate without signs of imminent failure.

| Table 6 – Selective Individual Repairs to Existing | |
|---|---|
| Replace western half of main deck | \$ 50,830 |
