# TECHNICAL MEMORANDUM

**Re:** City of Clearwater  
Disaster #4834DR  
Damage #1514623, Alligator Creek  
Sites 1, 2 & 3A (Repair & Mitigation)

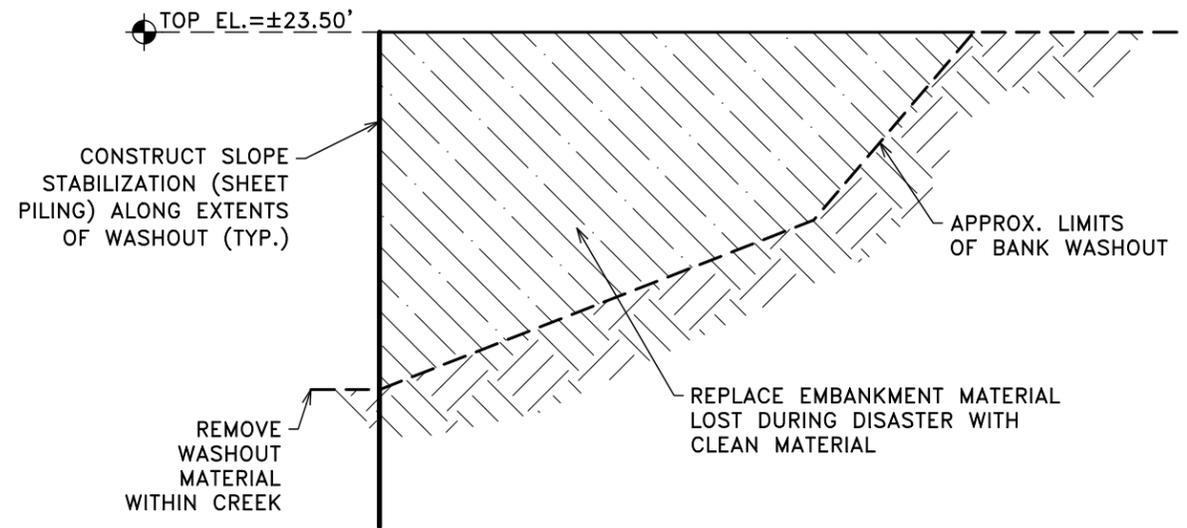
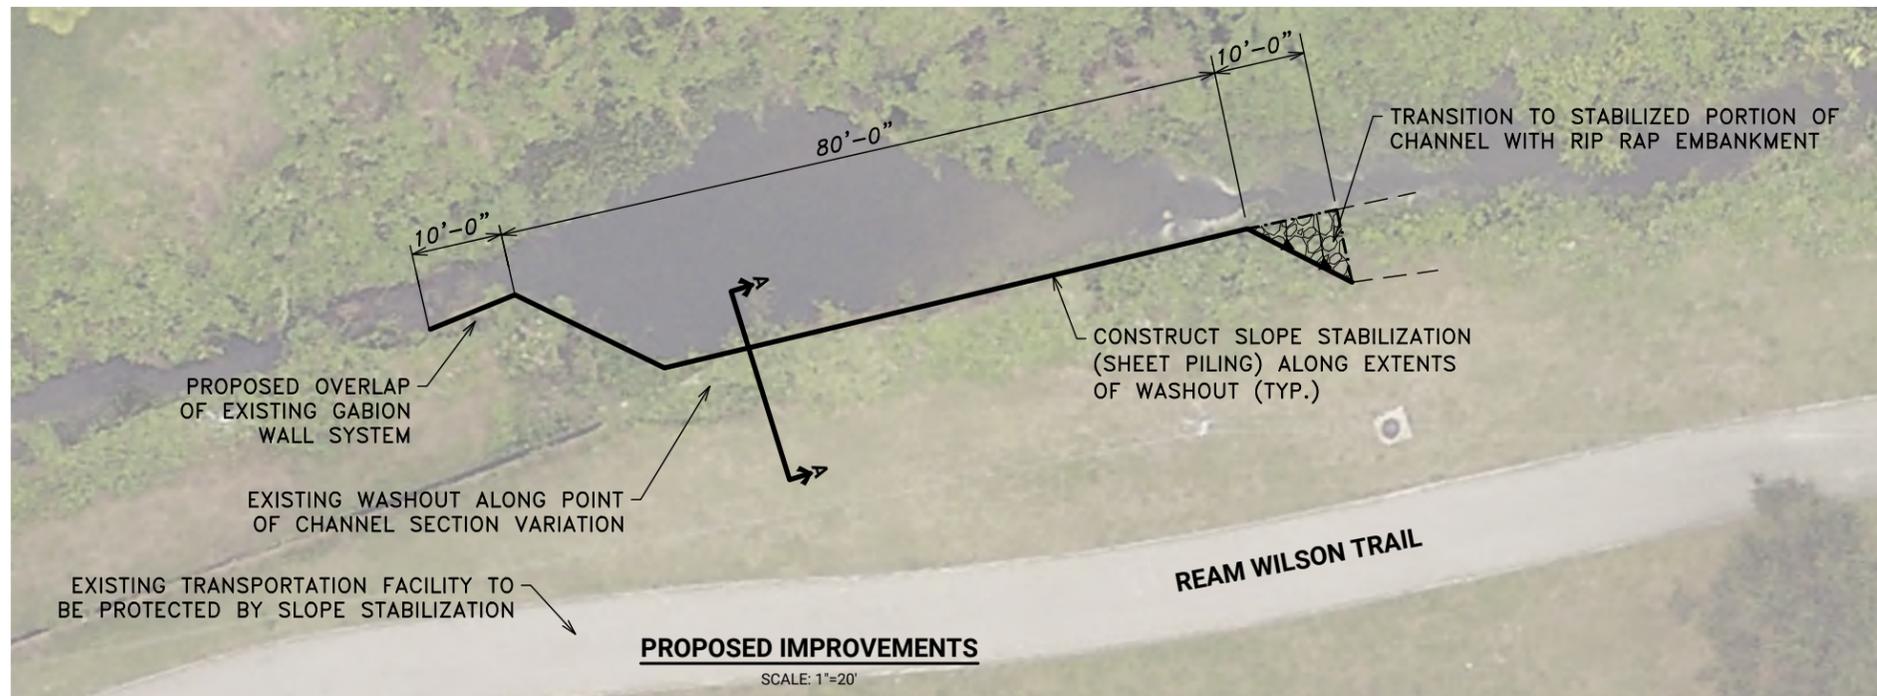
**DAMAGE #1514623,  
 ALLIGATOR CREEK  
 SITE 1 (REPAIR)**

The damaged embankment was a vegetated creek bank for a critical open conveyance facility. While the slope was stable in the pre-damage condition, it was relatively steep. This slope was stabilized solely through the presence of established vegetation whose root system penetrated deep into the ground. High velocities experienced during Disaster #4834DR resulted in a loss of this vegetation which in turn de-stabilized the slope and damaged the embankment.

Considering that this is an active open conveyance facility, reconstructing a stabilized vegetated slope is not practical. Repairing the bank through the placement of native soil and vegetation would not restore basic function and safety. Without a deep root system (which takes years to grow), this soil would be un-stabilized and thereby subject to future failures during non-severe storm events. As such, the City will be pursuing the installation of a sheet piling system as the means of slope stabilization repair.

Slope stabilization using sheet piling will require that the sheet piles be offset from the existing embankment toe of slope. Native soils would be placed landward of the slope stabilization to re-establish pre-damage runoff patterns.

The extents of slope stabilization cannot match the limits of the washout; they must extend beyond in either direction. Terminating at the point of connection can result in undermining and further washout. Therefore, slope stabilization is proposed to extend upstream and downstream of the limits identified in the DDD.

A transition will be needed between the method of slope stabilization (sheet pile wall system) and the connection to the existing embankment. This is because the typical sections differ. Since vegetated slopes cannot be repaired due to the time required for vegetation establishment, rip rap material will be needed to stabilize the new embankment.

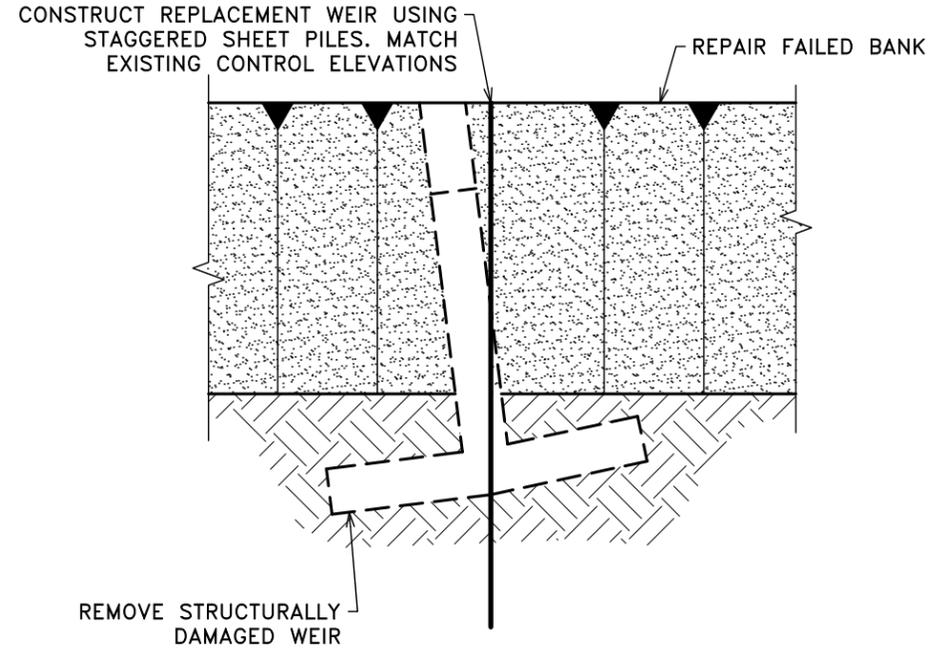
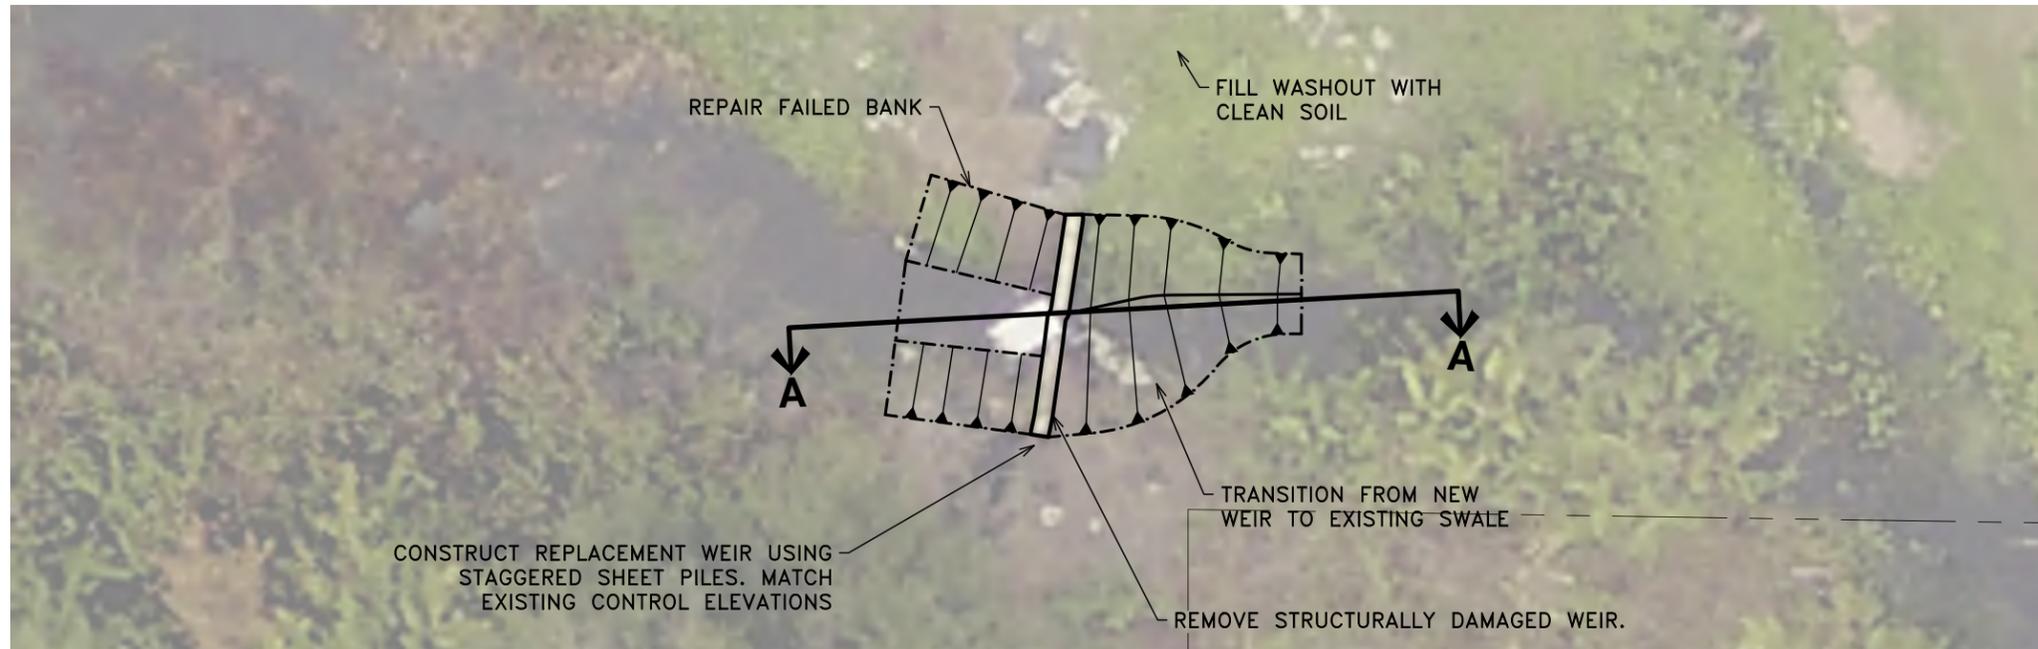
**DAMAGE #1514623,  
ALLIGATOR CREEK  
SITE 2 (REPAIR)**

A weir associated with a stormwater management facility is located at the site. High stages in the facility resulted in overtopping of the weir. This overtopping resulted in excessive velocities over the weir resulting in vegetation loss and eventual washout of the surrounding bank. The concrete weir structure was undermined and structural damage is apparent.

The weir structure will be repaired dimensionally in-kind to ensure that critical elevations are replicated. In lieu of constructing a concrete weir, the use of a staggered sheet pile system is proposed. Modification of the sheets will be needed to ensure dimensional replication of the existing facility.

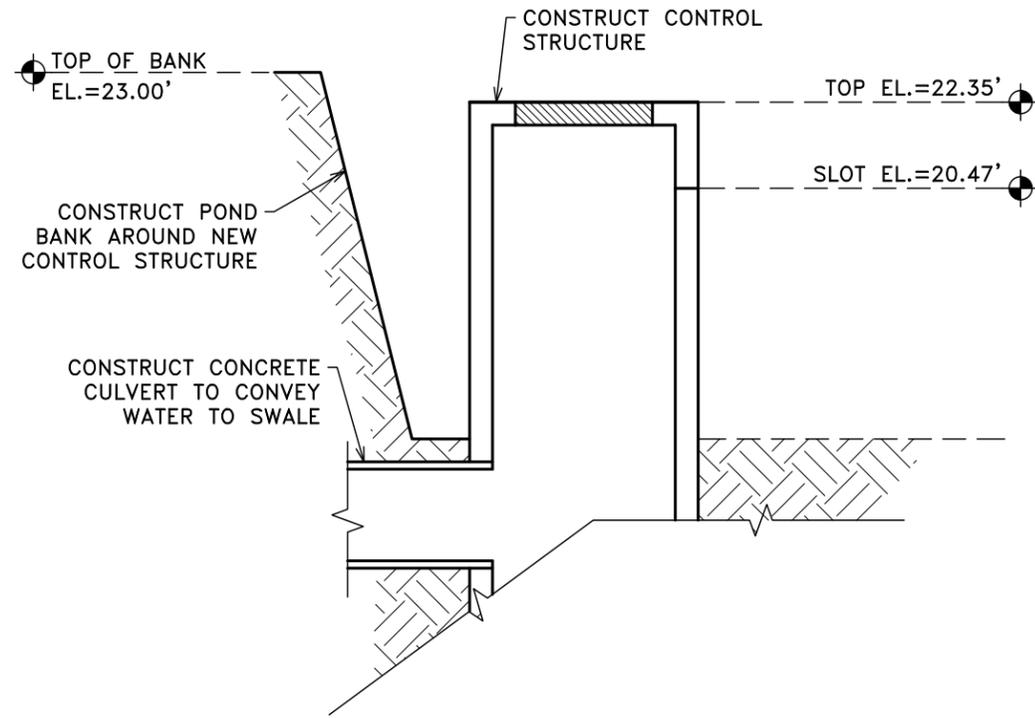
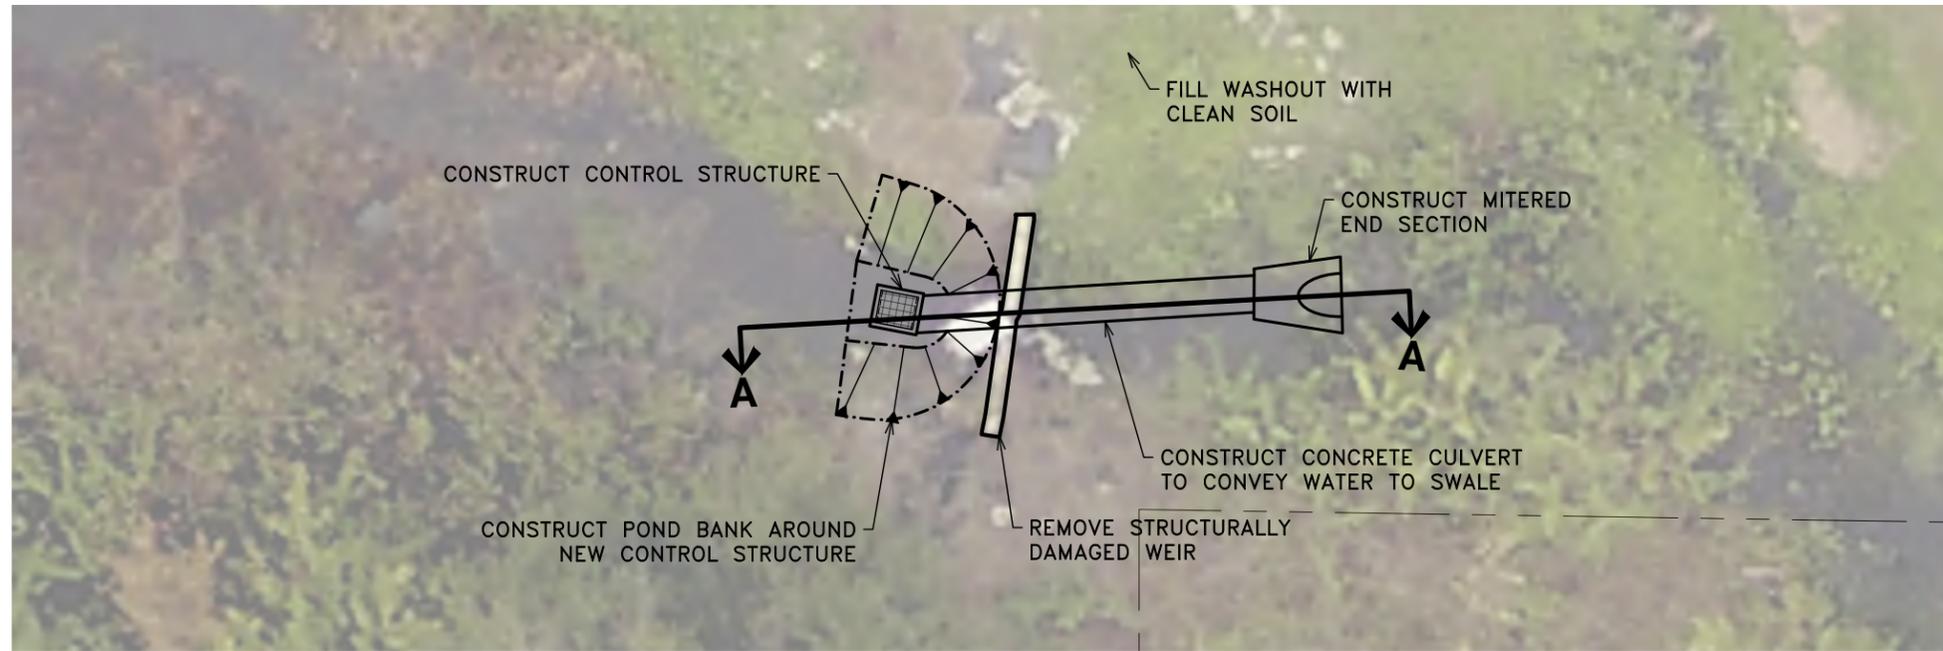
**DAMAGE #1514623,  
 ALLIGATOR CREEK  
 SITE 2 (MITIGATION)**

The stormwater management facility's only discharge is through this control weir. Water cascading over this weir causes erosion on the downstream side of the structure. The City continuously maintains this location to ensure that the erosion doesn't result in structure undermining. However, during severe and /or long-duration storm events, maintenance of this area is not possible and continued flow over the weir does compromise structure stability.

To mitigate this concern, the City is proposing constructing a new control structure with a fiberglass skimmer. Discharged flows would be routed to downstream areas via a new culvert resulting in less velocity and removing the cascading feature in its entirety. This structure would be located internal to the pond (versus near the bank) so it would be immune from washout concerns associated with high flows.

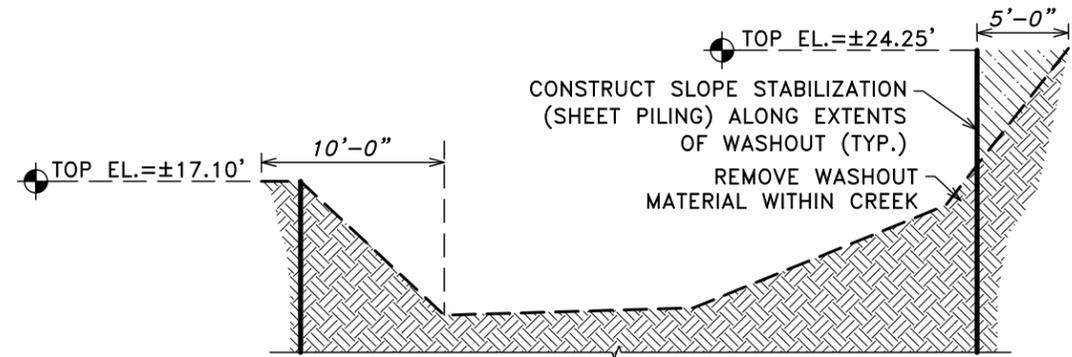
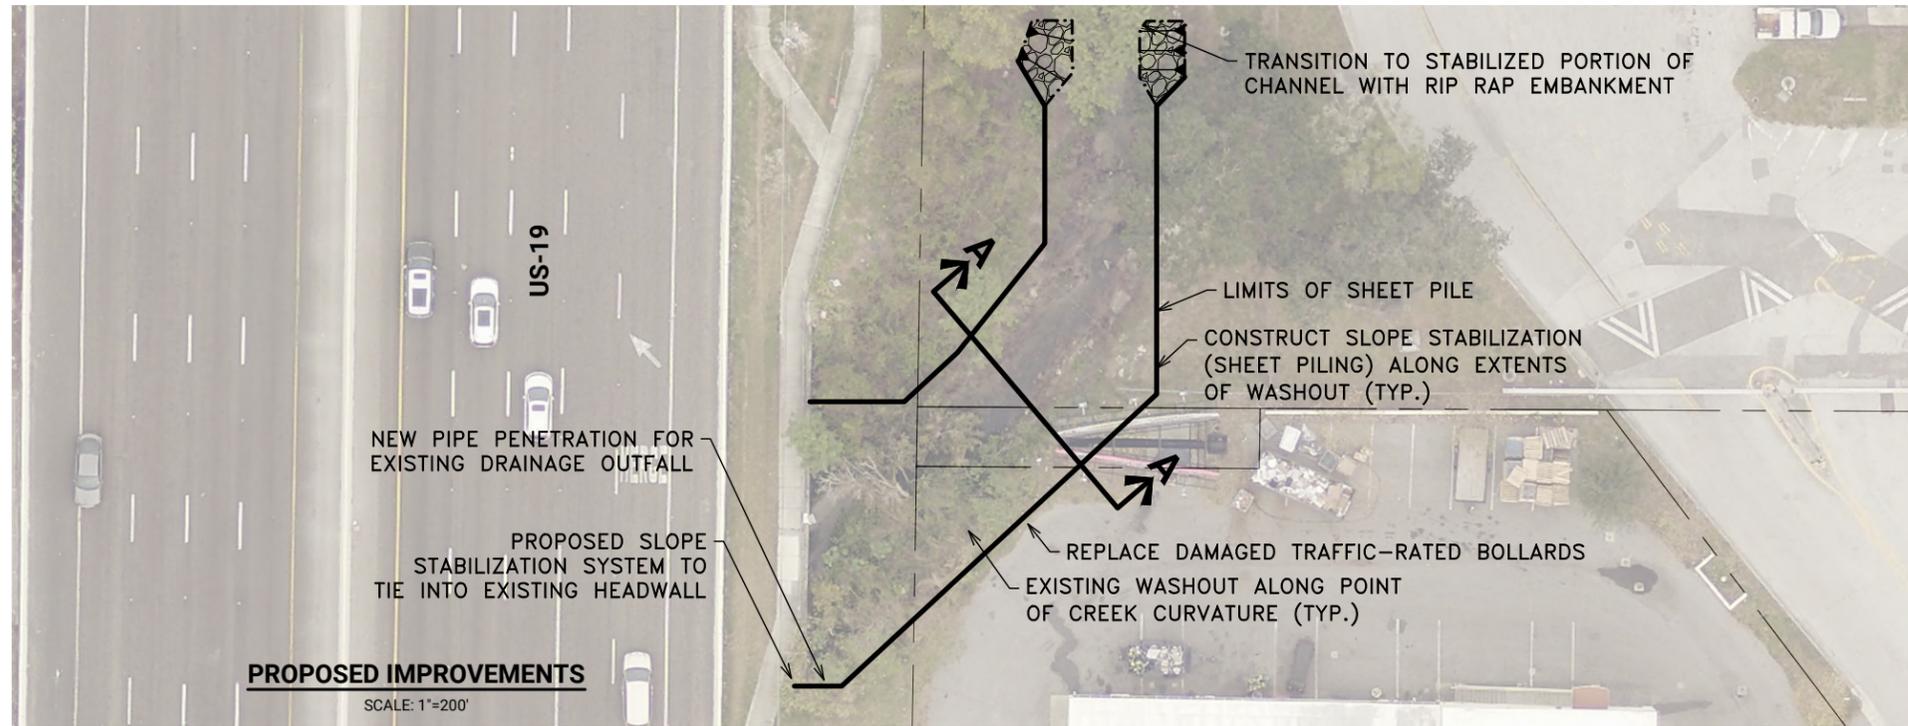
**DAMAGE #1514623,  
 ALLIGATOR CREEK  
 SITE 3 (REPAIR)**

This concern is exacerbated at Site 3A where the creek changes direction resulting in excessive forces on the outer banks.
