## FINAL REPORT

Prepared for the City of Clearwater  
January 2025

# HARBOR MARINA UNDERWATER INSPECTION REPORT

Clearwater, Florida

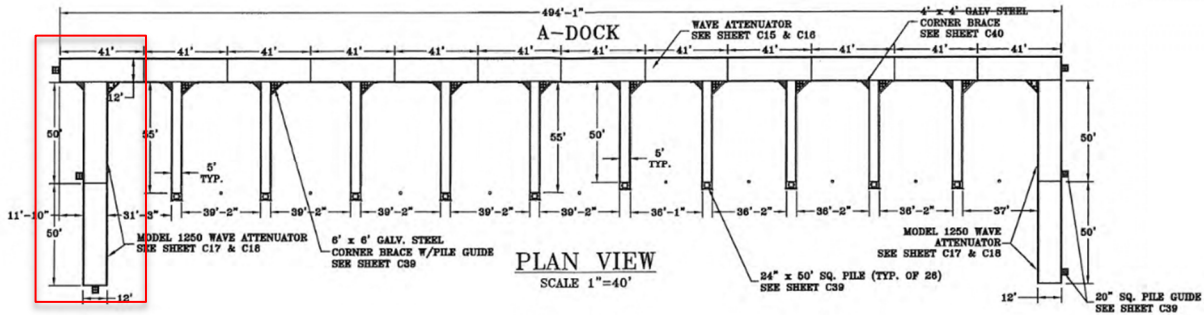
**Figure 2: Enlarged Planview A-Dock**

These large wave attenuators have two (2) tension cables that run along each side of the attenuator and connect the attenuators together. Also, there are cables on each side of the finger piers that attach them to the main dock sections. During the inspection, several of the cables were found to have more corrosion around the ends than was typically seen throughout the rest of the marina. This is especially concerning for A-Dock, since the cables in the main dock were replaced with the latest construction to replace the south wave attenuators in 2023 (see red box in Figure 2). Accelerated corrosion can be seen in Photo 2.

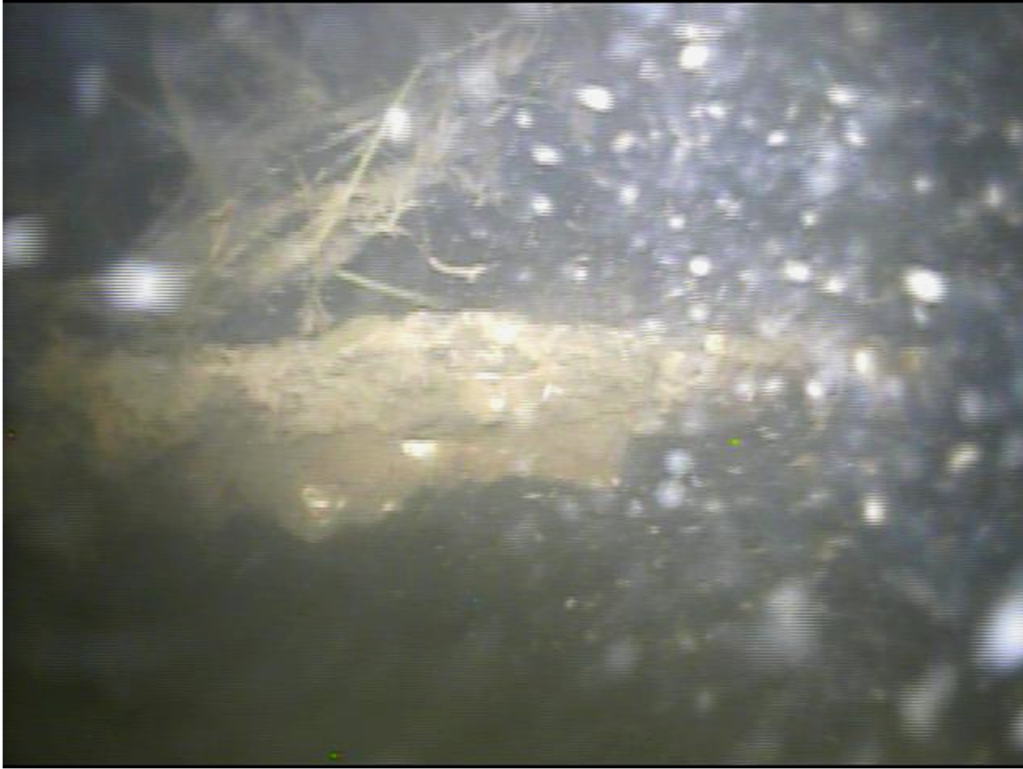
The most outer wave attenuator (northwest side) of the marina, referred to as A-Dock, consists of twelve (12) 41 feet long by 12 feet wide wave attenuator sections, as showing in Figure 2, with a total depth of 10', see Figure 3 below. A-Dock was inspected on Monday, October 21<sup>st</sup>, during the low tide there was approximately only 2 feet of water between the bottom of the float and the mudline at the northern corner of the dock. The floatation is designed to be throughout the entire length of the dock and sealed on the bottom with a polyurethane coating. During the underwater assessment, it was discovered that the polyurethane coating has failed in most areas with more than 20% of the floatation exposed to the elements. Typical exposed floatation can be seen in Photo 1.

***Photo 1: Polyurethane Liner Tear and Exposed Foam***

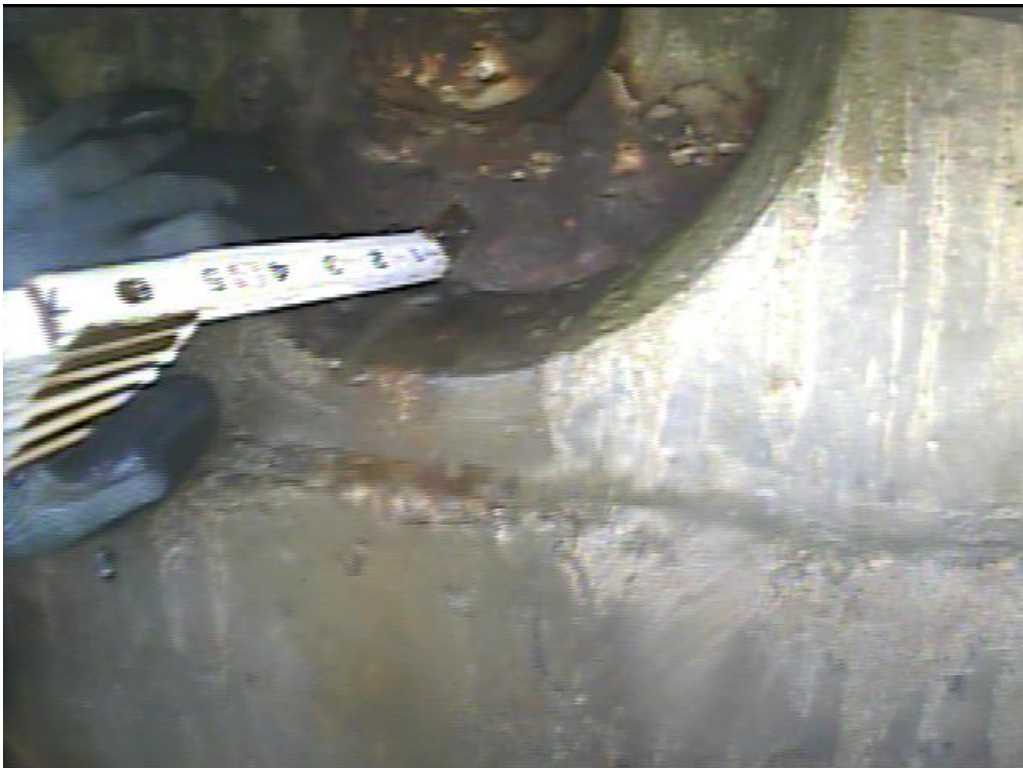
***Photo 2: Cable Corrosion Around Cable End***

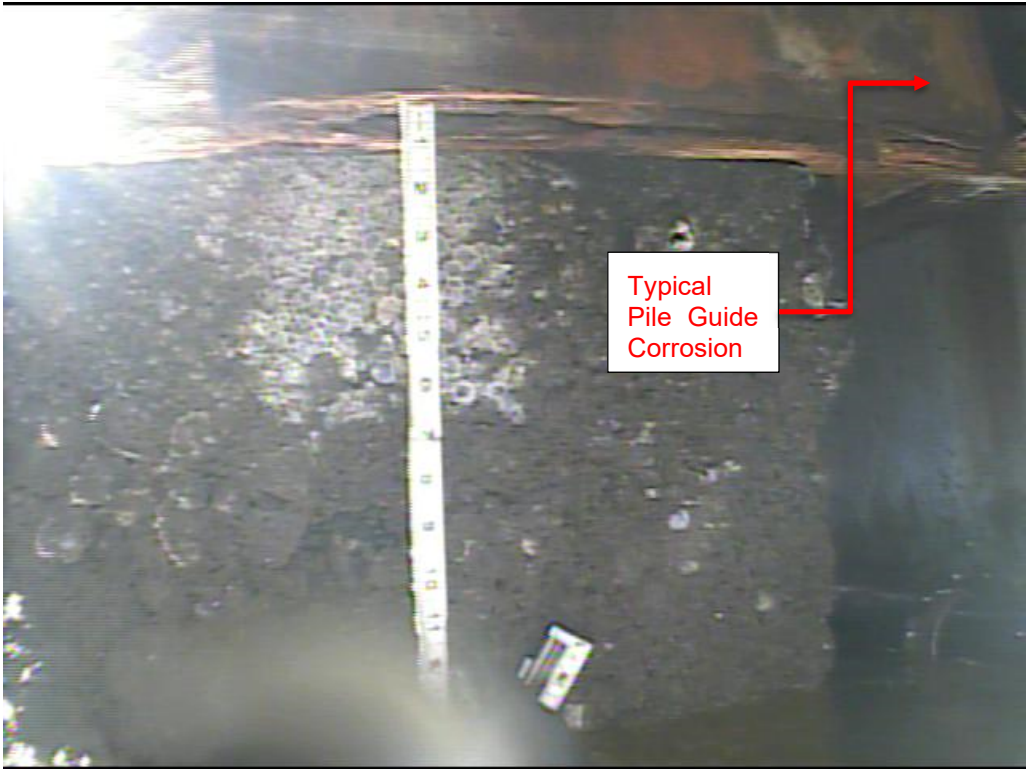
Several pile guides show serious corrosion as shown in Photo 3.

Photo 3: Typical Pile Guide Corrosion

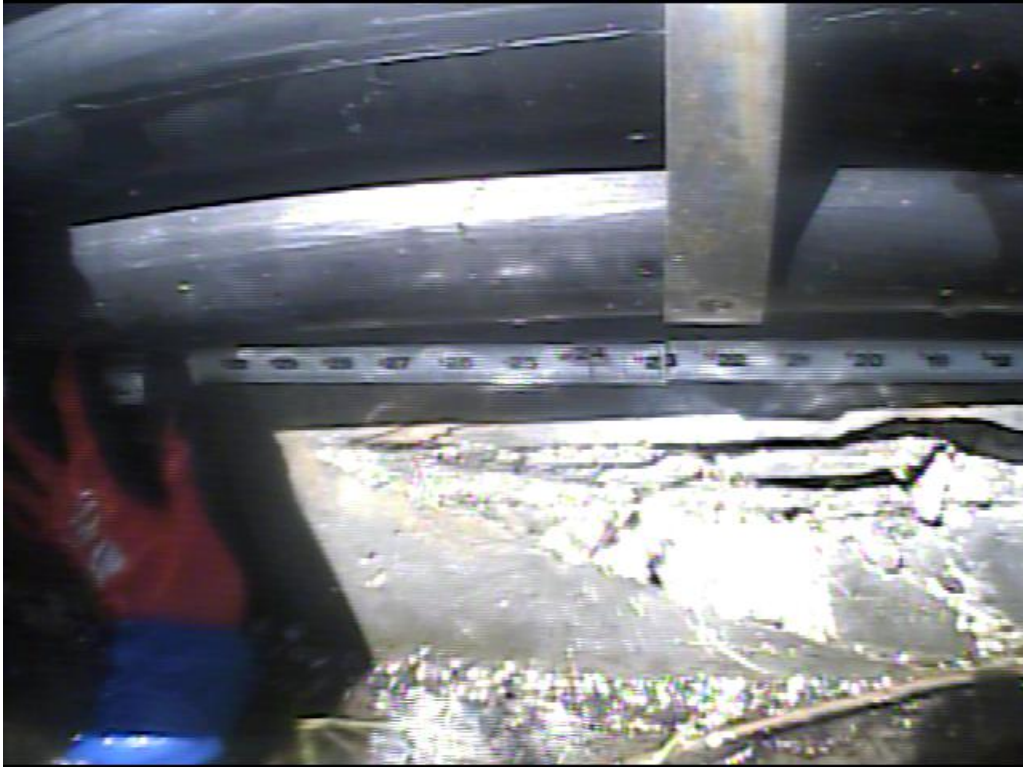
The concrete on the floats is in relatively good condition with limited spalling in some areas. Some of the spalling is minor, others are larger sections with corrosion bleed that could cause issue in the near future. An example of the largest of the large spalls can be seen in Photo 4 below.

***Photo 4: Large Concrete spall***

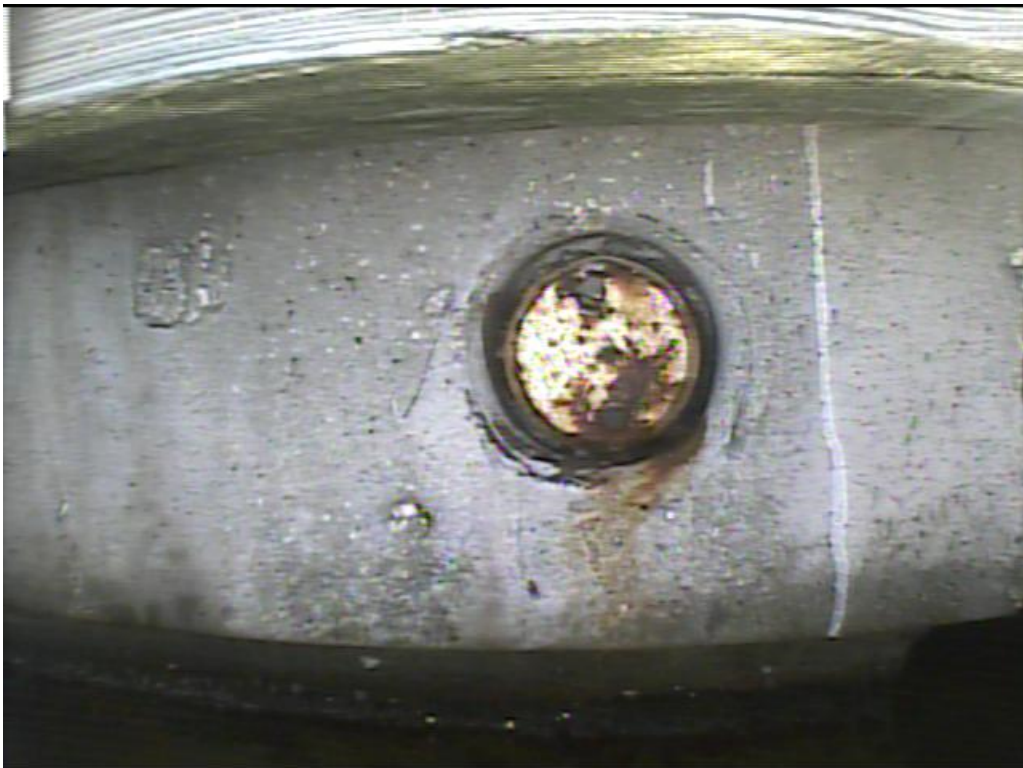
Severe corrosion was observed on many of the cables that run through the finger piers and the main dock. Photo 5 below shows one of the cables with a larger than average amount of corrosion. Although this cable does not show signs of spalling around the cable sleeve, this was observed on several cables within B-Dock.

***Photo 5: More than Average Cable Corrosion***

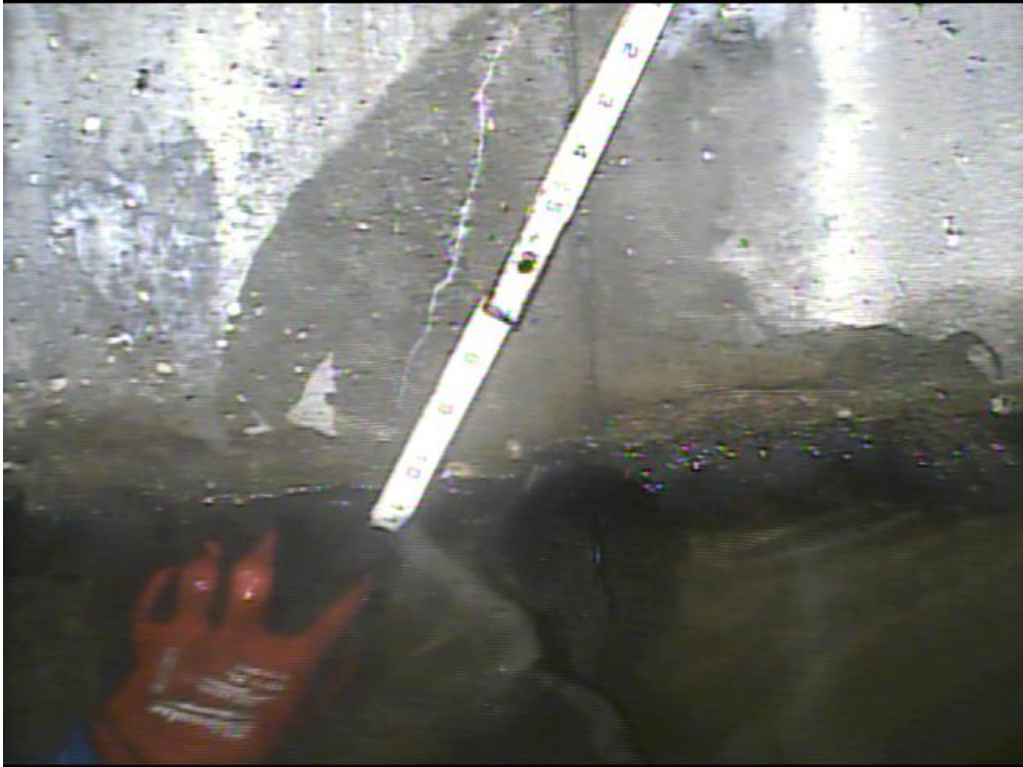
The concrete on the floats shows signs of surface cracks throughout the main dock and finger piers. These cracks appear to have corrosion pushing the crack out causing a bubble in the concrete. Photo 6 shows a typical crack that was observed during the inspection.

***Photo 6: Concrete Crack Typical***

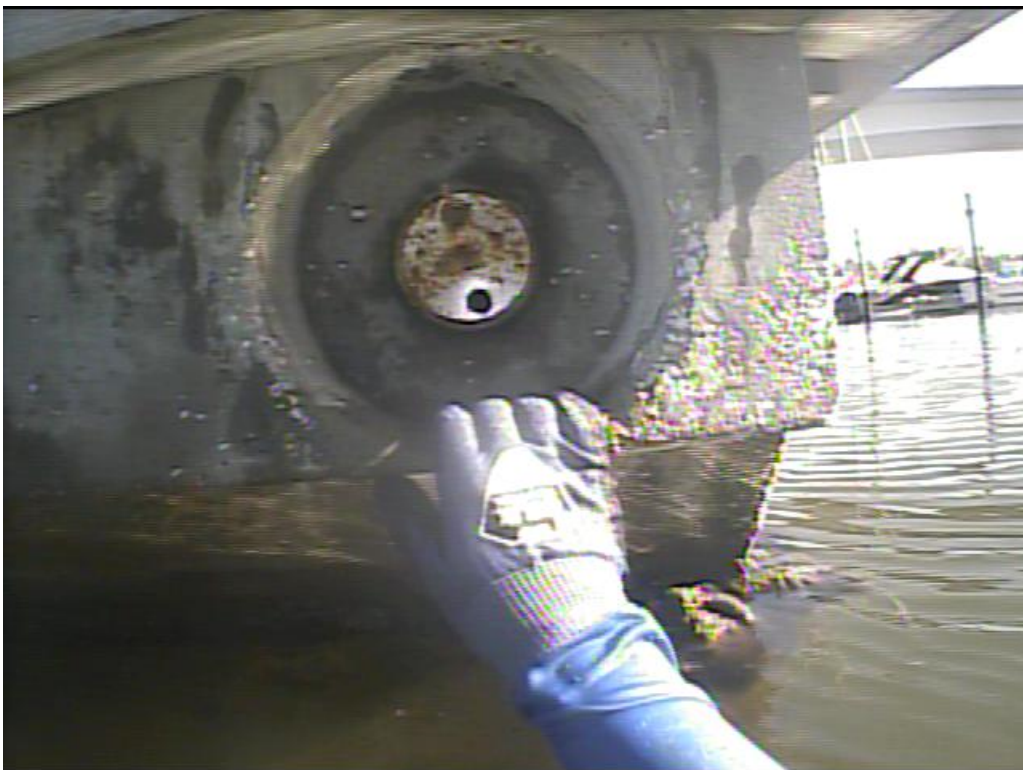
During the inspection, severe corrosion was observed on many of the cables that run through the finger piers and the main dock, several have concrete spalling around the cable sleeve. Photo 7 below shows one of the cables with a larger than average amount of corrosion and spalling than typically seen throughout the rest of the dock.

***Photo 7: Concrete Spalling around Cable Sleeve***

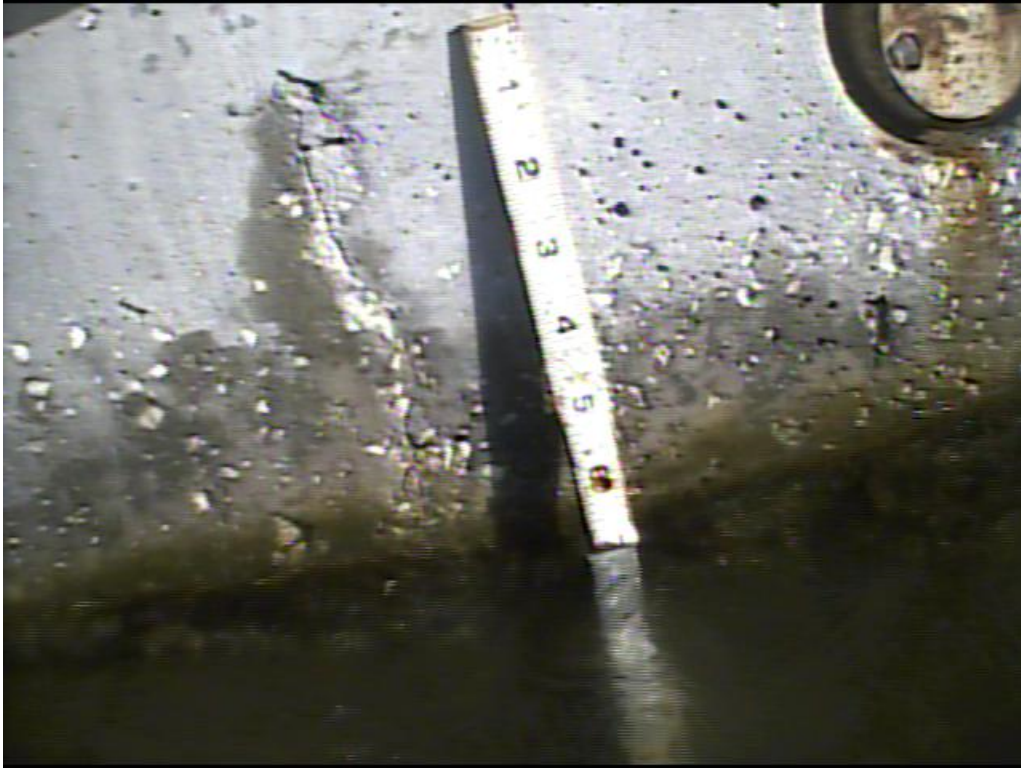
The concrete on the floats shows signs of surface cracks throughout the main dock and finger piers. These cracks appear to have corrosion pushing the crack out causing a bubble in the concrete. Photo 8 shows a typical crack that was observed during the inspection.

*Photo 8: Cracking at the west face*

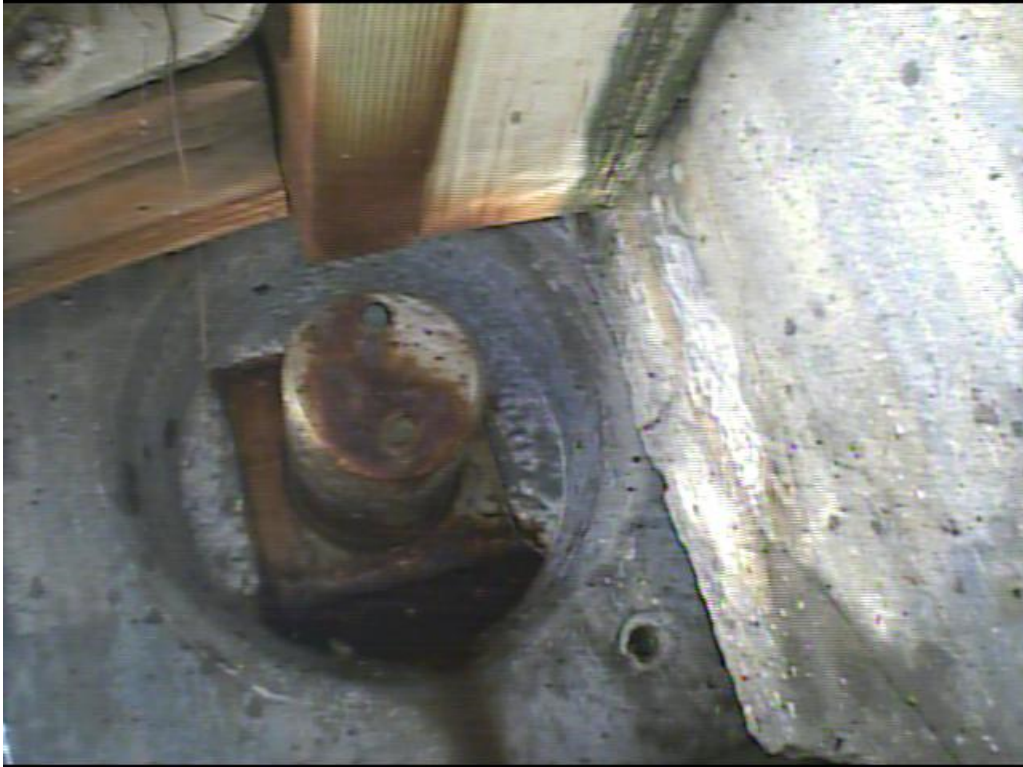
The main walkway from east to west at the north side of the south marina, called Marginal Walkway, consists of 10 feet wide concrete floats and two 12 feet wide wave attenuators at the west end, which are similar to the wave attenuators at A-Dock. The 10 feet wide floats have 1 cable on either side, where the wave attenuator has 2 cables on each side that connects the floats together. During the inspection, several of the cables were found to have more corrosion around the ends than was typically seen throughout the rest of the marina. This is especially concerning on the marginal walkway, since the entire marina is connected to the marginal walkway. Accelerated corrosion can be seen in Photo 9.

***Photo 9: Cable Corrosion***

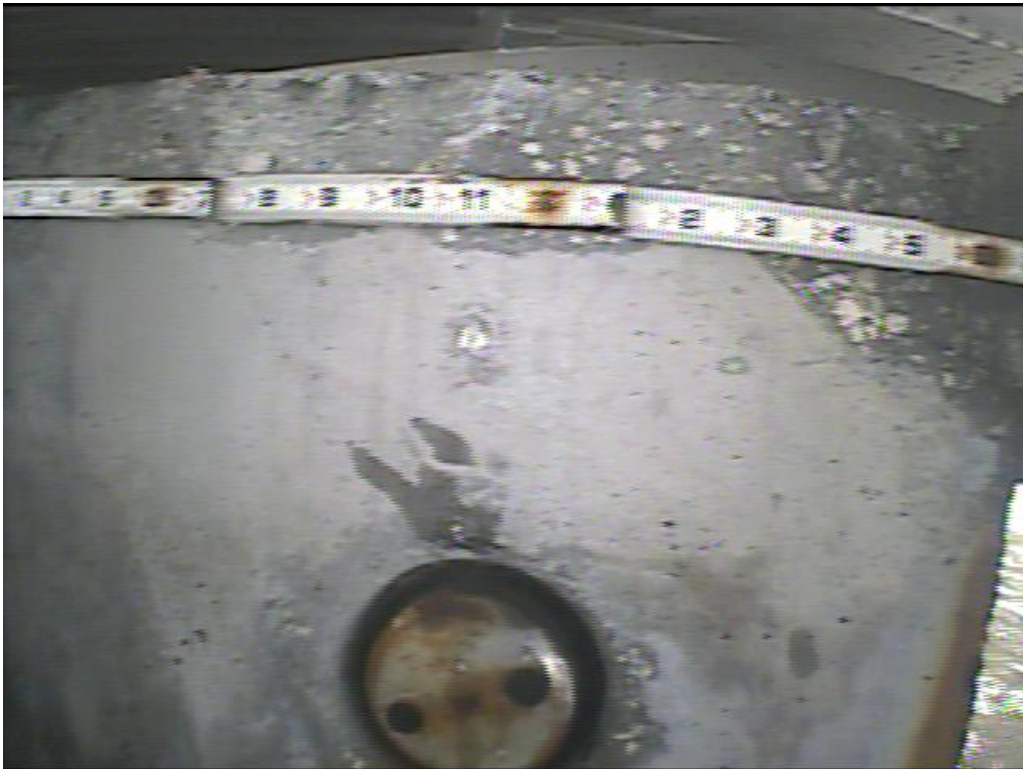
The 8 feet wide gangway to the marina caused concrete spalling damage to the first float of the marginal walkway due to the extreme high water during Hurricane Helene and caused the aluminium gangway to reverse its normal slope, causing impact to the end of the concrete float. Part of the extent of this spall can be seen in Photo 10.

***Photo 10: Concrete Spall Caused by Gangway***

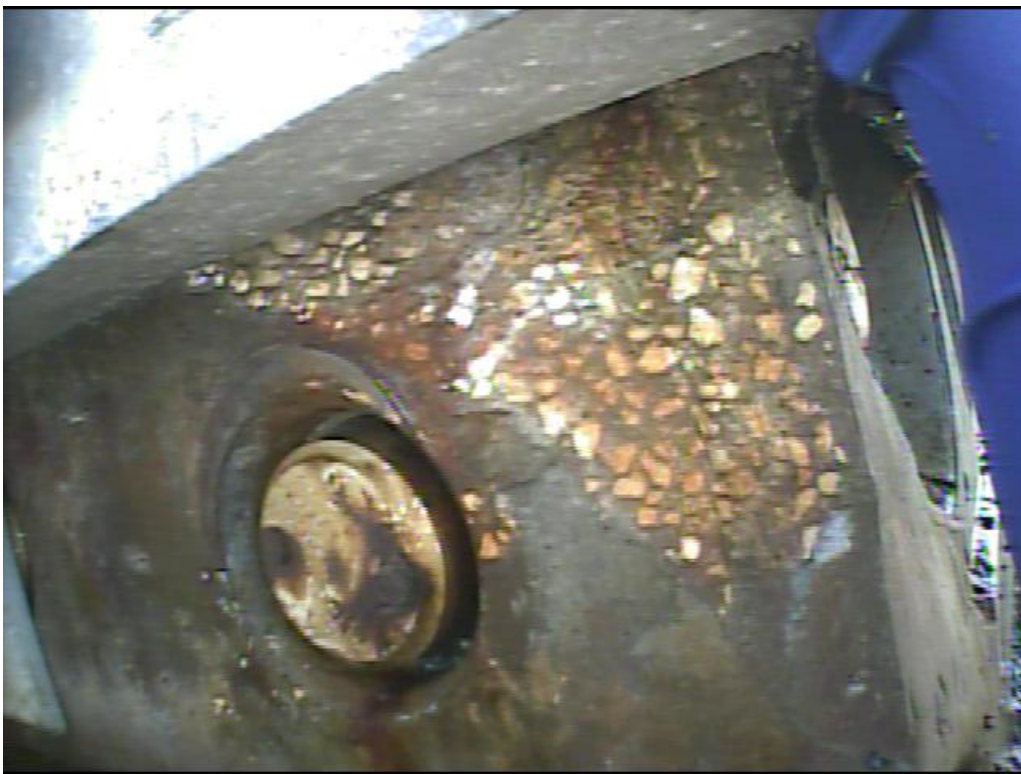
*Photo 11: NW Corner Concrete Spalling*

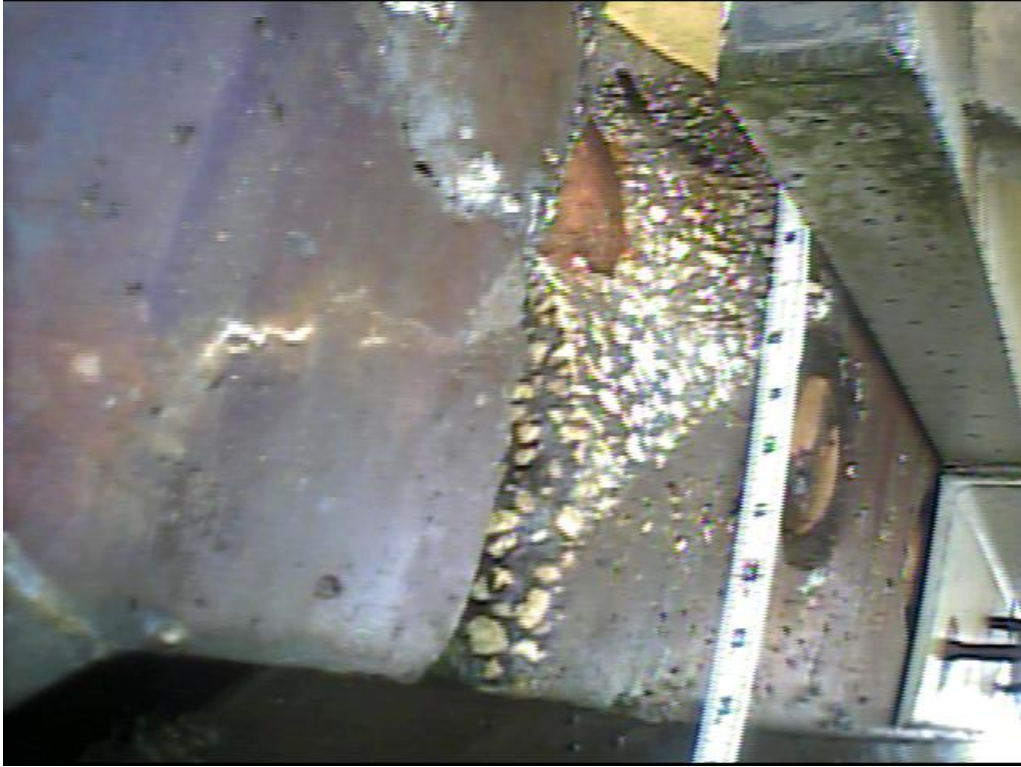
These large wave attenuators have two (2) tension cables that run through each side of the attenuator and connect the attenuators together. There are also cables on each side of the finger piers that attach them to the main dock sections. During the inspection, several of the cables were found to have corrosion around the ends. Particularly concerning is the northern most cable that shows larger sign of corrosion and cracking around the steel cable cap. Accelerated corrosion can be seen in Photo 11. In addition, several spalls with exposed steel were observed, see Photo 12.

**Photo 12: NE Corner Exposed Steel Conduit for Cable**

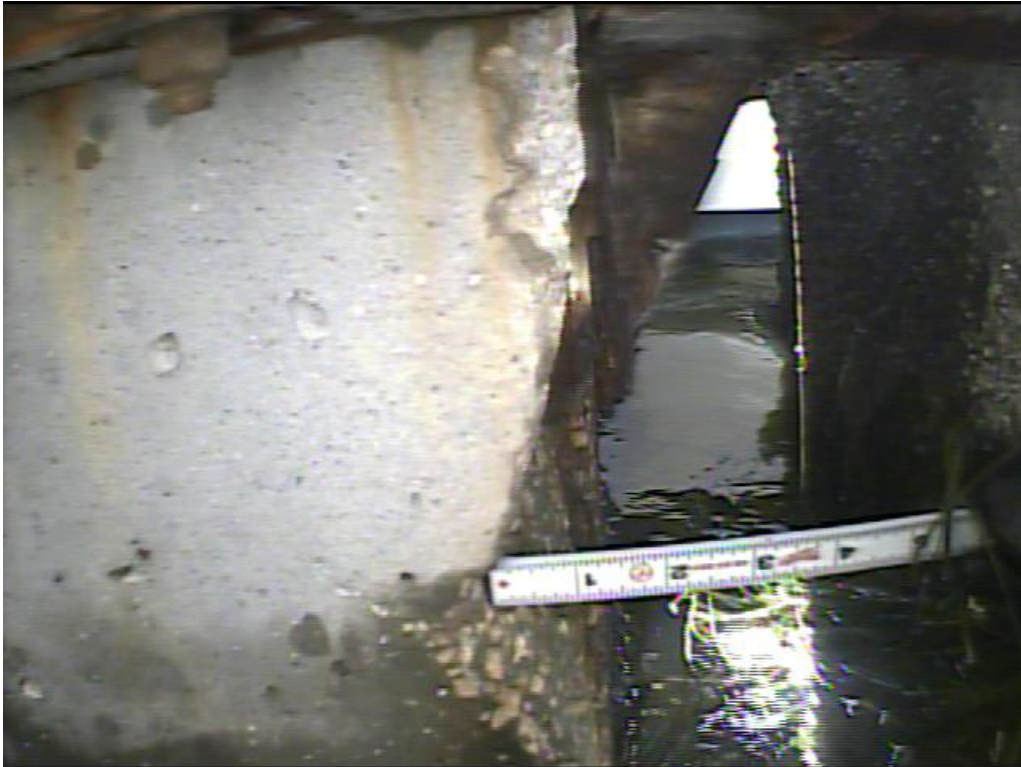
This dock is generally used to house the Freedom Boat Club and their fleet of smaller vessels. The concrete on the floats are in relatively good condition with limited spalling and cracking in some areas. Some of the spalling is minor, others are larger sections with corrosion bleed that could cause issues in the near future. An example of one of the larger spalls can be seen in Photo 13 below.

*Photo 13: NW Corner Spall*

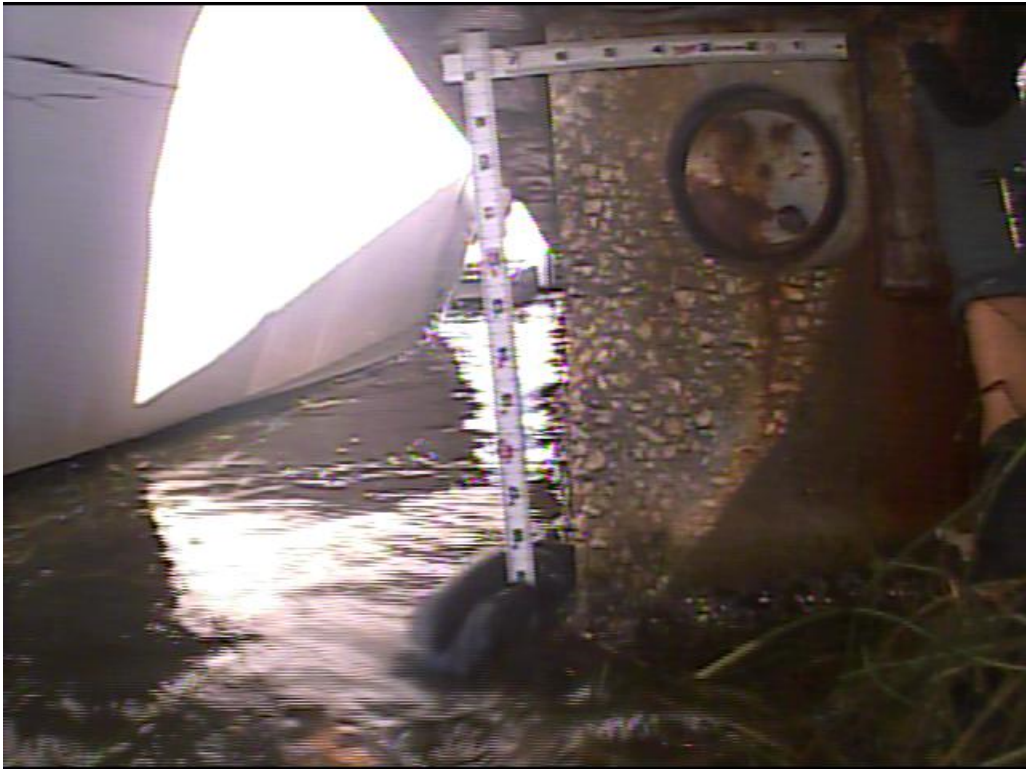
During the inspection, severe corrosion was observed on many of the cables that run through the main dock and finger piers. Photo 14 below shows one of the cables with a larger than average amount of corrosion.

**Photo 14: NW Corner Concrete Spalling**

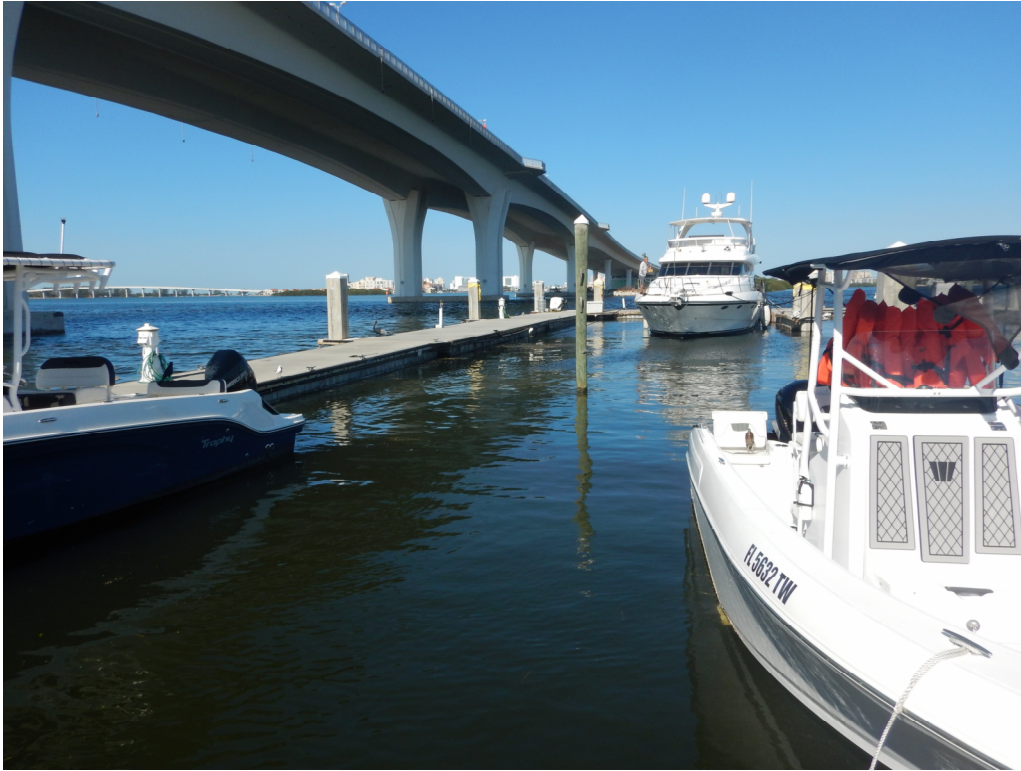
During the underwater assessment, it was discovered that the polyurethane coating has failed in most areas with more than 50% of the floatation exposed to the elements or large holes have been created. In some areas have whole sections of floatation missing, this could be the reason that there has been noticeable listing (high spots and low spots) along the walkway, see Photo 15.

*Photo 15: Walkway Listing*

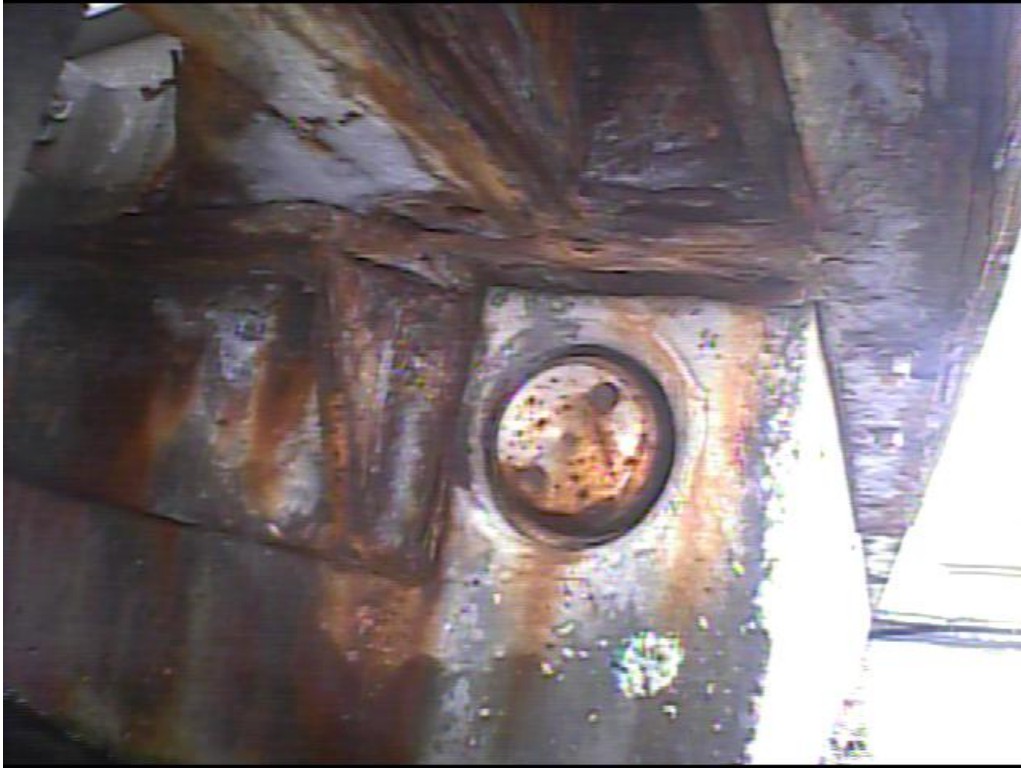
Several of the cables were found to have corrosion around the ends as typically seen throughout the rest of the marina, see Photo 16.

**Photo 16: Corroded Cable End**

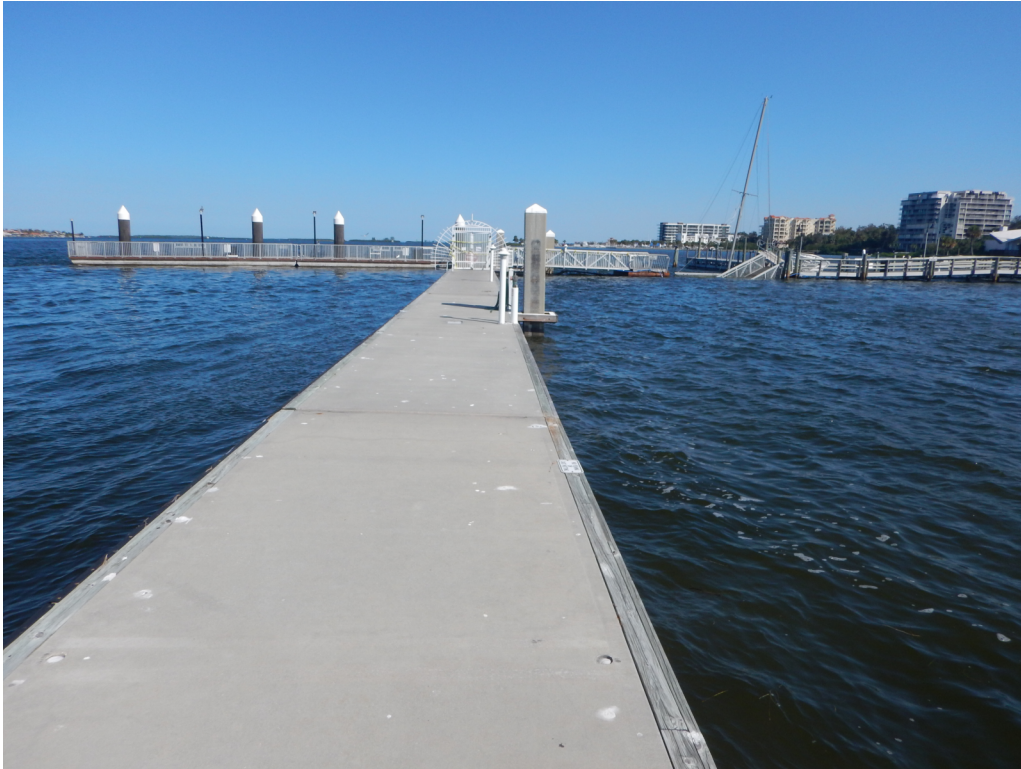
During the underwater assessment, it was discovered that the polyurethane coating has failed in most areas with more than 30% of the floatation exposed to the elements or large holes have been created. In some areas have whole sections of floatation missing, this could be the reason that there has been noticeable listing (high spots and low spots) along the walkway, see Photo 17.

***Photo 17: Walkway Listing***

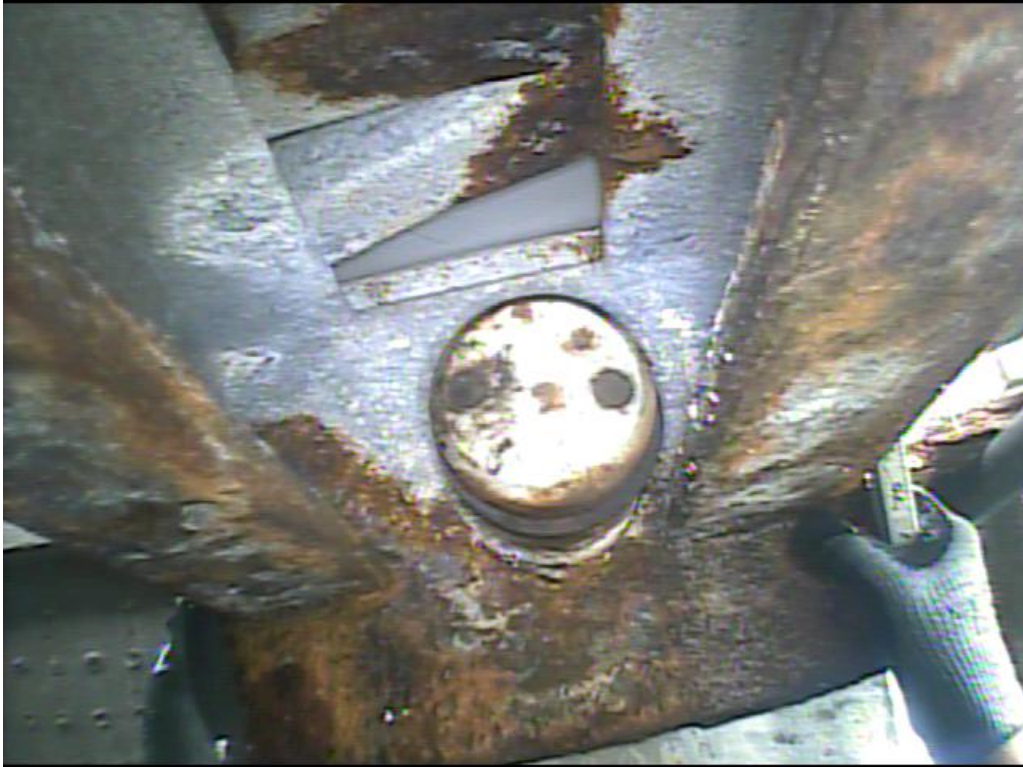
Several of the cables were found to have corrosion around the ends as typically seen throughout the rest of the marina, see Photo 18.

***Photo 18: Corroded Cable End***

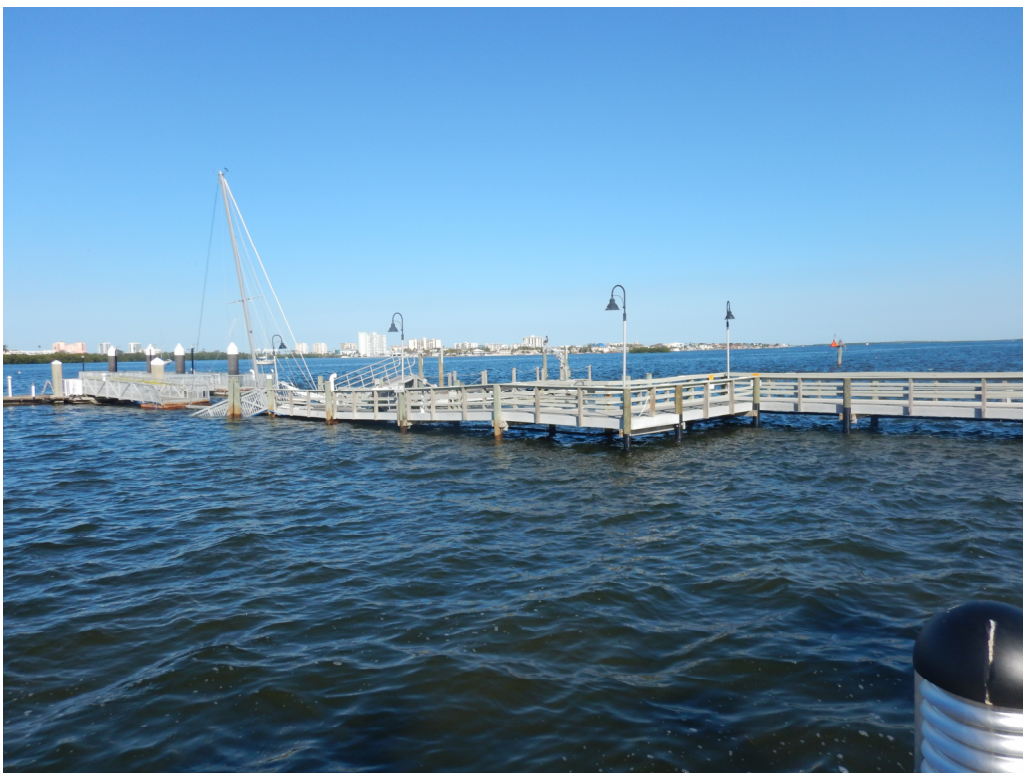
The most northern part of the shore side walkway including a fishing pier was not accessible due to a sunken sailboat, see Photo 19.

***Photo 19: Sunken Sailboat***
