# North Ward Elementary School

City Council Work Session  
Sept. 15, 2025

# BUILDING ASSESSMENT & REPAIR RECOMMENDATIONS

Building Assessment  
August 13, 2024

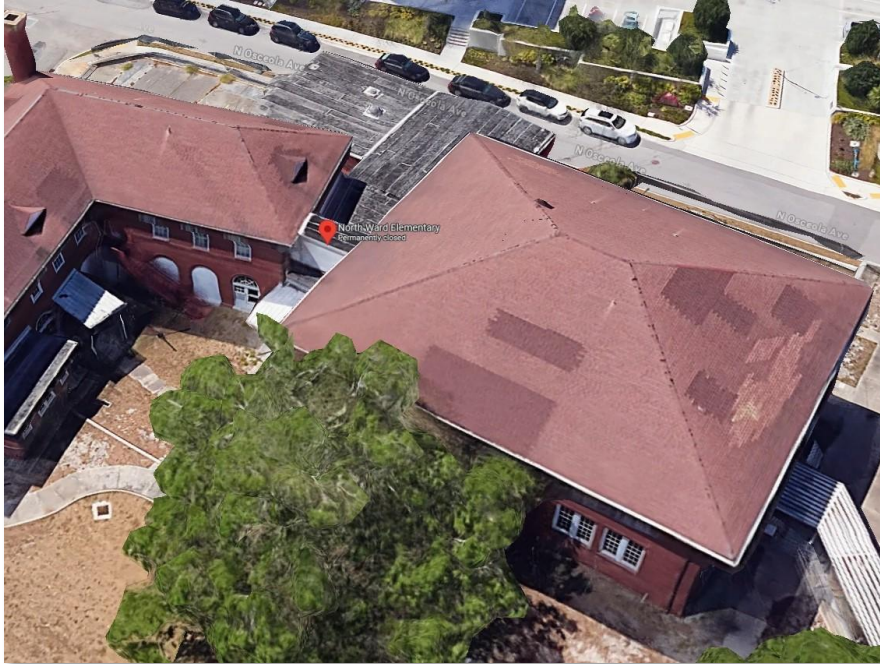
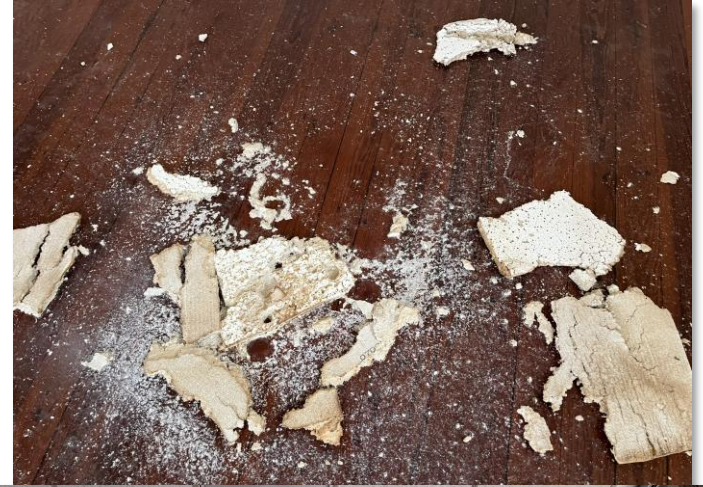
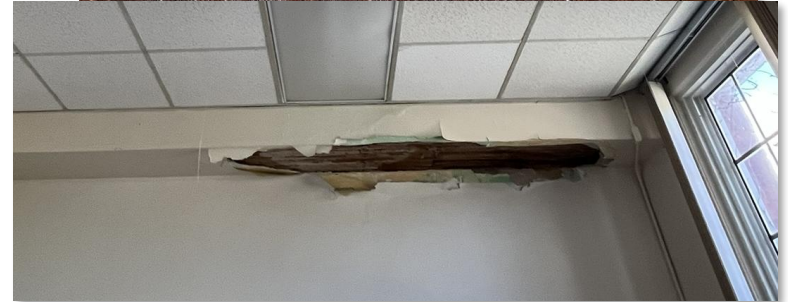
## AREAS OF CONCERN - ROOF LEAKS

- *ROOF REPLACEMENT & HURRICANE STRAPPING*
- *SECURITY & FIRE PROTECTION MONITORING SYSTEM*

- +/-15 YEAR LIFESPAN
- IN-KIND REPLACEMENT
- APPROXIMATELY \$200,000

- +/-50 YEAR LIFESPAN
- IMPROVES STANDING FOR HP GRANTS
- APPROXIMATELY \$700,000

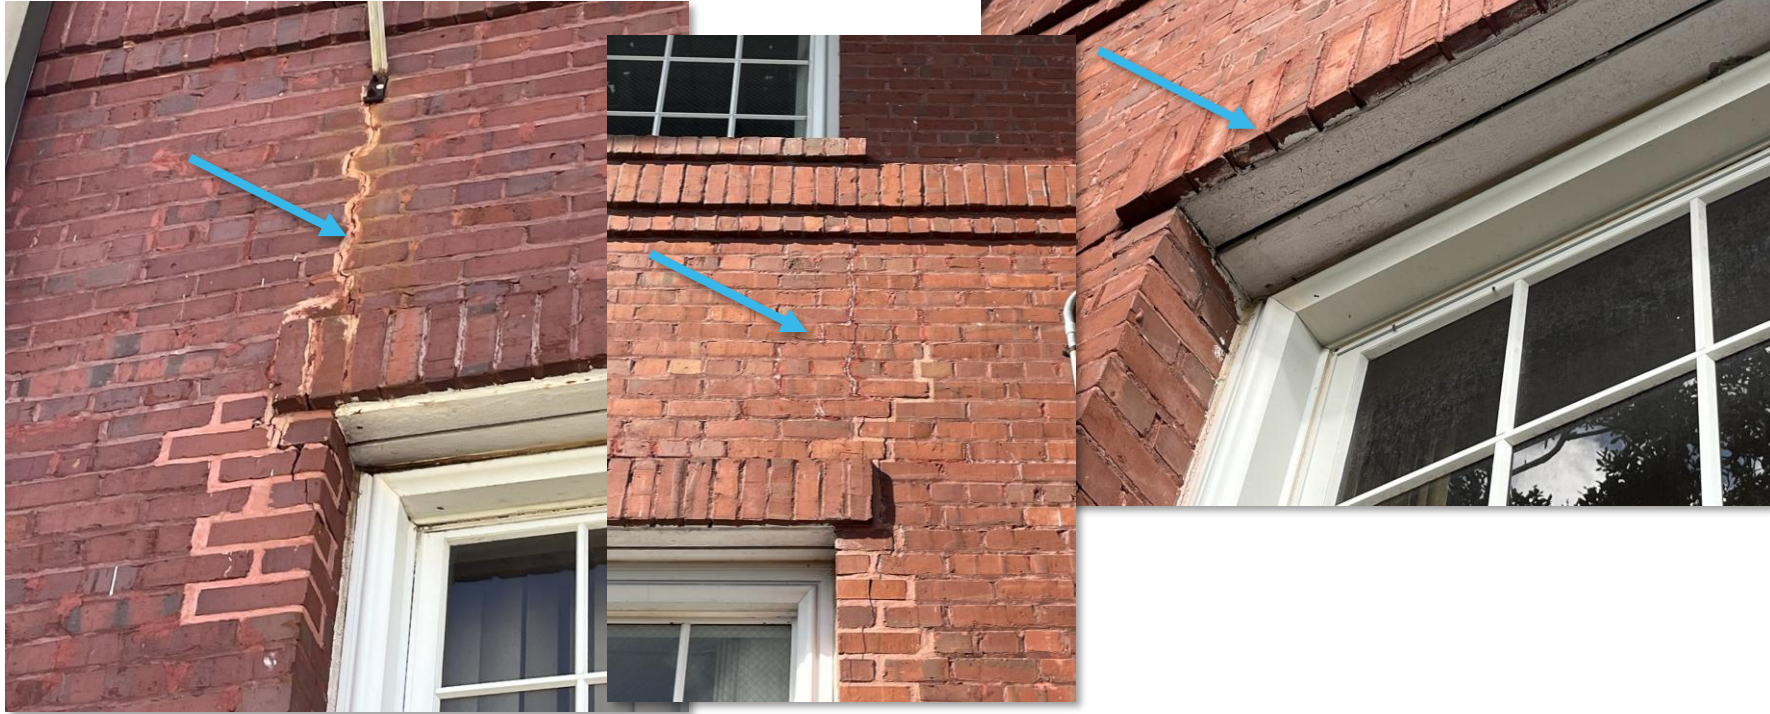
## AREAS OF CONCERN - STRUCTURAL SETTLING

- *REPAIR STEP CRACKING*
- *TERMITE TREATMENT*
- *MECHANICAL MEANS TO PROMOTE AIR MOVEMENT*
