Regarding: Condition of damaged fishing pier – Downtown Marina  
Blanket Purchase Order BR512526

RE: Clearwater Harbor Marina & Boatyard  
Fishing Pier  
210 Drew St  
Clearwater, FL 33755

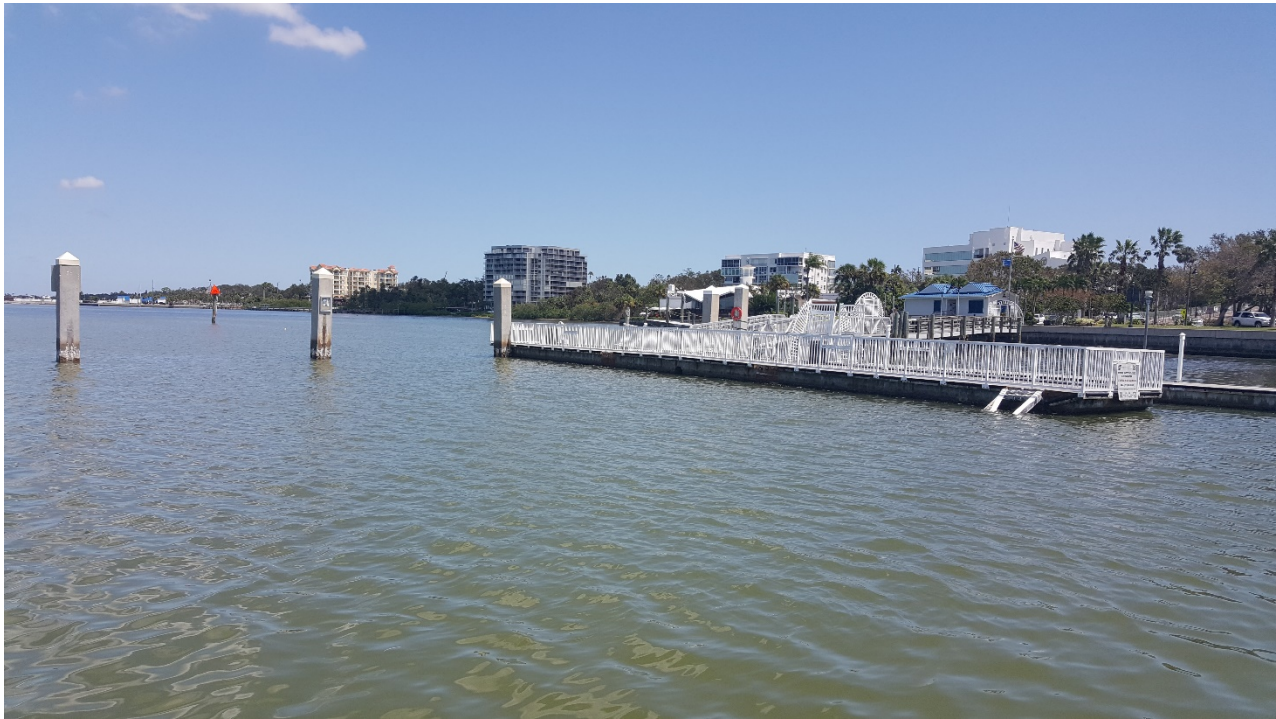
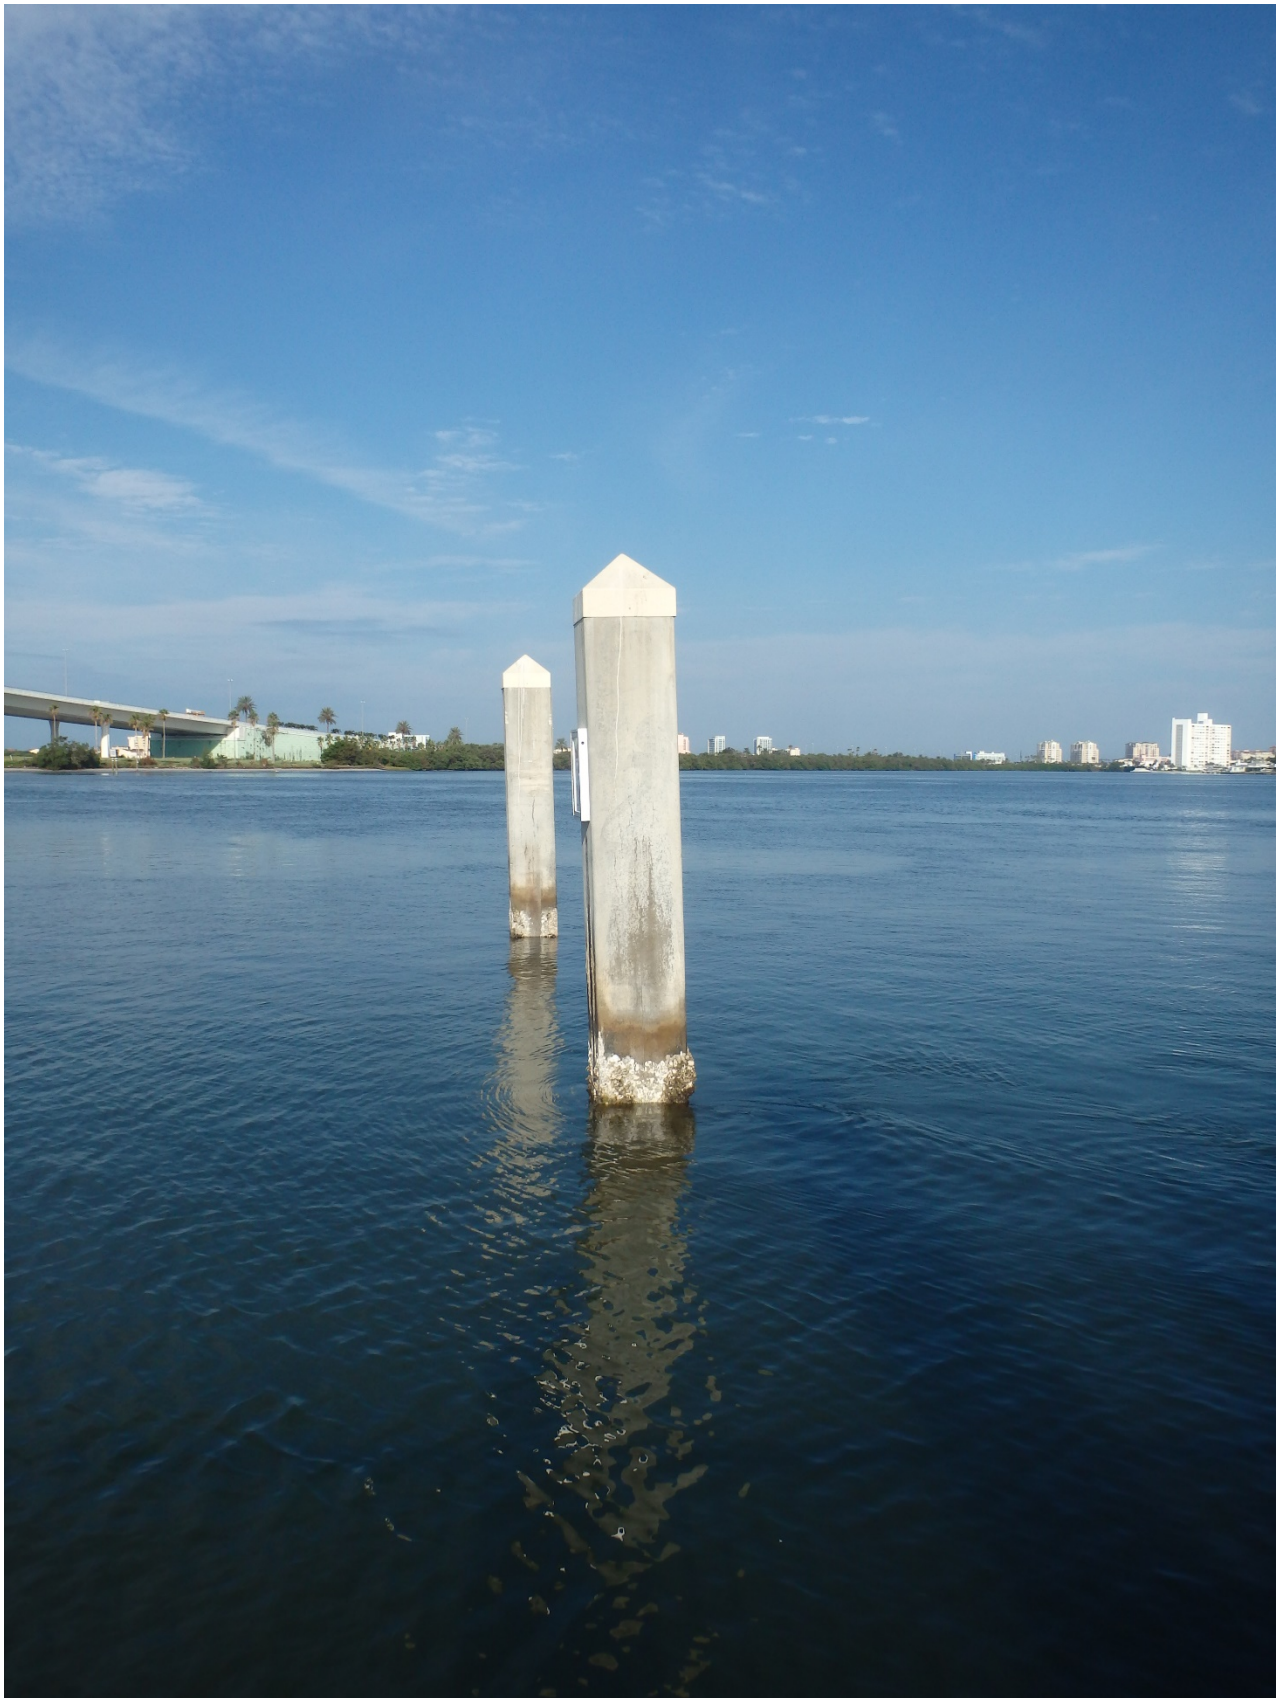
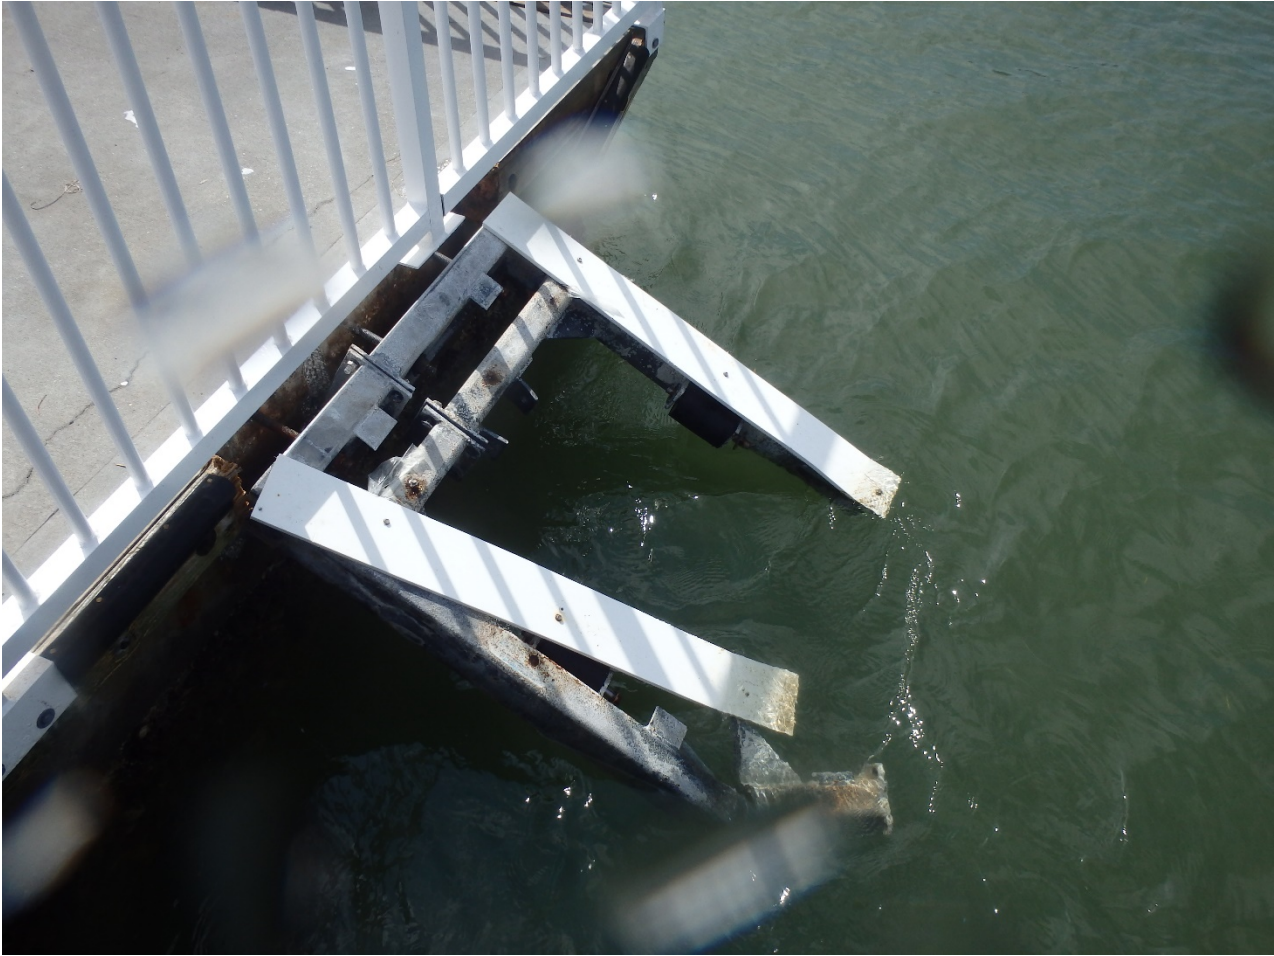
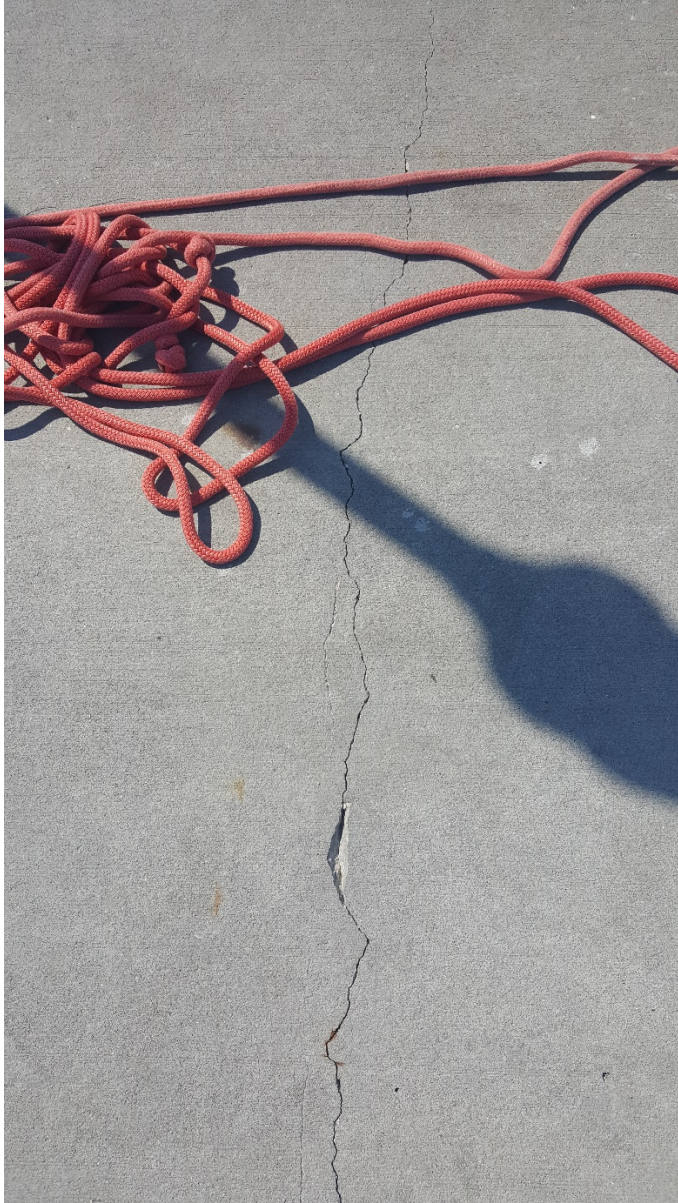
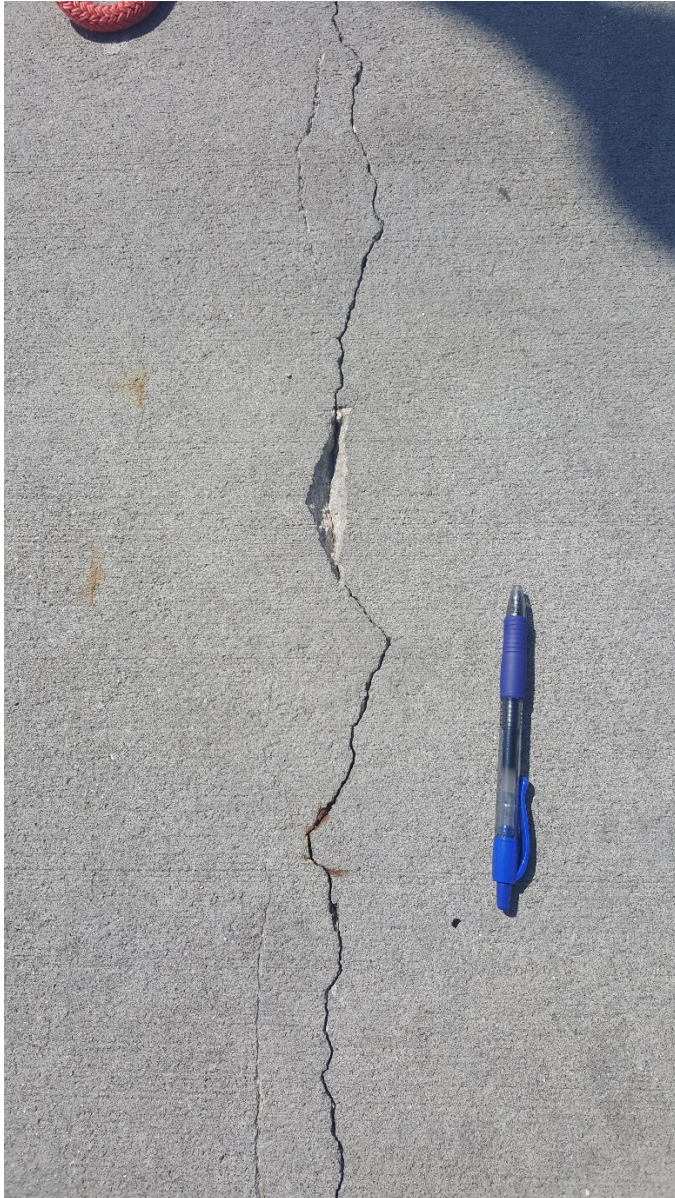
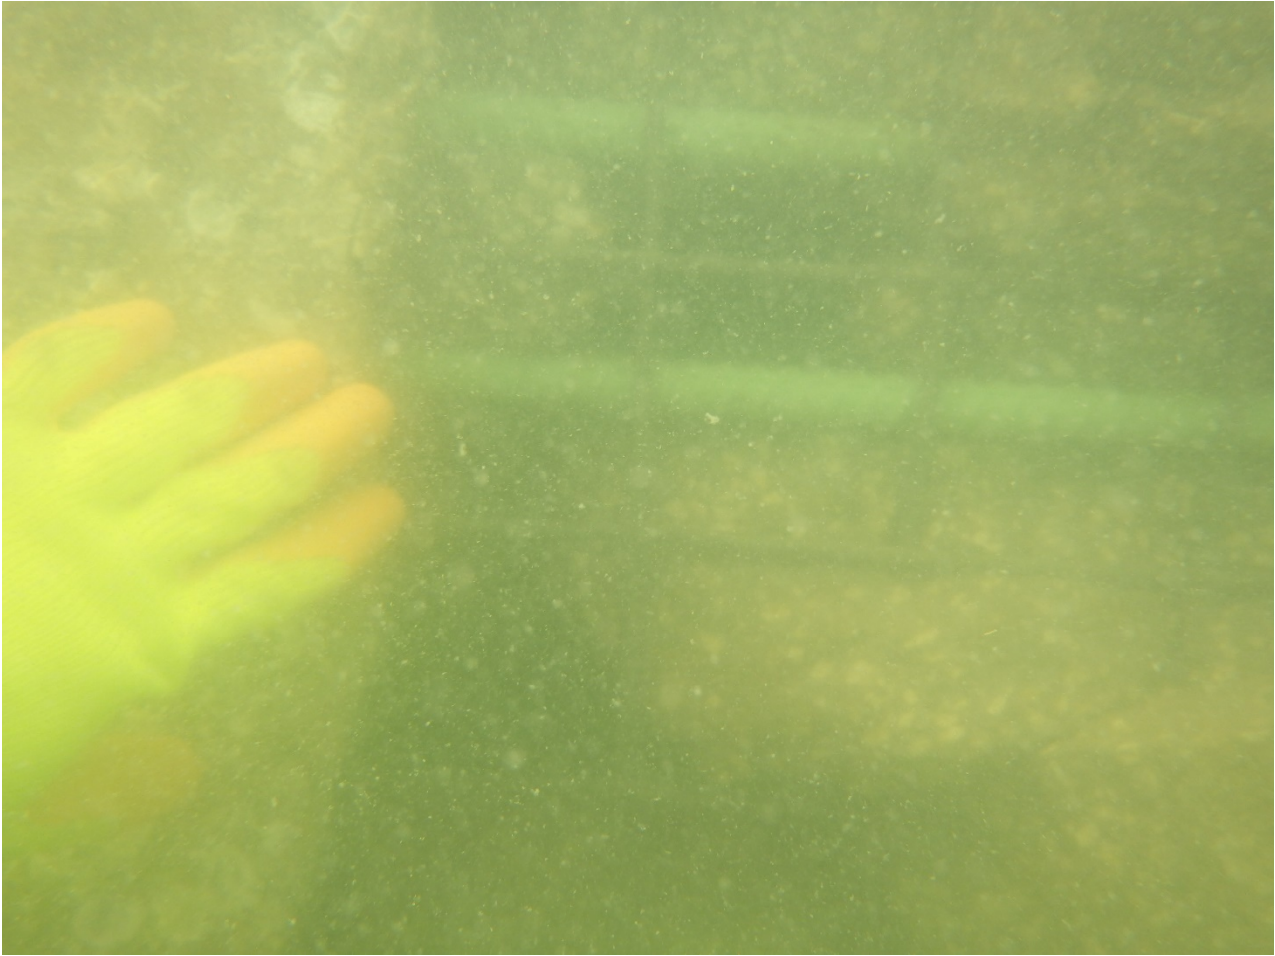
Regarding the concrete piles, the topside and underwater inspections revealed that two of the four piles are visibly leaning in the same direction as the dock displacement. The degree of displacement is approximately 10 inches at the top of the pile. No cracks were observed above the mudline. Leaning of this magnitude, in conjunction with the absence of cracking above the mudline, together indicate that these piles have likely either (a) broken or cracked beneath the mudline, or (b) rotated in-tact thereby displacing the soils beneath the mudline. The two leaning piles were initially installed with a pile driving hammer that advanced the piles downward until firmly embedded in the underlying rock, which is hard, inflexible, and not easily displaced; therefore, it is likely that these piles broke beneath the mudline. However, without extensive subsurface exploratory inspection, it is very difficult to know for sure if these piles are merely bent over or cracked/broken. In either case, the leaning posture makes attachment to the existing dock (or a future dock) ill-advised as the floating docks are designed to ride up and down on a vertically plumb pile. We expect that reuse of the two leaning piles, if in fact possible (although unlikely), would result in faster wear and tear and more frequent repairs and replacement, to the rollers, steel framed pile guides, and the dock itself.

The fishing pier western floating dock sectional has visible topside cracks on the walking surface of the dock. The fishing pier eastern floating dock sectional has extensive below water damage to the wave attenuation. Although these damages are well documented within the enclosed photographs, the diving videos provide the best visual data of these damages. The underwater damages include extensive fractures and spalling of concrete, which in turn have exposed the structural rebar to the highly corrosive salt water environment. These extensive damages rule out repair as an economically feasible option.

All four of the fishing pier's steel framed pile guides were damaged beyond repair. Only one remains attached to the dock, the other three broke from the docks and slid down the piles where they are currently resting on the seabed.

A water line was also visibly damaged and has been capped off.

In consideration of the extensive damages described above, to both the concrete floating dock sectionals as well as the concrete piles, Orion hereby submits for City approval its recommendation to replace the fishing pier in its entirety with a new fishing pier of similar design, comprised of concrete floating dock sectionals, and supported by new concrete piles. Complete replacement is necessary to ensure structural and wave movement compatibility between the concrete dock sectionals that combine to form the fishing pier. It is also recommended that the four existing piles simply be cut off at the mudline and the above mudline portion be disposed.
