City of Clearwater Parks and Recreation 2025 Pier 60 Renovation/Conceptual Repairs

Project No. CLWRC24023

Issue Date: May 8, 2025

Limited Visual Assessment Report: Mechanical, Plumbing, and Fire Protection Systems

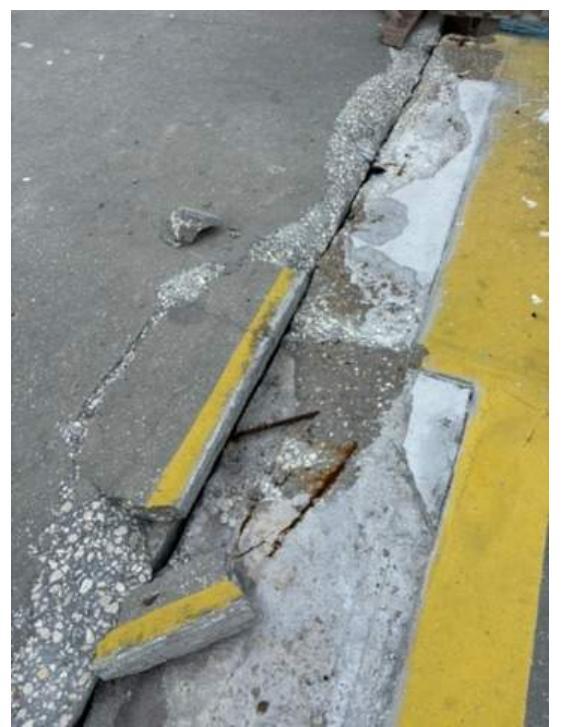
Figure 6 – T Connection Post Helene

Damage to the end of the T-Head occurred during Helene that included lateral movement from waves causing damage to the main expansion joint and end joints. See the below photo examples.

To address this area of localized damage, it was discussed that the removal of the 120' x 20' T' section, and supporting piles located at the west end of the pier could be addressed by developing a mitigation method to minimize future damage. Resulting in a 16' pier termination at the end of the Pier Deck Propper.

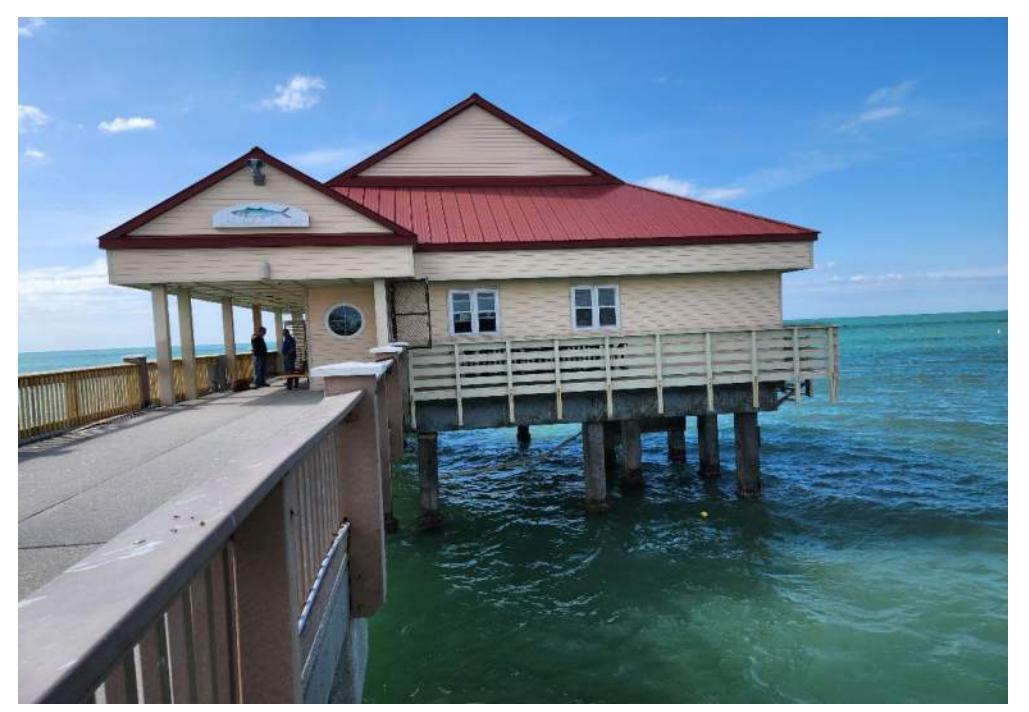
Photo 1. Gift Shop East Exterior

- a. The existing DX-split system includes a vertical indoor air handling unit (AHU) and an outdoor condensing unit, previously mounted on the pier deck on the west side of the gift shop (Photos 1, 2).
- b. The outdoor condensing unit was destroyed during the hurricanes, likely due to hurricane-force winds and storm surge (Photo 3).
- c. The indoor AHU and associated air distribution system (ductwork, diffusers, and grilles) showed no visible storm damage and appeared in good condition (Photo 4, 5).
- d. Restroom exhaust fans were observed to be operational, with no apparent damage.

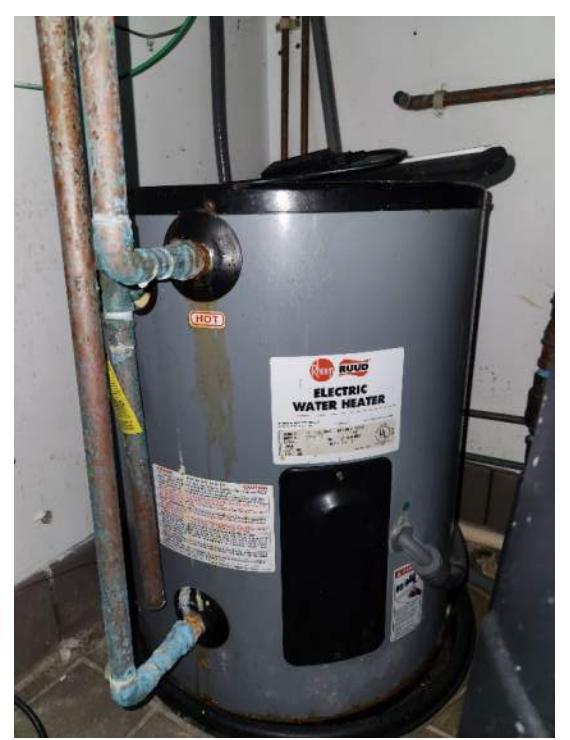
- a. The gift shop's electric water heater, located indoors, showed significant corrosion on its exterior tank and associated copper piping, as well as signs of aging and potential water damage from storm infiltration (Photo 6). The unit appeared operational but exhibited rust, leaks at pipe connections, and general wear indicative of prolonged exposure to a harsh marine environment.
- Multiple hose bibbs are located west of the gift shop, connected to PVC piping secured to the north side of the pier railing, exposed above the deck (Photos 7, 8, 9).
- c. The hose bibbs and piping were unprotected and vulnerable, showing signs of wear, corrosion, and potential storm damage, including loose fittings and exposed sections.

Photo 6. Electric Water Heater

Description: Replace the existing 20-gallon, electric water heater and piping showing signs of deterioration.

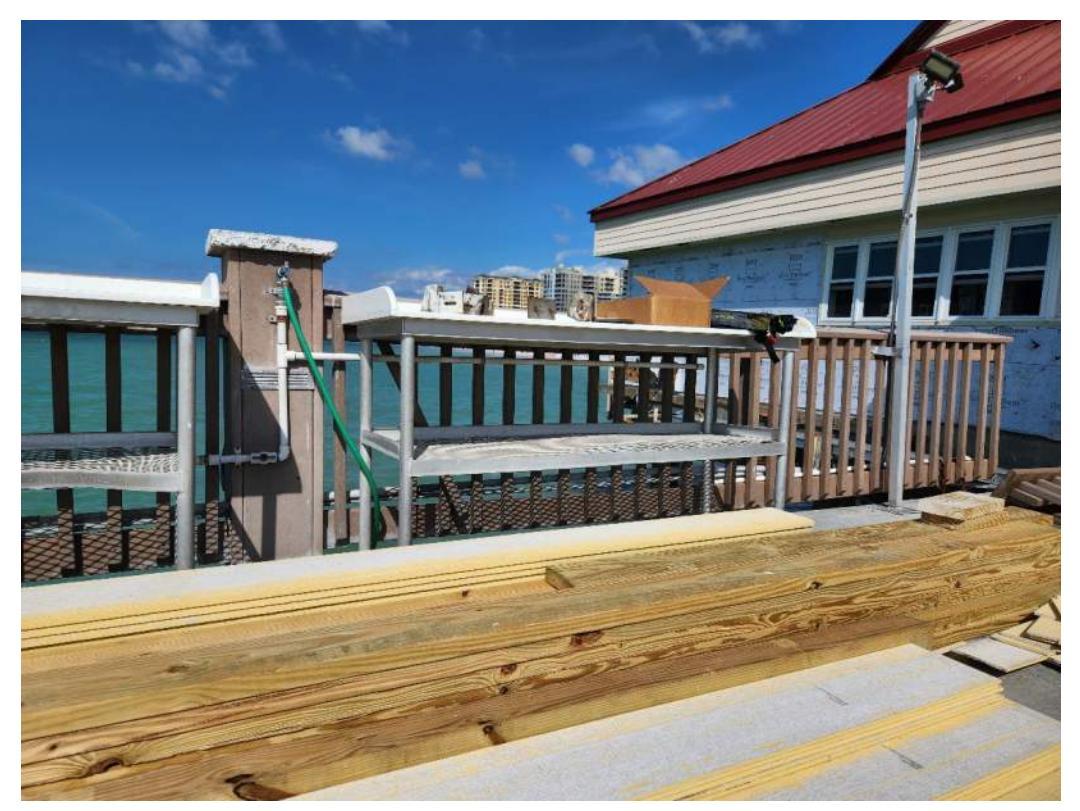
Photo 7. Fish Cleaning Stations with Hose Bibbs.

a. Replace Hose Bibbs and Piping for Storm-Resiliency

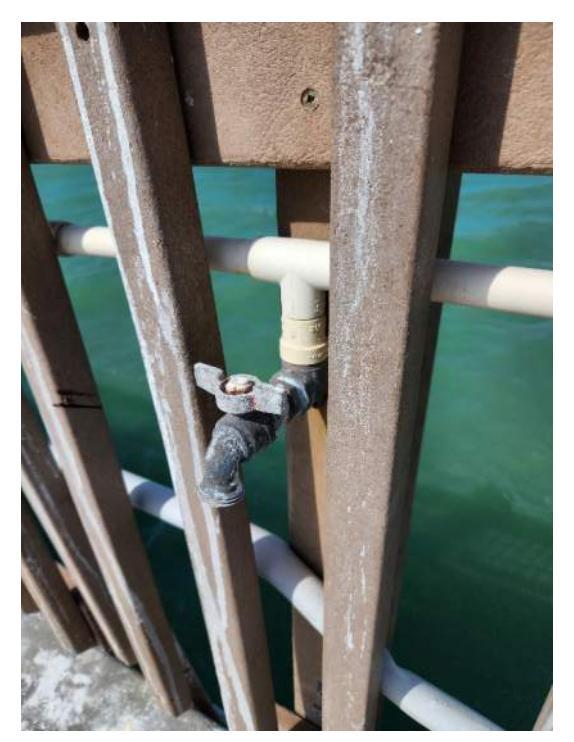
Photo 8. Domestic Water Piping

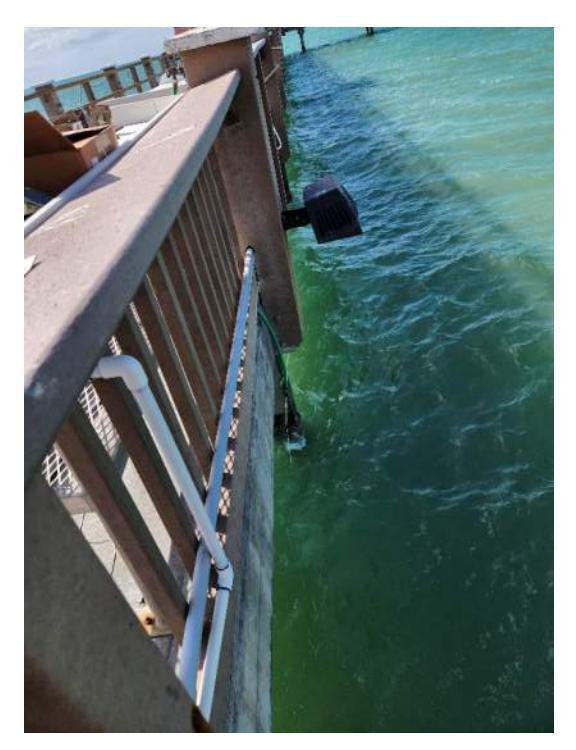
Photo 9. Exterior Hose Bibb

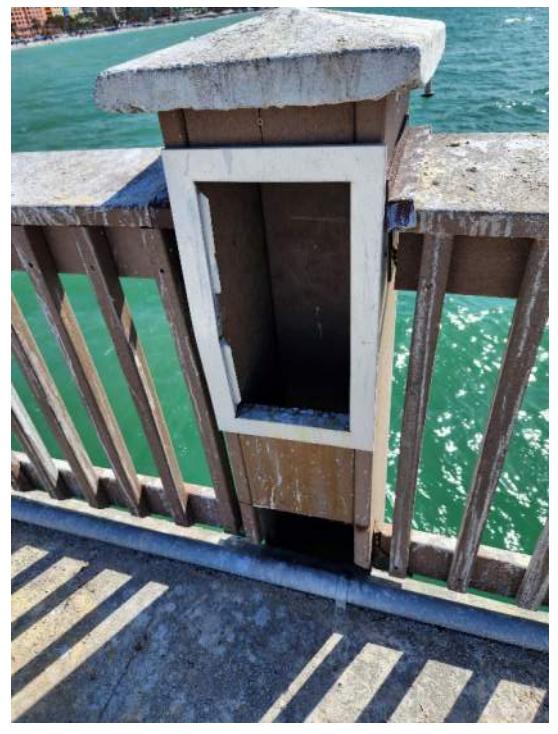
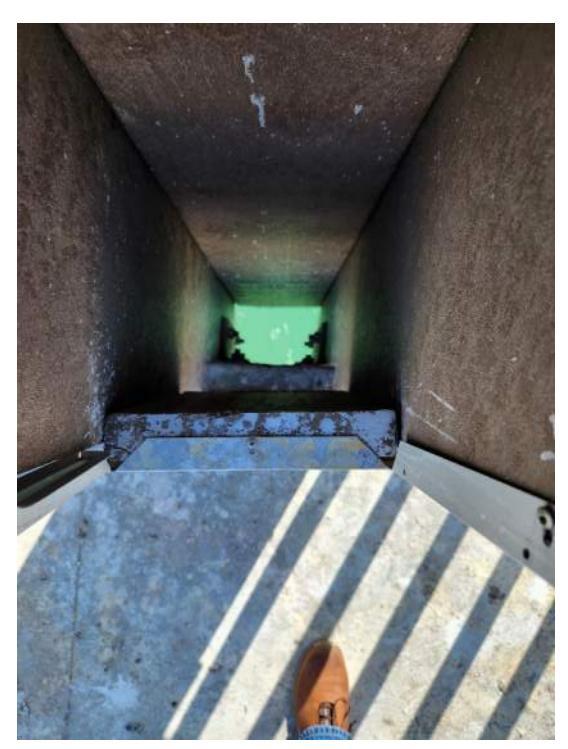
- c. Fire protection standpipes are located along the pier in boxed-out, wood enclosures integrated into the south railing.
- d. At least one standpipe was missing, likely due to storm damage, leaving an empty enclosure (Photos 10, 11).
- e. Remaining standpipes showed signs of wear but were intact, though the wooden enclosures appeared vulnerable to future hurricane impacts (Photo 12).

- b. **Missing Standpipe**: The loss of at least one standpipe compromises fire protection coverage along the pier, posing a safety risk.
- c. Vulnerable Enclosures: The wooden enclosures for standpipes are susceptible to hurricane damage, including wind, water intrusion, and structural failure, potentially leading to additional standpipe loss or damage.

Photo 10. Missing Fire Protection Standpipe

Photo 11. Missing Fire Protection Standpipe

- Description: Install new, ASTM A312 Type 316/316L Stainless Steel, Schedule 40 piping from existing upland connection to new fire protection stand pipes along pier deck. Route distribution piping along north face of the pier's concrete deck. Extend branch piping to standpipes within chases built into new handrail.

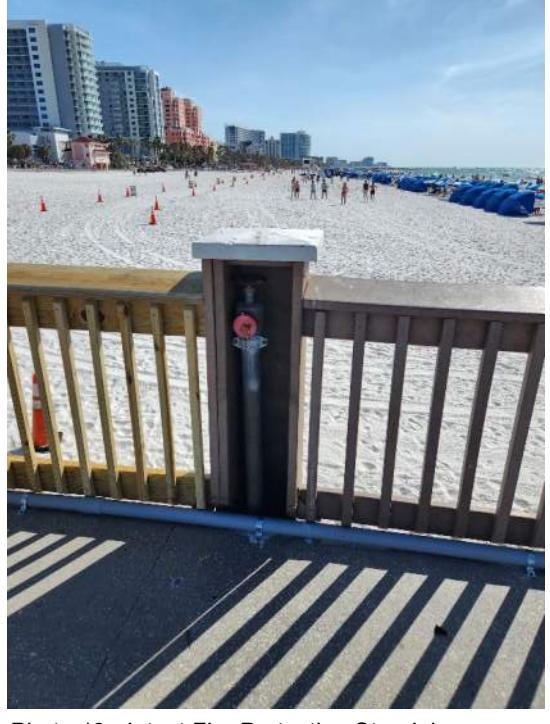
Photo 12. Intact Fire Protection Standpipe

a. **Description:** Secure piping and enclosures with hurricane-rated supports and fasteners at intervals not to exceed 4'-0". Use stainless steel materials resistant to UV and saltwater corrosion, and ensure piping enclosures are designed to withstand Cat 4 hurricane winds and storm surge with drainage to prevent water accumulation. Refer to schematic plan for conceptual layouts.

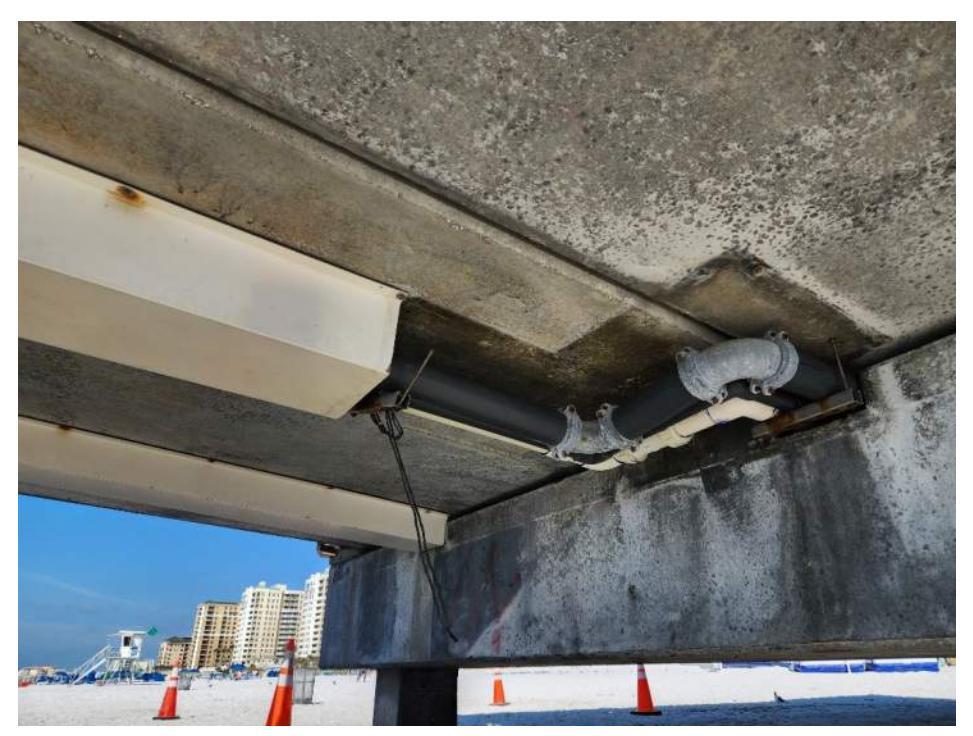
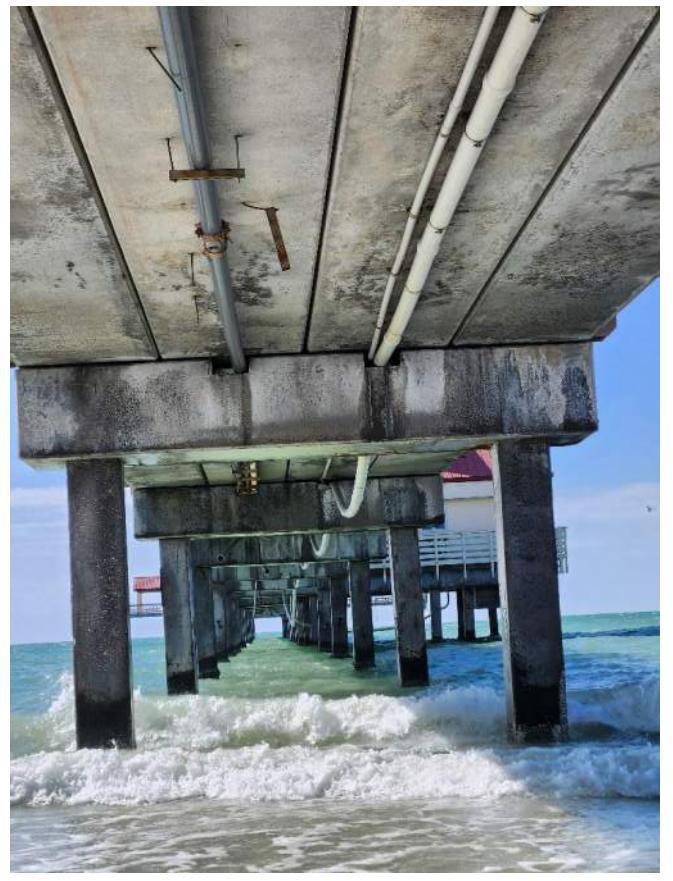
d. Main domestic water piping under the pier deck is enclosed in a fiberglass shroud, but multiple sections of the shroud were missing, exposing the piping to environmental damage (Photos 13, 14). Exposed pipe sections exhibited sagging, damage, and complete loss in some areas.

- a. **Exposed Piping and Hose Bibbs**: The PVC piping and hose bibbs, mounted above the pier deck and unprotected, are vulnerable to wind damage, debris impact, and storm surge, leading to potential leaks or failures.
- b. **Inadequate Shroud Protection**: The missing sections of the fiberglass shroud under the pier deck expose domestic water piping to corrosion, physical damage, and environmental degradation, increasing the risk of system failure.
- c. **Water Heater Deterioration**: The gift shop's electric water heater shows significant corrosion and aging piping making it vulnerable to failure due to prolonged exposure to the marine environment.

Photo 13. Under deck piping and fiberglass shroud

Photo 14. Under deck piping and supports
