## APPLICATION FOR TREE REMOVAL

Permit TRF 2025-11015

# Basic Tree Risk Assessment Form

Client City of Clearwater Date December 3, 2025 Time \_\_\_\_\_  
 Address/Tree location 1934 Marlinton Way; Southern Corner of lot Tree no. 1 Sheet 1 of 2  
 Tree species Live Oak - Quercus Virginiana dbh 9 inches Height \_\_\_\_\_ Crown spread dia. \_\_\_\_\_  
 Assessor(s) Robert E. Robicheau Tools used Diameter tape Time frame \_\_\_\_\_

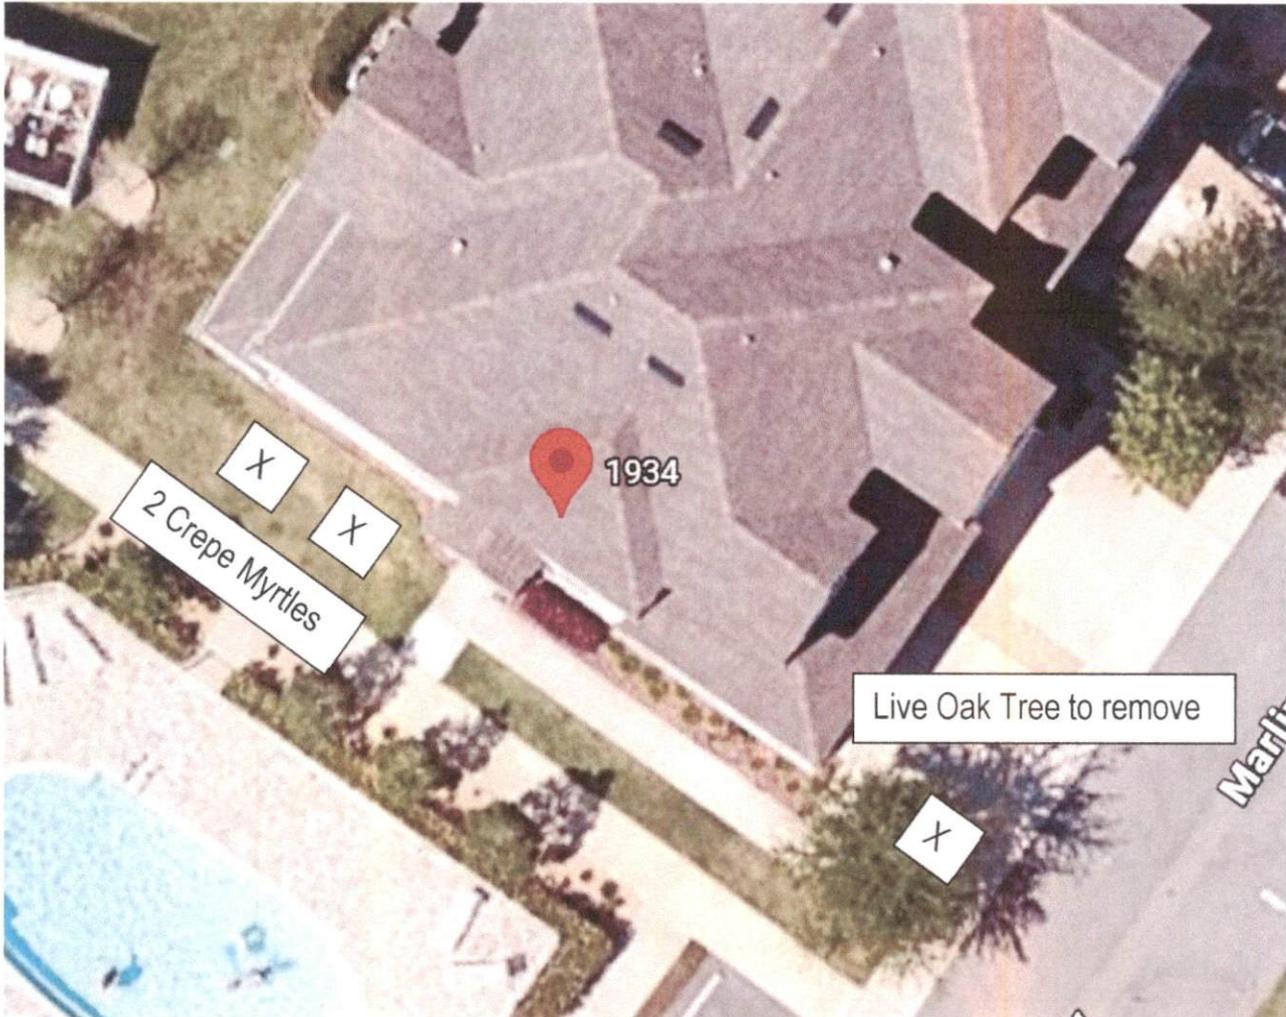
I would like to **remove one Live Oak** from front of town home and **replace it with two Crepe Myrtles** on the side of the town home as indicated below.
