Subject: Mandalay Vacation Rentals - Traffic Impact Study Determination

Subject: Mandalay Vacation Rentals - Stormwater Narrative 635 Mandalay Townhomes PID # 05-29-15-54747-084-0010

Project: MANDALAY VACATION RENTALS

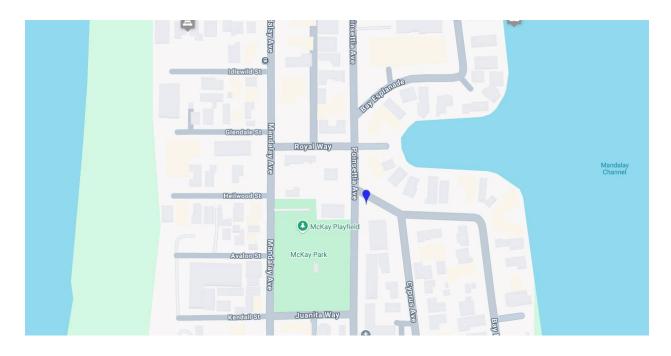
# Community Crime Map Traffic Accidents – April 1, 2021 - March 31, 2022

- Zero accidents are shown within the last year adjacent to our project location. See attached map.
- 4. The Traffic Operations Manager or their designee deems it necessary to require such assessment in the plan review process. Examples include developments that are expected to negatively impact a constrained roadway or developments with unknown trip generation and/or other unknown factors.
  - Two vacation rental properties will not have a negative impact on the surrounding roadway. Project results in 19 trips per day.

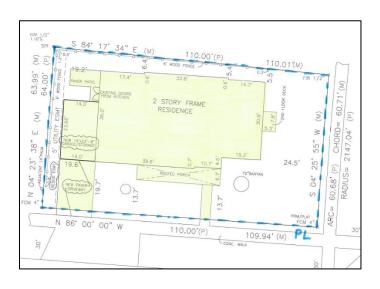
Applications must provide a to-scale site plan or copy of the survey highlighting the areas that are included in the ISR calculation. The example to the right shows the impervious areas in yellow and property line with blue dashes.

**IMPERVIOUS AREA** 9,627

EQUALS 78.7

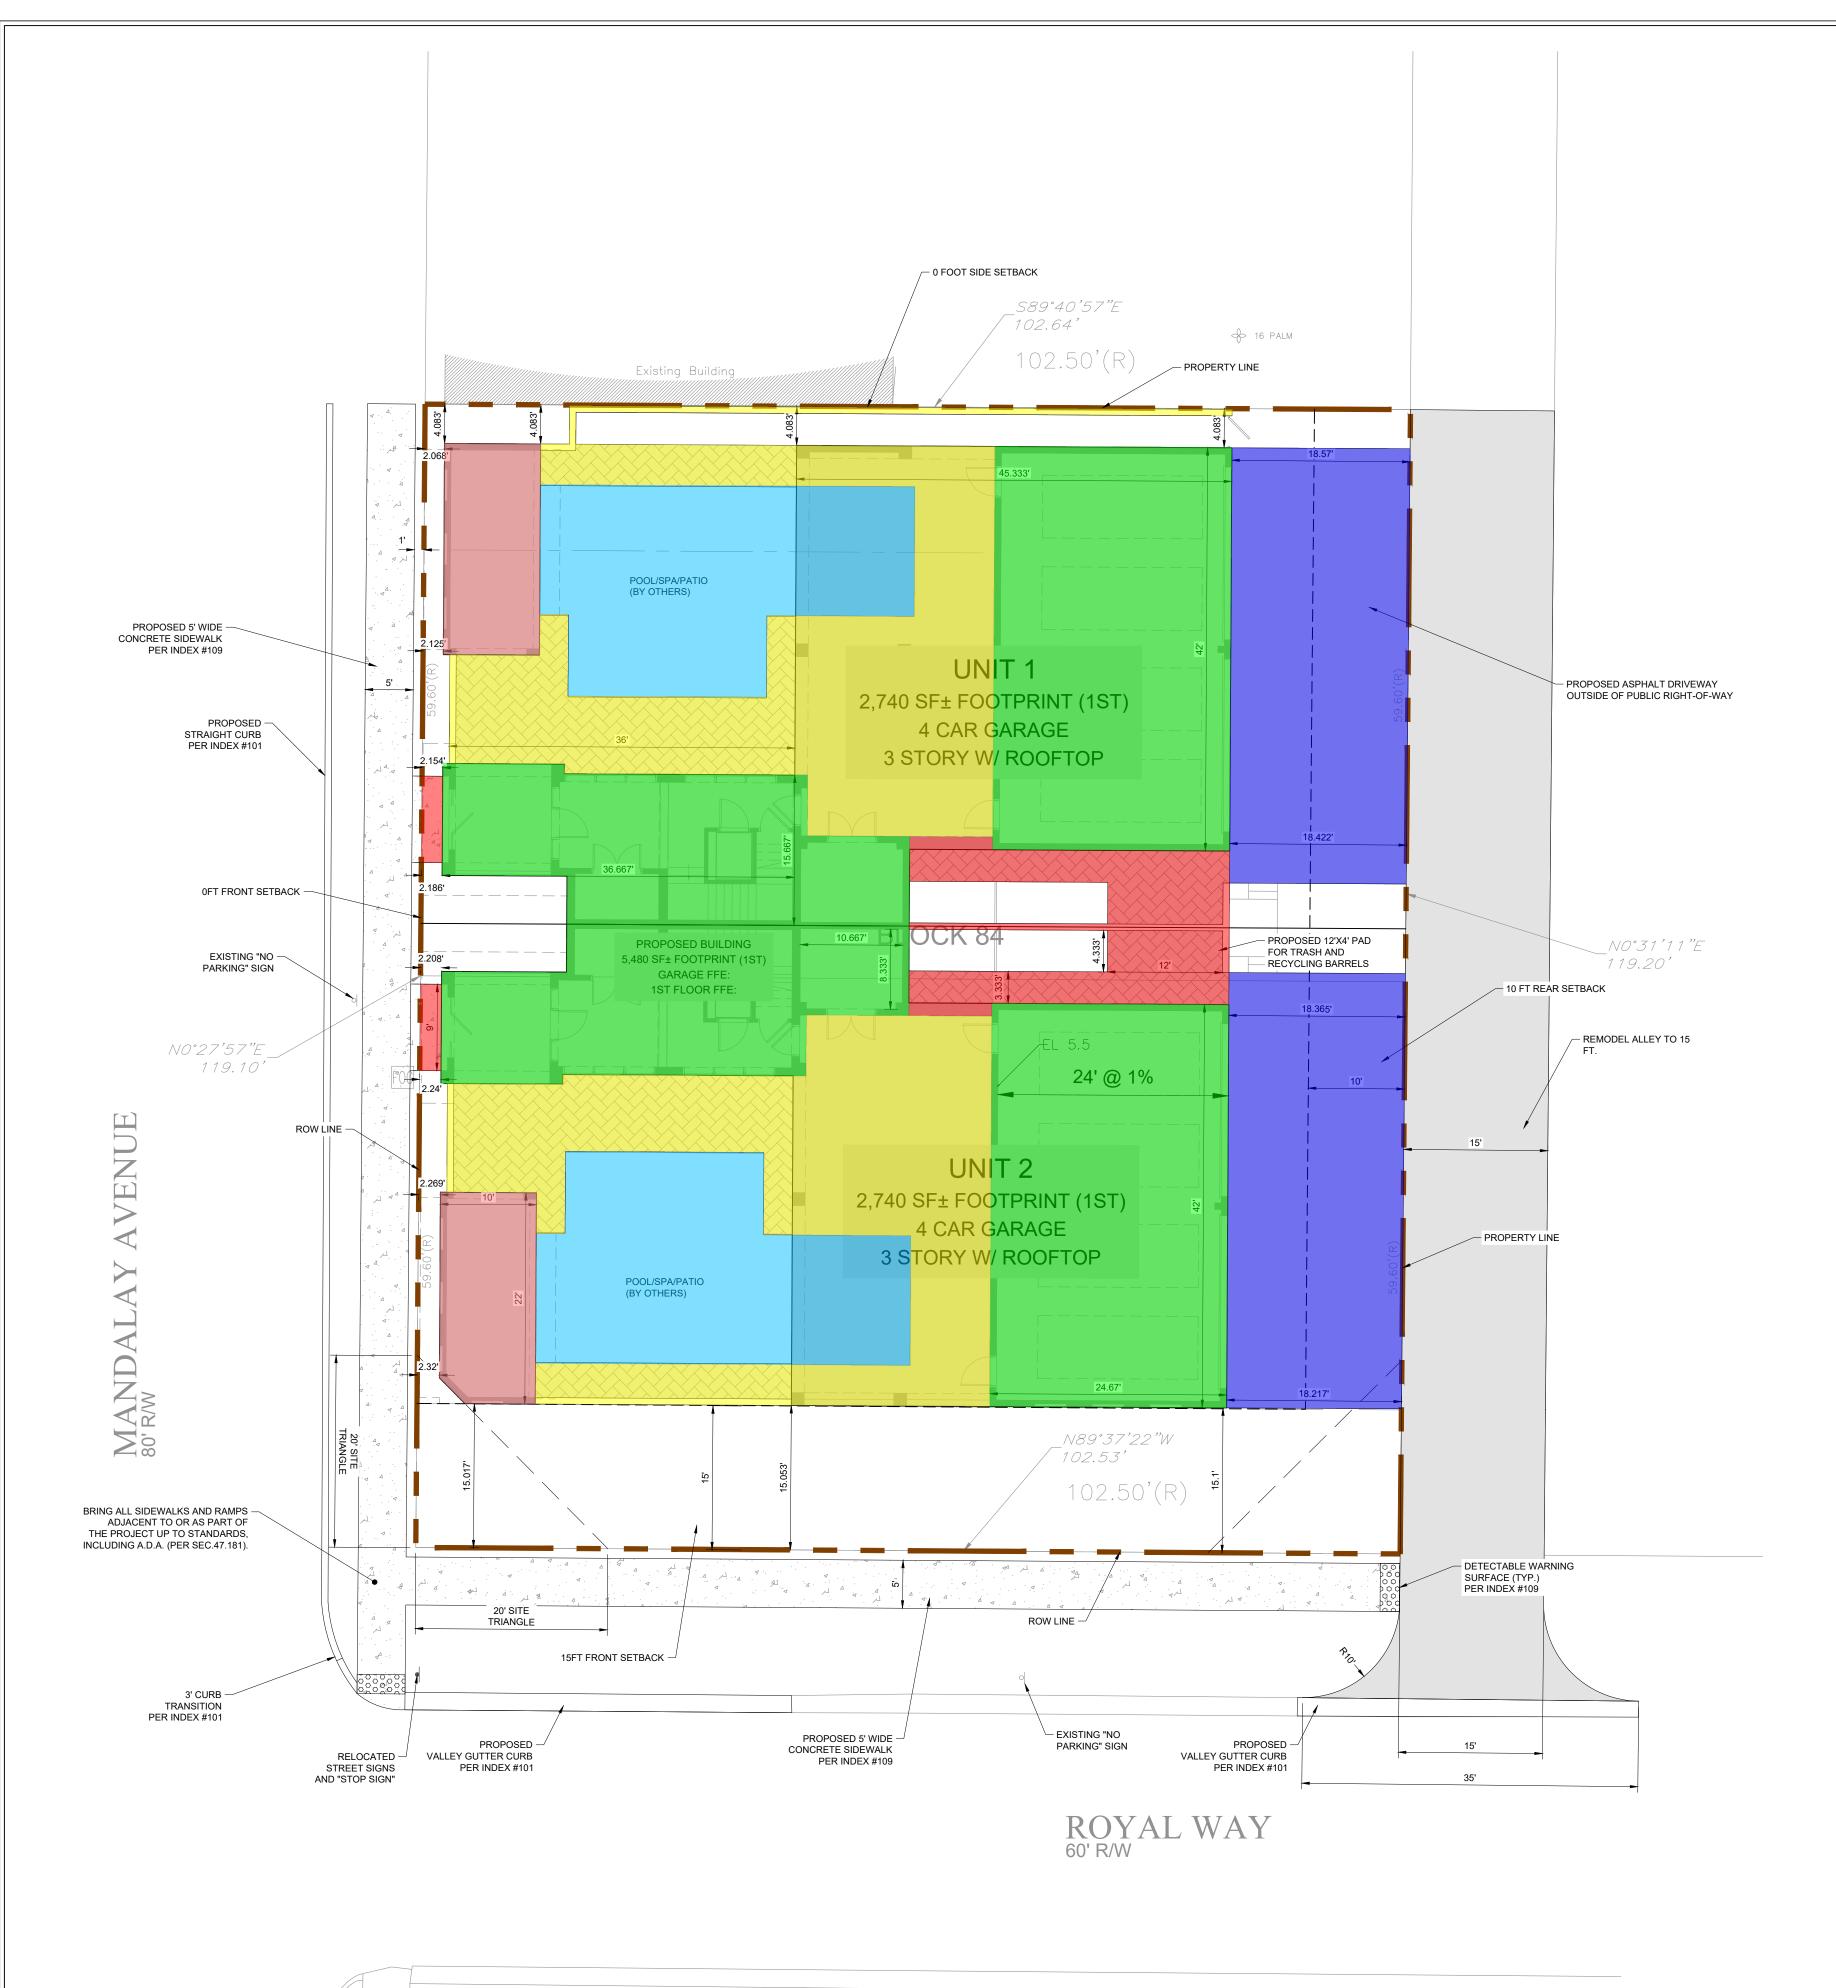
DRAWING: SITE PLAN - ISR **CALCS**

Site Data Table PROJECT LOCATION CITY OF CLEARWATER, FLORIDA PARCEL ID & ADDRESS 05-29-15-54747-084-0010 633 MANDALAY AVE, CLEARWATER PROPERTY AREA 0.28 AC (12,222 SF) RFH RESORT FACILITIES HIGH T - TOURIST ZONING OVERLAY OLD FLORIDA DISTRICT (BEACH BY DESIGN) CURRENT USE DENSITY 30 DU/AC DENSITY PROPOSED MIN. LOT AREA REQUIRED MIN. LOT AREA PROPOSED 12,222 SF MAX BUILDING HEIGHT 65FT (DFE + 2FT) MAX BUILDING HEIGHT PROPOSED MAX FAR FAR PROPOSED MAX ISR 0.95 (11,612 SF) ISR PROPOSED 0.79 (9,648 SF) BUILDING SETBACKS/ STEP BACK | SEE PLAN ROYAL AVE (FRONT) = 15 FT MANDALAY AVE (FRONT) = 0 FT REAR (EAST) = 10 FT SIDE (NORTH) = 0 FT PARKING REQUIRED SFD 1.5 SPACES PER UNIT 1.5 \* 2 = 3 SPACES REQUIRED PARKING PROPOSED 8 SPACES (4 GARAGE SPACES PER UNIT) UTILITIES WATER | CITY OF CLEARWATER SEWER | CITY OF CLEARWATER

DRIVEWAY: 1668 SF WALKWAYS: 366 SF PATIO/LANAI: 931 SF

PERVIOUS AREA: LAWN: 2,593 SF (0.21%)

LOT AREA: 12,222 SF IMPERVIOUS AREA: BUILDING/SCREEN WALLS: 5,592 SF

POOL/SPA: 1072 SF TOTAL = 9,629 SF (0.79%)

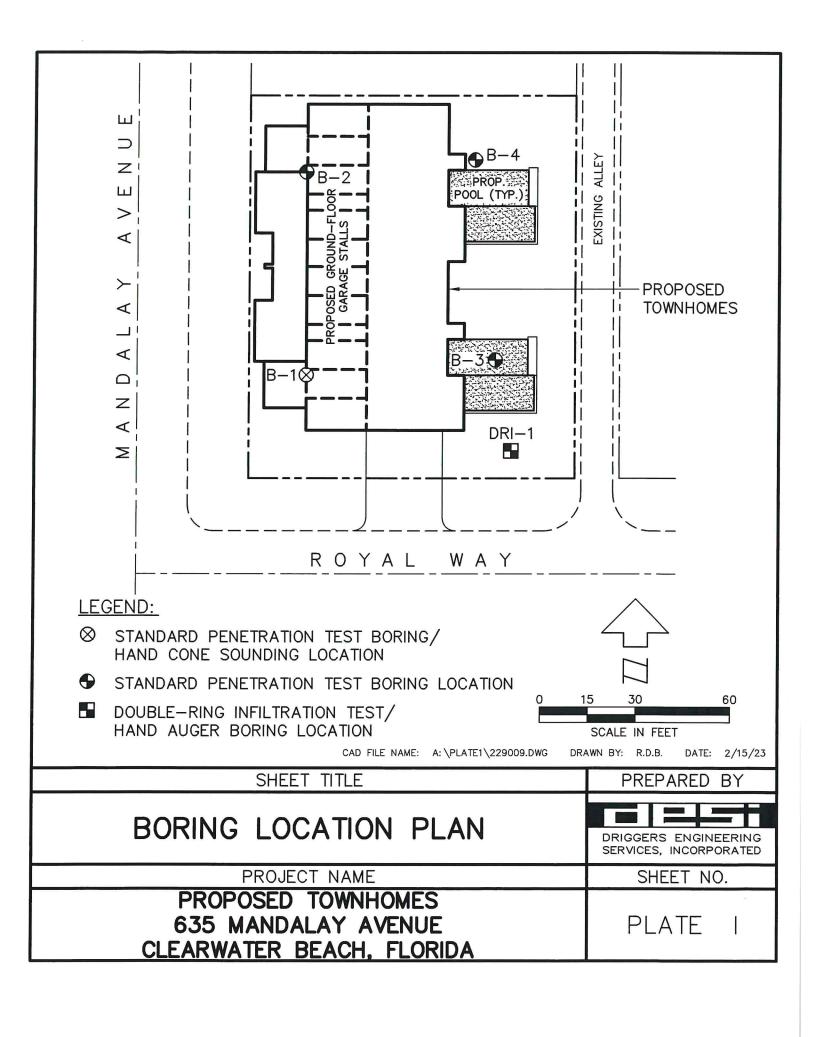
PLATE I – BORING LOCATION PLAN

Plate I of the report illustrations identifies the respective positioning of four (4) Standard Penetration Test (SPT) borings that were requested to investigate subsurface conditions. These test borings were performed in accordance with ASTM D-1586. A brief description of this method of sampling is included in the report attachments.

In conjunction with the Standard Penetration Test borings, you also requested one (1) Double-Ring Infiltration (DRI) test which is positioned approximately as seen on the attached Plate I. A classification boring was conducted at the location of the DRI test and the results are included in the report attachments. Care should certainly be exercised in the application of infiltration test results to the design of stormwater retention areas. The analyses must consider the permeability characteristics of all the subsurface soil strata that will be impacted together with hydraulic boundary conditions. The accommodation of which will control retention area exfiltration rates.
