# PROJECT INFORMATION

- New construction
- 5-story building
- **Unit Mix:** 82-unit apartment community:
  - 1 Bedroom: 36 units
  - 2 Bedroom: 40 units
  - 3 Bedroom: 6 units
- **Households served:**

### Project Property Address

1219 S Ft Harrison Ave. Clearwater, FL 33756

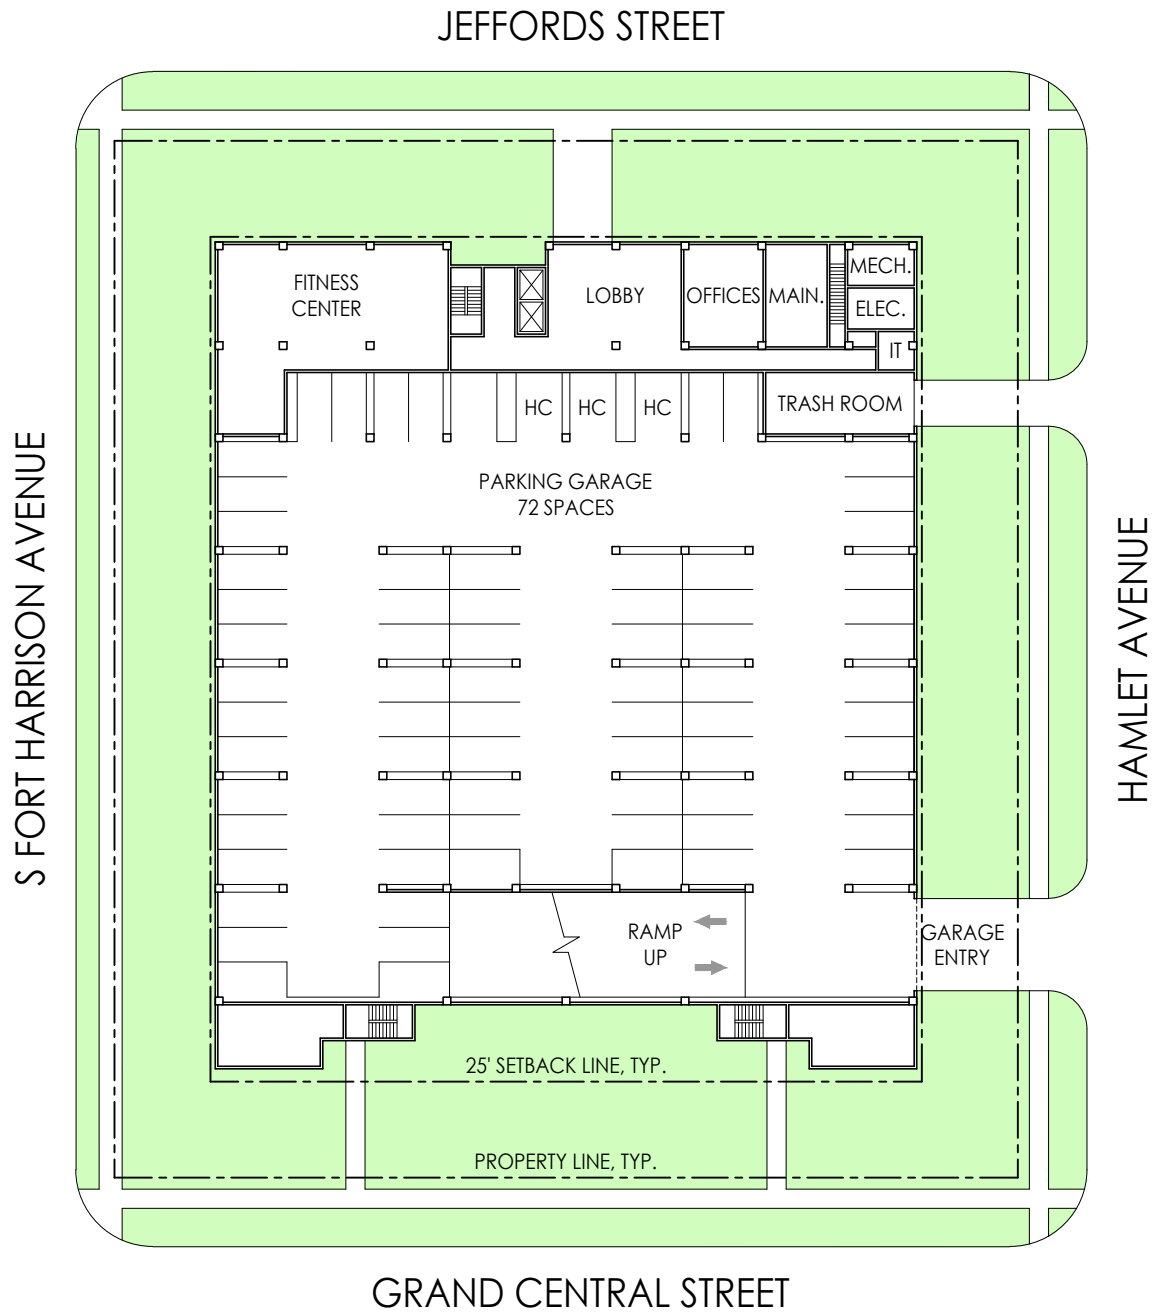
A1

Site Plan

SCALE: 1" = 60'-0"

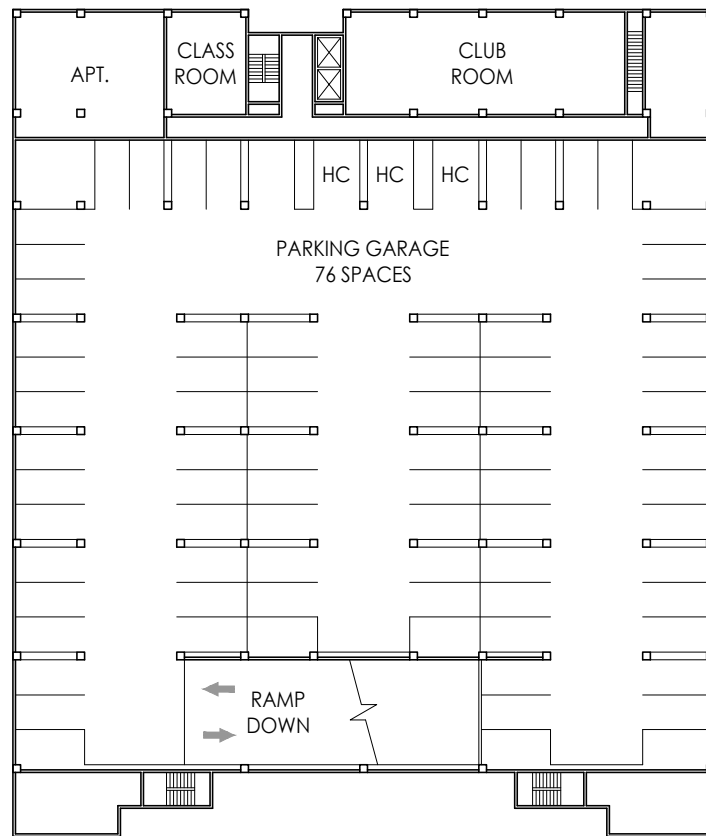
# A2

## 2nd Floor Plan

SCALE: 1" = 60'-0"

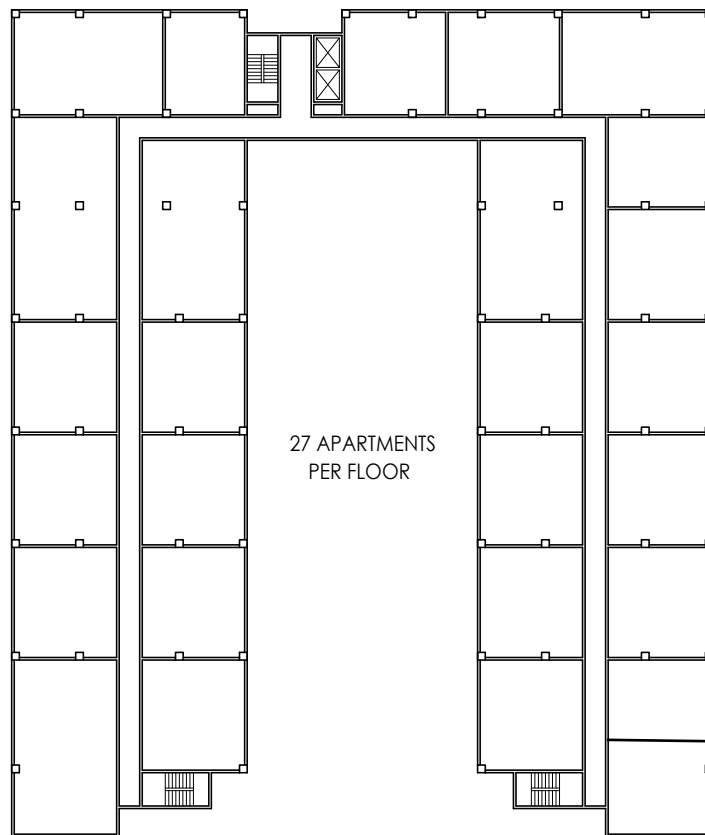
A3

3rd-5th Floor Plan  
SCALE: 1" = 60'-0"

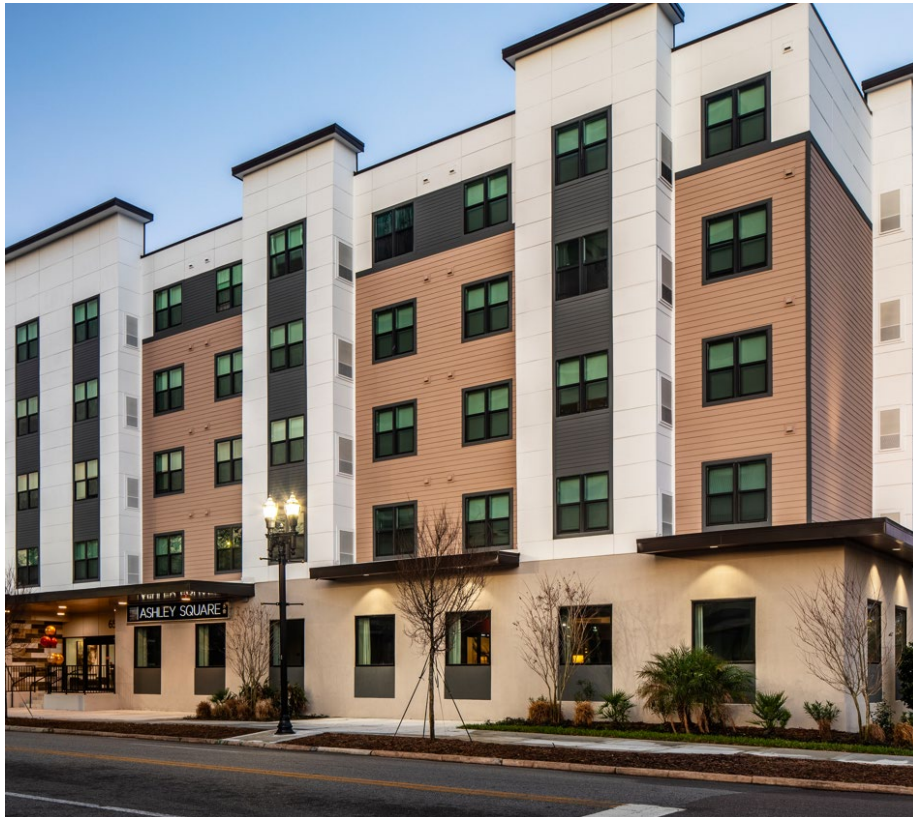
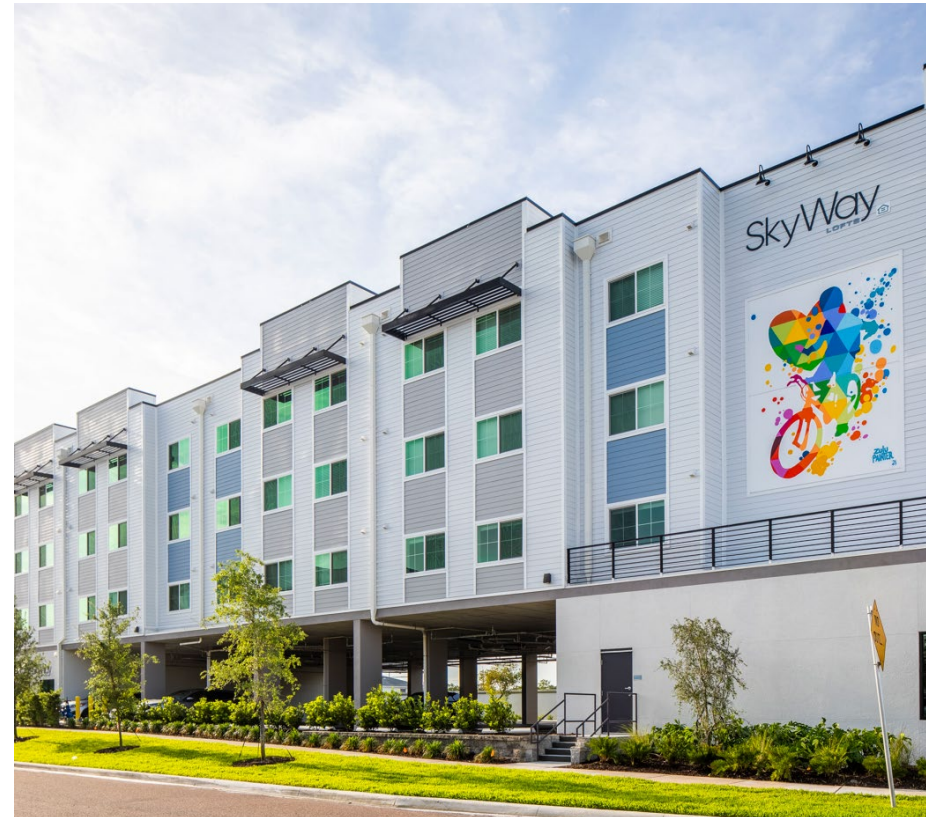
# Example Renderings/Elevations

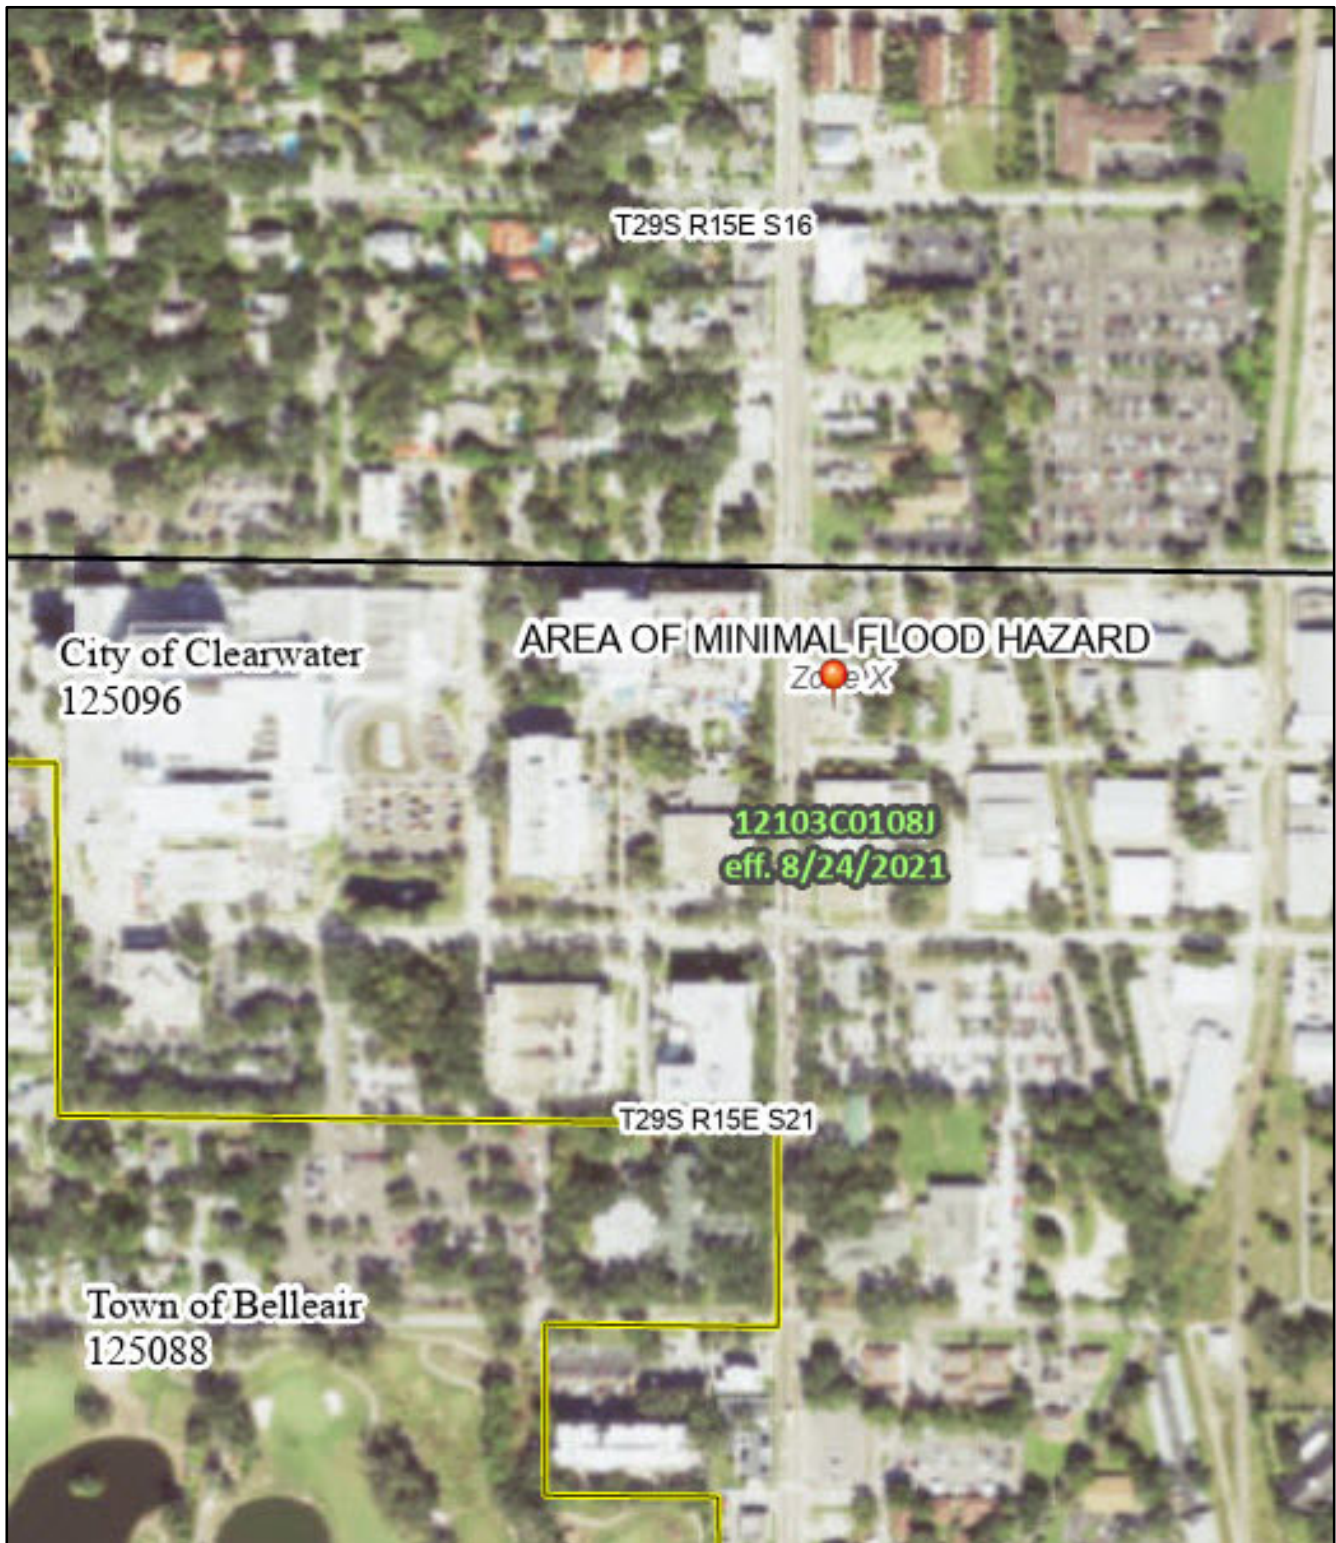
## FLOOD MAP

According to the Department of Housing and Urban Development, Flood Hazard Boundary Map, Community Panel 12103C01081 dated August 24, 2021, the subject property appears to be located within Zone "X". Zone "X" is an area outside the 100-year flood plain; mandatory flood insurance purchase requirements do not appear to apply.
