RE: The Long Center Natatorium Life Cycle Analysis

WJ Architects has completed the Life Cycle Analysis associated with The Long Center Natatorium. Our process and findings are described in the following pages and documents.

## **Technical Memorandum Draft Long Center Structure Repairs Phase II**

# LONG CENTER NATATORIUM STRUCTURAL FRAME REPAIRS

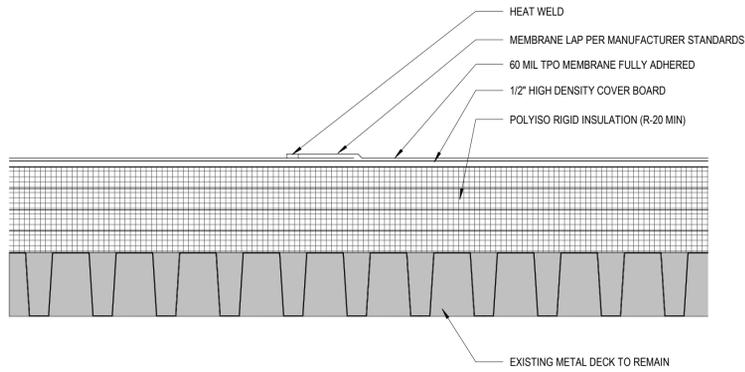
2 OPT 1 - DETAIL - TYPICAL TPO ROOF ASSEMBLY  
1 1/2" = 1'-0"

- ROOFING PRODUCT BASIS-OF-DESIGN: 60 MIL TPO SINGLE PLY MEMBRANE ROOF OR APPROVED EQUAL (COLOR WHITE) RIGID INSULATION BOARD MECHANICALLY FASTENED TO STEEL ROOF DECK. INSULATION TO HAVE AN AVERAGE R-20 @ ALL ROOFS OVER CONDITIONED SPACES. PROVIDE ROOFING COMPONENTS AND MATERIALS APPROVED BY THE ROOFING PRODUCT MANUFACTURER. ASSEMBLE ROOFING COMPONENTS INCLUDING FLASHING, ROOF DRAINS, ETC. PER THE ROOFING PRODUCT MANUFACTURER'S DETAILS AND INSTRUCTIONS SO AS TO QUALIFY FOR, AND RECEIVE A SPECIAL 20-YEAR WEATHER-TIGHTNESS WARRANTY FROM THE MANUFACTURER AS WELL AS A SPECIAL 2-YEAR PROJECT WARRANTY FROM THE ROOFING INSTALLER COVERING ALL COMPONENTS OF THE ROOFING SYSTEM SUCH AS ROOFING, BASE FLASHING, ROOF INSULATION, FASTENERS, COVER BOARDS, ETC. PROVIDE ROOFING FROM A QUALIFIED MANUFACTURER THAT IS FM GLOBAL APPROVED FOR ROOFING SYSTEM IDENTICAL TO THAT USED FOR THIS PROJECT.

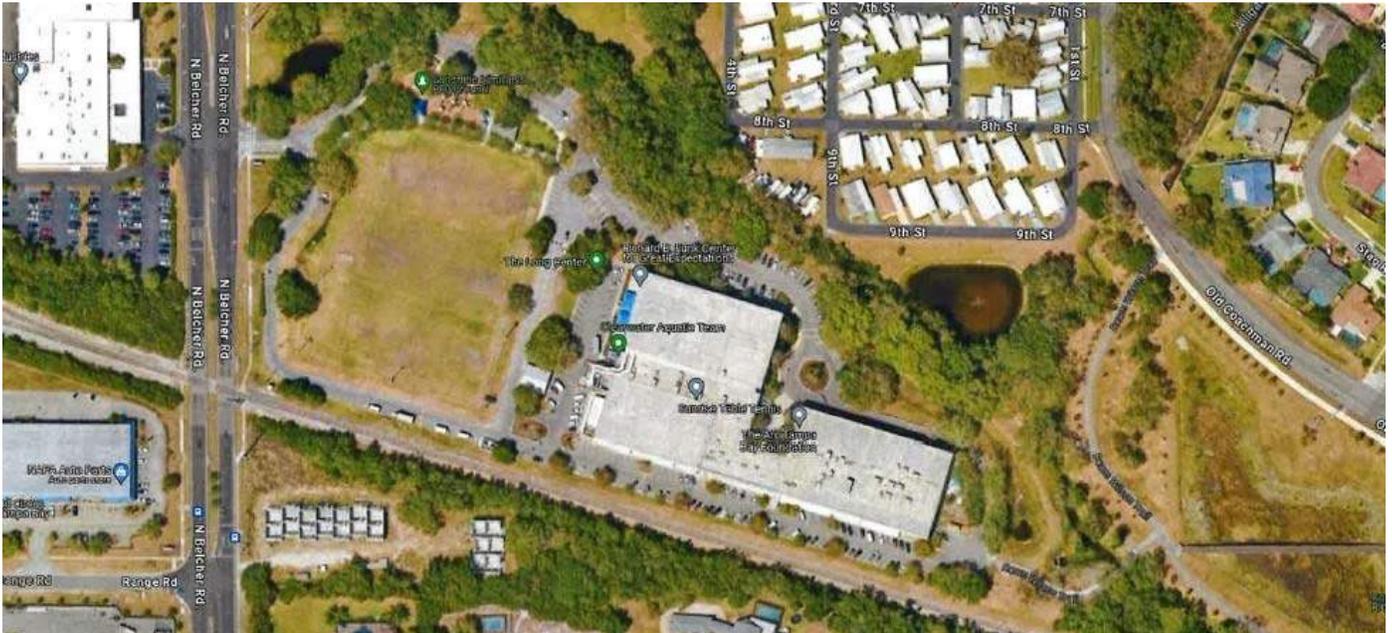
Figure 1.1 - Existing Long Center Site & Complex Layout

The record drawings reviewed indicated the LCN as "Building A" for the complex. The four building complex is "L"-shaped with Building A and Building B comprising the north / south oriented leg and Building B, Building C and Building D comprising the east / west oriented leg. Building A is north of Building B. The site and building complex layout is shown below in **Figure 1.1**.

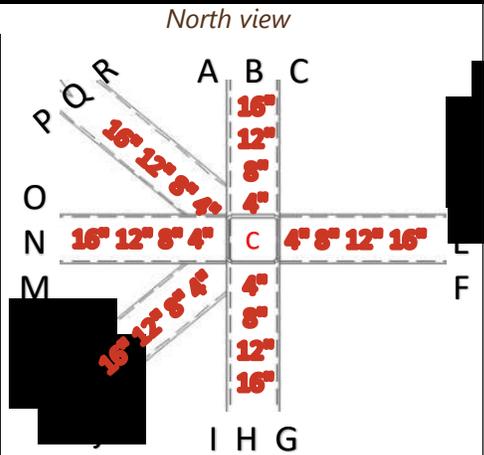
4"	8"	12"	16"	20"	24"	28"	32"
A			0.366"	0.361"				
B	0.353"	0.352"	0.358"	0.360"				
C	0.357"	0.357"	0.358"	0.361"				
D								
E	0.070"	0.353"	0.345"	0.344"				
F	0.076"							
G			0.362"	0.357"				
H	0.352"	0.351"	0.351"					
I				0.356"				
J								
K	0.233"	0.234"	0.234"	0.234"				
L		0.239"	0.234"	0.234"				
M								
N	0.228"	0.231"	0.231"	0.231"				
O			0.241"	0.241"				
P								
Q	0.212"	0.239"	0.237"	0.235"				
R		0.237"	0.237"	0.237"

Notes: Some faces of the HSS members could not have thicknesses retrieved due to window framing covering the surface area.

\*Material was observed to be thin along the E and F face corners at connection joint

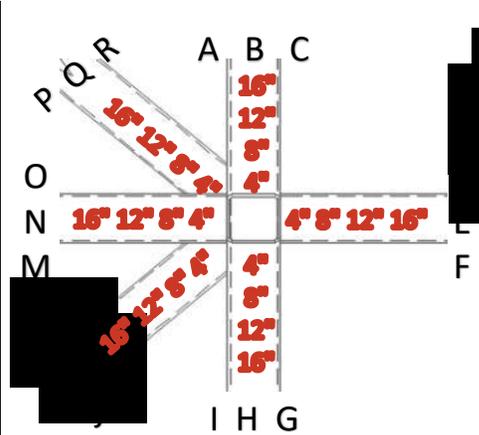
North view

*Notes: Some faces of the HSS members could not have thicknesses retrieved due to window framing covering the and/or due to thickness of epoxy coating along the surface areas.*

*\*Center and E Face was observed to have a thin wall along the its joint, additional readings along the other sides could not be taken due to window framing covering the surfaces.*

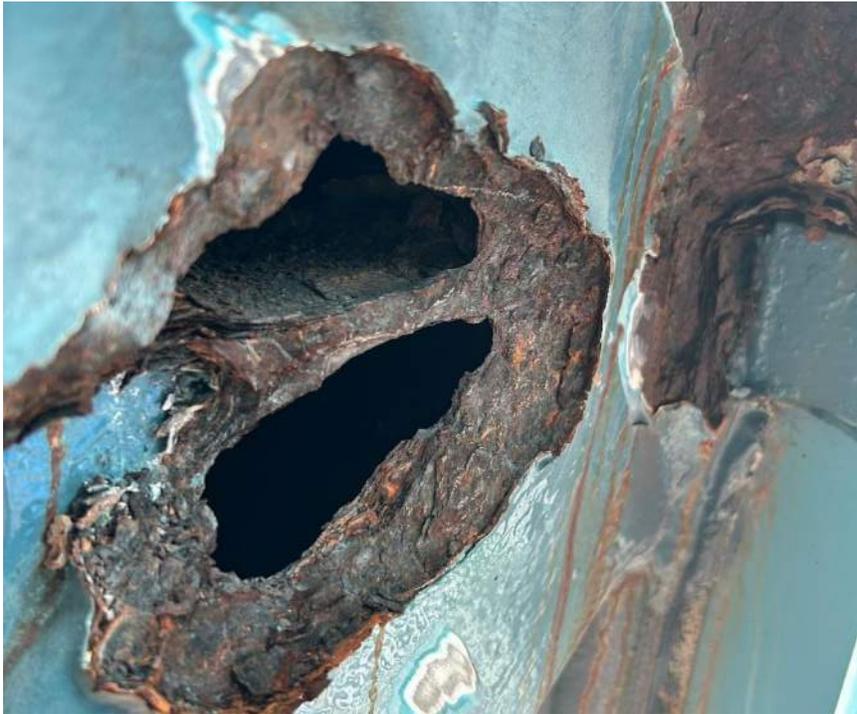
Photographer: Larry Jernigan	Date: 10-9-23
<b>9</b>	<b>Location / Orientation</b>	D-1-T2-3	
	<b>Remarks</b>	Hole

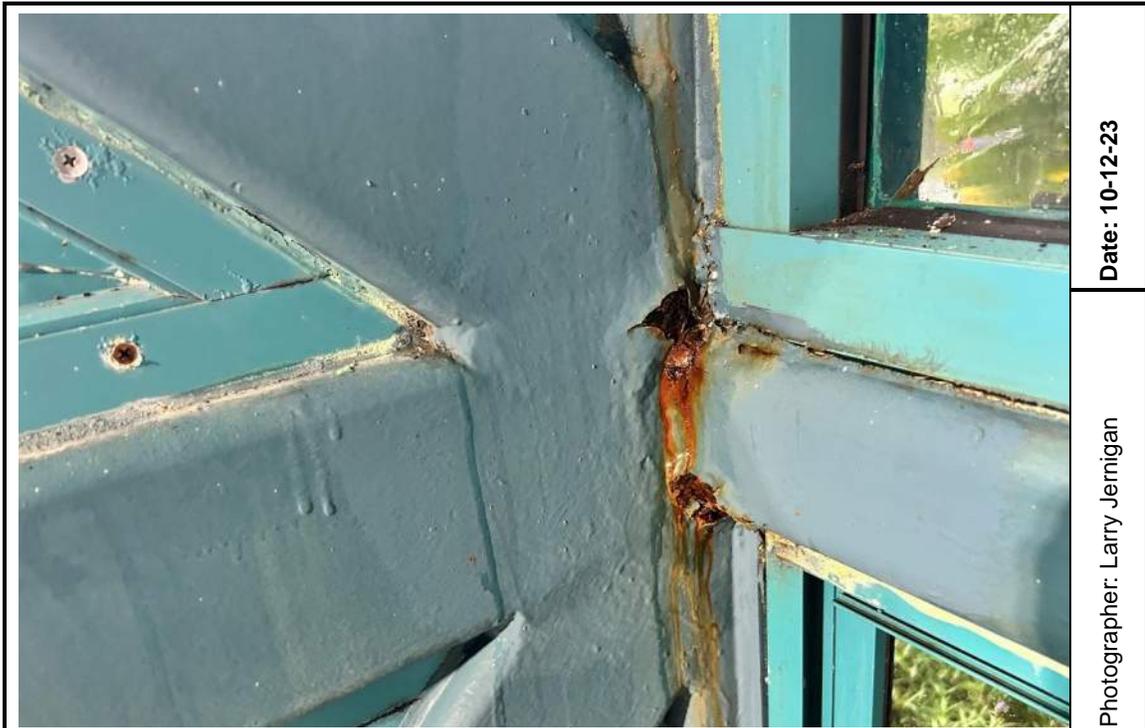
<b>11</b>	<b>Location / Orientation</b>	B-10_10.3 truss joints
	<b>Remarks</b>

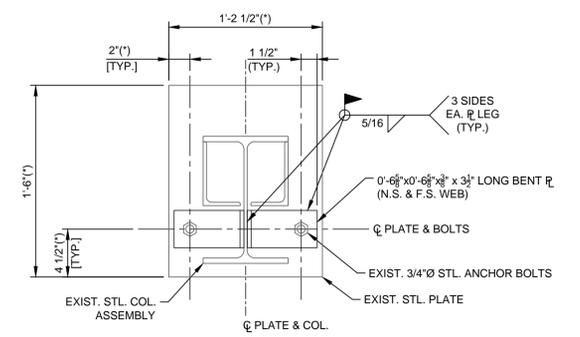
5 - DETAIL - EXIST. BASE PLATE MOD KEY NOTE 2  
SCALE: 1 1/2" = 1'-0"

- REFERENCE KEYNOTE 1 FOR REMOVING EXISTING RUST, COATING & BOLT HARDWARE. REFERENCE KEYNOTE 1 FOR PREP OF EXISTING STEEL. REINFORCE PLATE AS INDICATED DETAIL 7-S1.09. REPAIR ANCHOR BOLTS PER DETAIL 8-S1.09 IF BOLT OR THREADS DAMAGED BEYOND REPAIR. INSTALL NEW COATING SYSTEM.

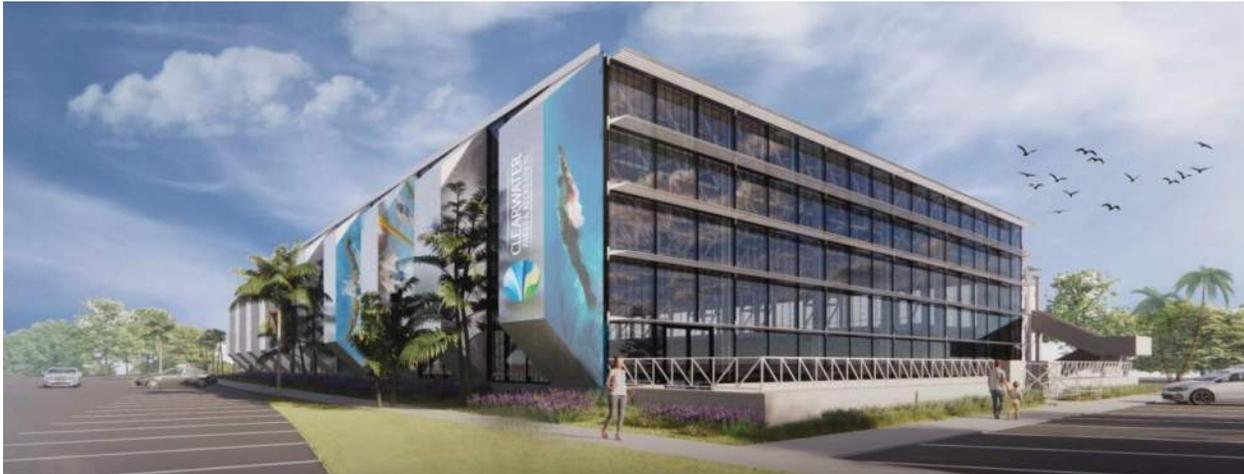
Below is a brief rendering of the architectural design for Option 1. Please refer to Wannemacher Jensen Architect's reports and drawings for more information. We understand the new glass curtain wall structure will be completely thermally-broke from the existing steel structure, so that the outside temperature will not transfer to the inside steel and cause condensation (and eventually corrosion of the steel). The new glass values are Winter U-Value 0.24, Summer U-value 0.20, and Solar Heat Gain Coefficient 0.22.

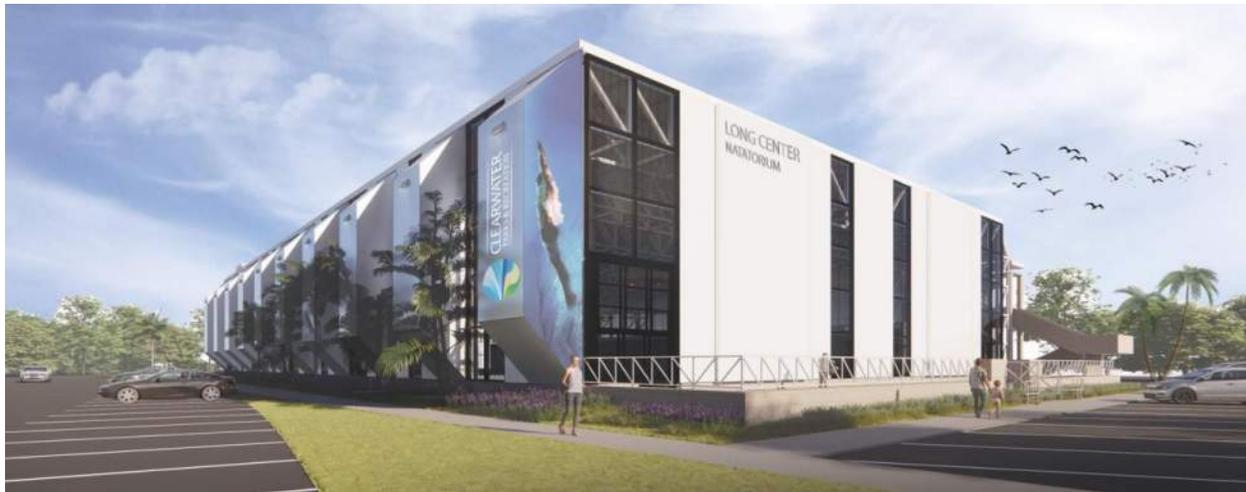
Above is an architectural rendering of Option 2 provided by Wannemacher Jensen Architects. See their documentation for more information. The exterior glass area has been reduced.

We have modeled this Option 2 building in our HVAC load calculation software and determined that it will not reduce the HVAC equipment sizes from Option 1. The tonnage of the equipment is based largely on the pool's latent heat load (moisture removal load) and air exchanges. Both of those are the same in Option 1 and Option 2. A reduction of the exterior glass only reduces the sensible load (radiated heat load), and not by enough to reduce the overall tonnage of the equipment. The glass being specified has excellent insulation performance.

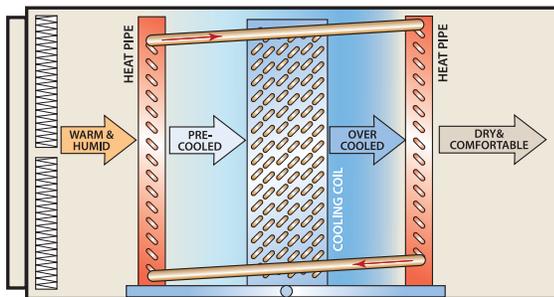
Air entering the evaporator coil is assisted to a lower temperature, therefore coming closer to saturation and resulting in greater condensate removal by the coil. The "over-cooled" air is then reheated to a desirable temperature by the reheat heat pipe section, using the heat transferred from the pre-cool heat pipe. This entire process of pre-cool and reheat is accomplished with very little additional energy use.

Figure 1 - SelectAire Plus™ Series unique enhanced latent design with heat pipe assembly

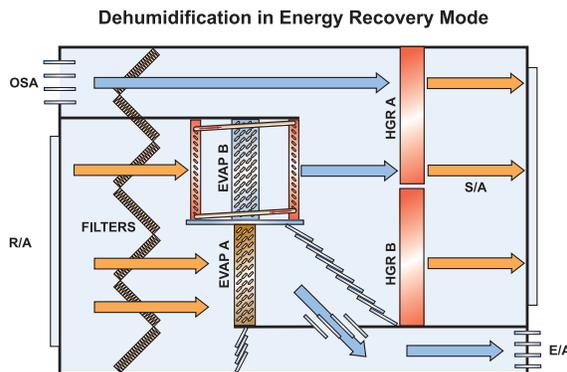
In the dehumidification mode the system will capture the high energy content of the exhaust air and return this energy back to the air or pool water at an industry-leading coefficient of performance (COP) approaching 5. This helps to minimize the amount of new energy required to make up the ventilation load's heating requirement.

Figure 3 - Dehumidification in Energy Recovery Mode

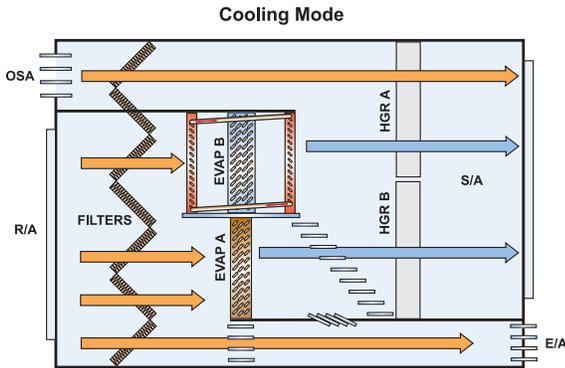
Many conventional dehumidifiers exhaust the air after the evaporator coil for construction convenience. The SelectAire Plus™ System strategically configures its airflow arrangement to “Select” where the exhaust air is coming from. In the cooling mode the higher enthalpy return air is exhausted before the evaporator coil thus maintaining all of the cooling performed by the evaporator and delivering this cool air to the space. In the heating mode the energy of the high enthalpy containing return air is recovered by the evaporator coil and the cool air is exhausted after the coil. Refer to Desert Aire’s Technical Bulletin 6 – SelectAire Heat Recovery System, for more details.

Figure 4 - Dehumidification in Cooling Mode

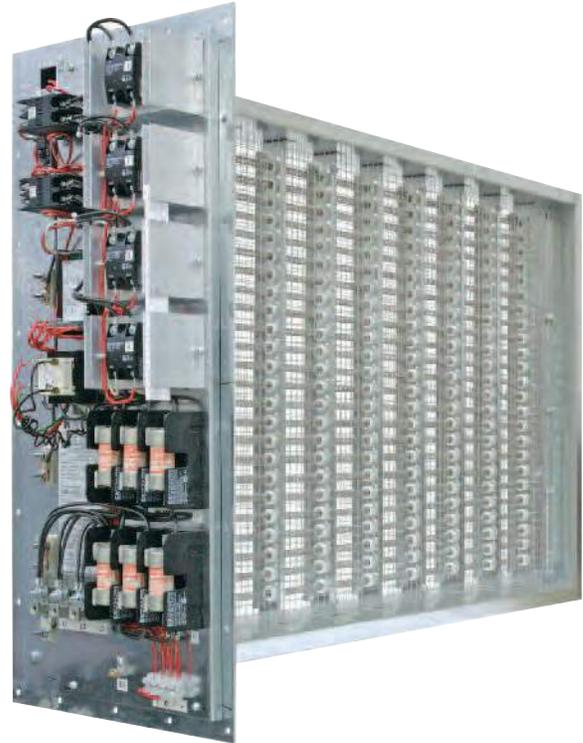
- System Single Point Power to Dehumidifier
- NiCr 60 Corrosion-Resistant Element
- Welded Construction Using 20 MSG Galvanized Steel
- Automatic Reset High Temperature Limit Safety Switch
- Manual Reset High Maximum Temperature Limit Safety Switch
- Air Flow Pressure Switch
- Fusing as Required for Each 48 Amp Circuit
- Fused Circuits per N.E.C., UL, and CSA
- SCR modulation

Figure 1 - Detail of Electric Heating Element for SelectAire Plus™ Series Unit

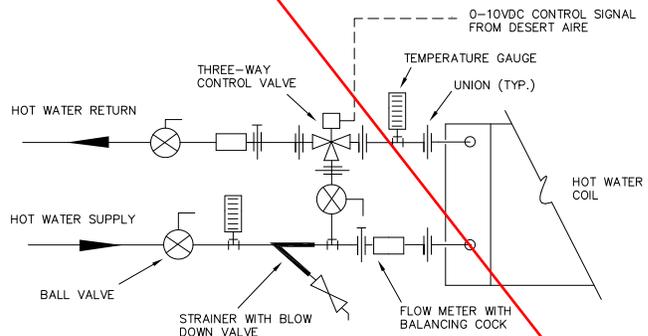
Figure 1 - Hot Water Piping Detail

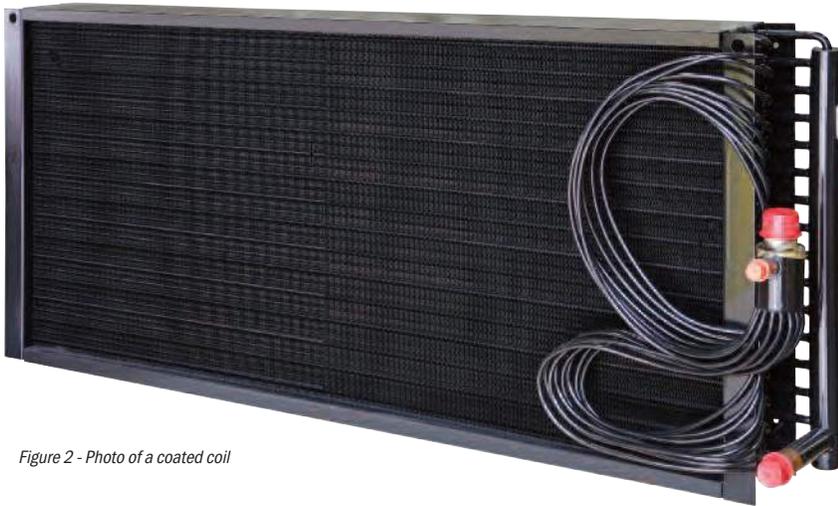
Not all coil coatings are the same. Many dehumidifier companies use a fin stock coating that is applied to the aluminum stock before the coil is manufactured. This means the edges of the fin, the copper tubes and the steel header remain uncoated.

Figure 2 - Photo of a coated coil

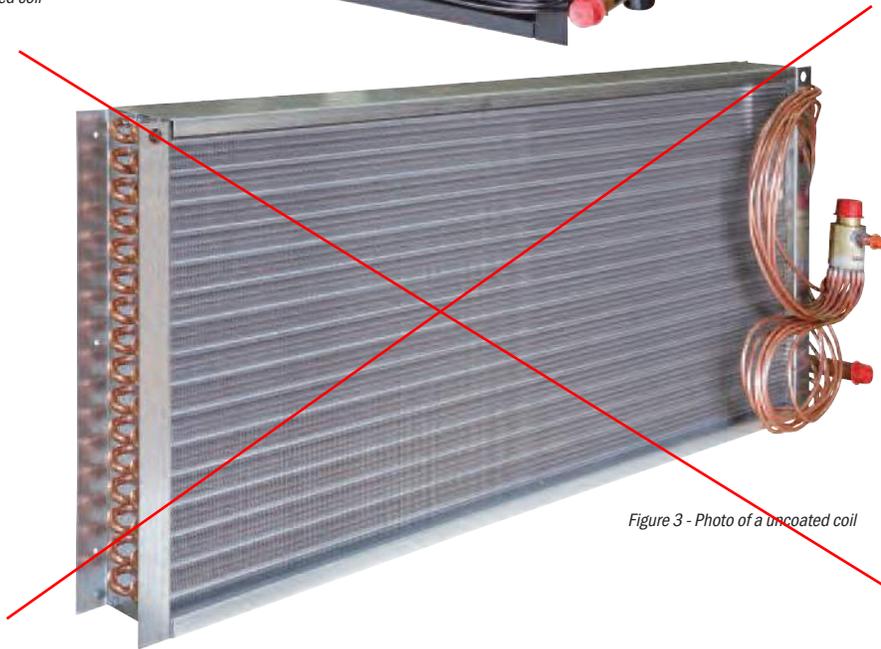
Figure 3 - Photo of an uncoated coil

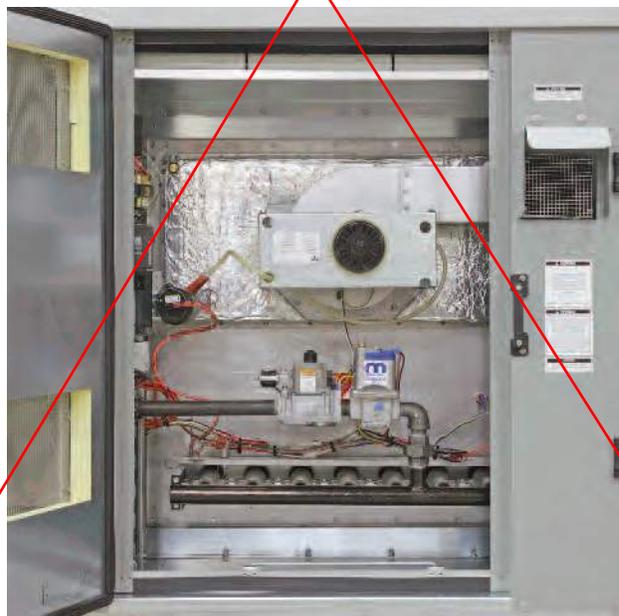
Input Capacity (MBH)	Output Capacity (MBH)	Gas Module Qty.	Effective Turndown Ratio	Gas Connection
800	640	2	10 to 1	One 2" NPT
1,000	800	2	10 to 1	One 2" NPT
1,200	960	2	10 to 1	One 2" NPT
1,600	1,280	4	20 to 1	Two 2" NPT
2,000	1,600	4	20 to 1	Two 2" NPT
2,400	1,920	4	20 to 1	Two 2" NPT

Figure 1 - Detail of Gas Heat Compartment on SelectAire Plus™ Series Unit

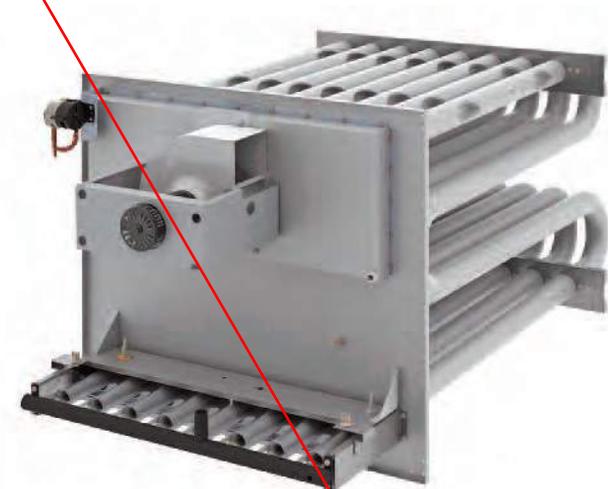
Figure 2 - Detail of Gas Heat Burner Assembly

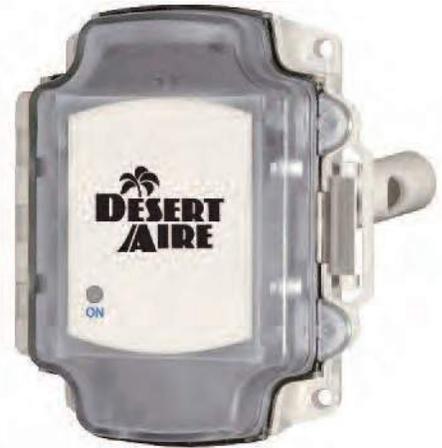
Figure 1 - Duct Mounted VOC Sensor

- Power: 15 to 35 VDC @ 50 mA
- Power Sensing Element: VOCs: Micro-machined Metal Oxide Quick Response Sensor through Aspiration Tube
- Analog Outputs: 0 to 10VDC, (>10KΩ impedance)
- VOC Contaminants: 0 to 2,000 PPM CO<sub>2</sub> Equivalent
- VOC Detection Range: 0 to 100%
- Response Time: Less Than 60 Seconds
- Start-Up Time: 15 minutes
- Operating Environment: 32 to 122°F (0 to 50°C)  
0 to 95%RH non-condensing
- Dimension: 4.91"H x 3.21"W x 1.20"D  
(124.6 x 81.5 x 30.5 mm)
- Enclosure Rating: NEMA 4
- Enclosure Material: Polycarbonate, UL94 V-0
- VOC Duct Sensor
- Certifications: RoHS
- Warranty Period: Two years from manufacture date

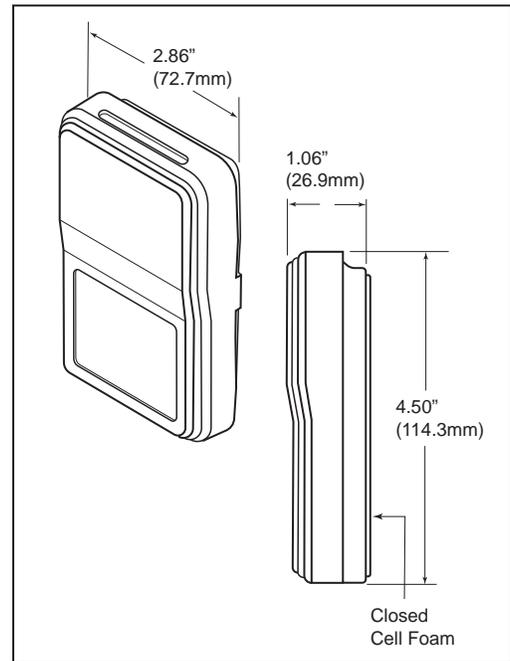
Figure 2 - Wall Sensor Dimensions

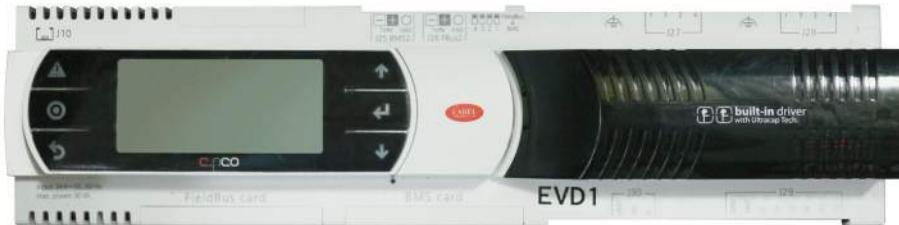
CM3560 Controller Used on SP Series Dehumidifiers

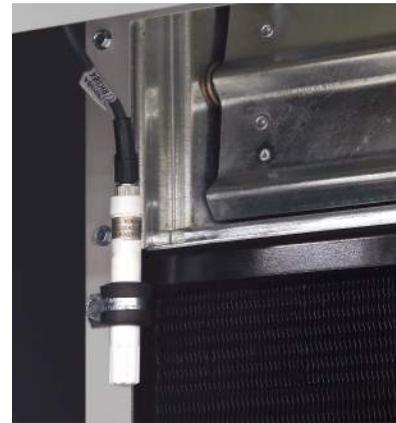
Integral Return Temperature & Humidity Sensor

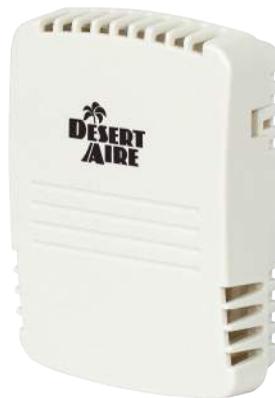
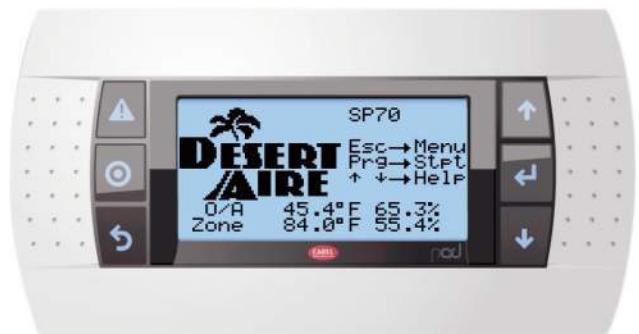
CM3560 Series Optional Remote Display Terminal (RDT)

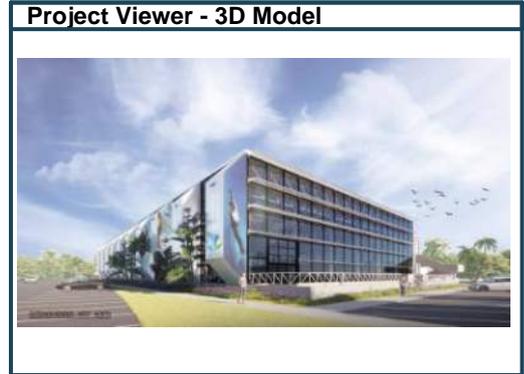
Annual Energy Consumption (kBtu/ft²/year) & CO2 KgCO2/ft²/yr			
Energy End Use	Site Energy	Source Energy	CO2 Emissions
Heating Fossil Fuel	0.0	0.0	0.0
Heating Electricity	56.7	178.7	10.0
Space Cooling	27.3	86.0	4.8
Fans Interior	11.0	34.5	1.9
Heat Rejection	1.7	5.5	0.3
Pumps	0.0	0.0	0.0
DHW Fossil Fuel	0.0	0.0	0.0
DHW Electricity	0.0	0.0	0.0
Interior Lighting	4.8	15.0	0.8
Exterior Lighting	0.0	0.0	0.0
Receptacle	1.9	6.1	0.3
Data Center	0.0	0.0	0.0
Cooking Fossil Fuel	0.0	0.0	0.0
Cooking Electricity	0.0	0.0	0.0
Elevators & Escalators	0.0	0.0	0.0
Refrigeration	0.0	0.0	0.0
Process	0.0	0.0	0.0
<b>TOTAL (ex renewables)</b>	<b>103</b>	<b>325</b>	<b>18</b>
