City of Clearwater Parks and Recreation 2025 Pier 60 Renovation/Conceptual Repairs

Project No. CLWRC24023

Issue Date: May 8, 2025

Limited Visual Assessment Report: Mechanical, Plumbing, and Fire Protection Systems

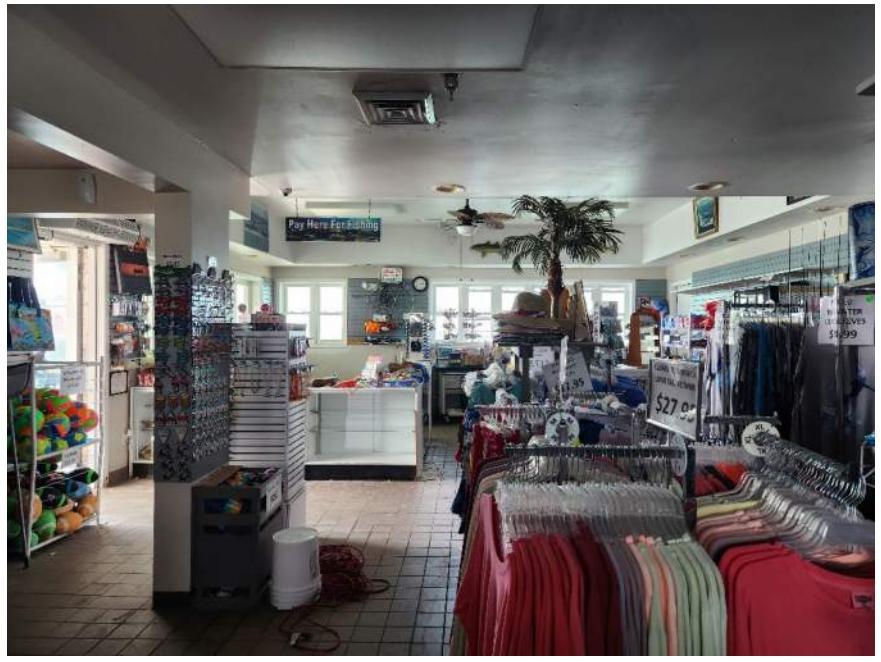
Photo 4. Gift Ship Interior

- a. The existing DX-split system includes a vertical indoor air handling unit (AHU) and an outdoor condensing unit, previously mounted on the pier deck on the west side of the gift shop (Photos 1, 2).
- b. The outdoor condensing unit was destroyed during the hurricanes, likely due to hurricane-force winds and storm surge (Photo 3).
- c. The indoor AHU and associated air distribution system (ductwork, diffusers, and grilles) showed no visible storm damage and appeared in good condition (Photo 4, 5).
- d. Restroom exhaust fans were observed to be operational, with no apparent damage.
