## FINAL REPORT

Prepared for the City of Clearwater  
January 2025

# HARBOR MARINA UNDERWATER INSPECTION REPORT

Clearwater, Florida

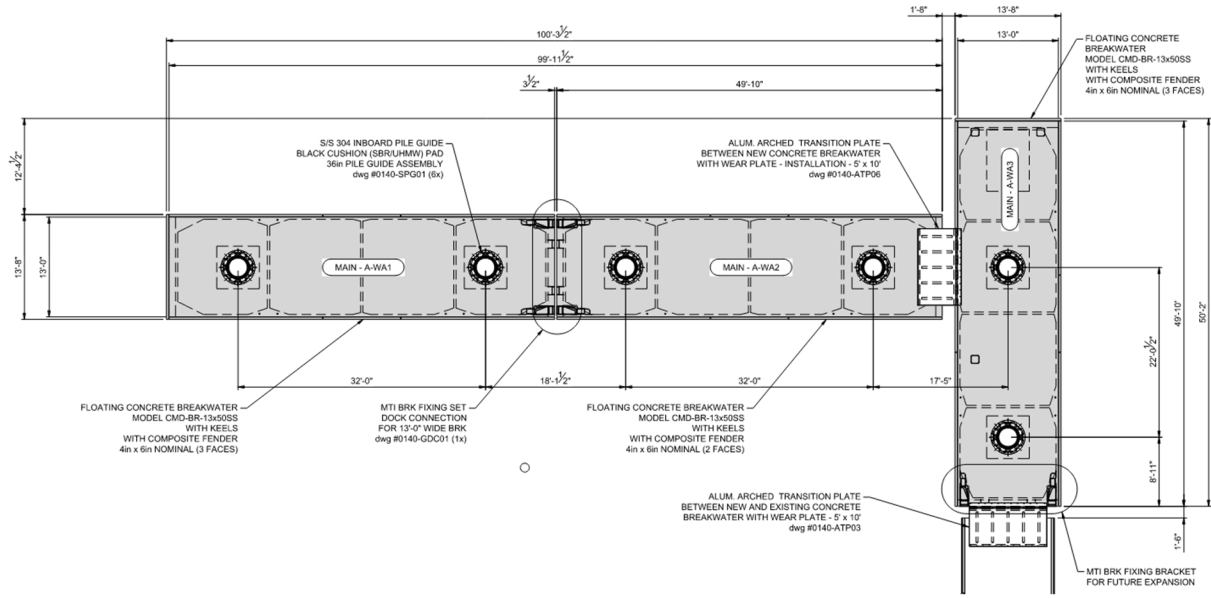
Figure 4: New Wave Attenuator Plan View

The new wave attenuators at the south corner are 50-feet long by 13.5-feet wide with a 20-inch freeboard and internal steel pipe piles, as shown in Figure 4. Although just being installed, the new concrete wave attenuators show some signs of defects, whether from production or just wear and tear. The edges show signs of aggregate loss, surface cracking, and even a few cracks with corrosion bleed out at the waterline. These items should be watched carefully. In addition, it should be noted that both transition plates have sheared off at the connection points. One was swept away during Hurricane Helene, and the other was removed from the dock after coming loose and put into storage.

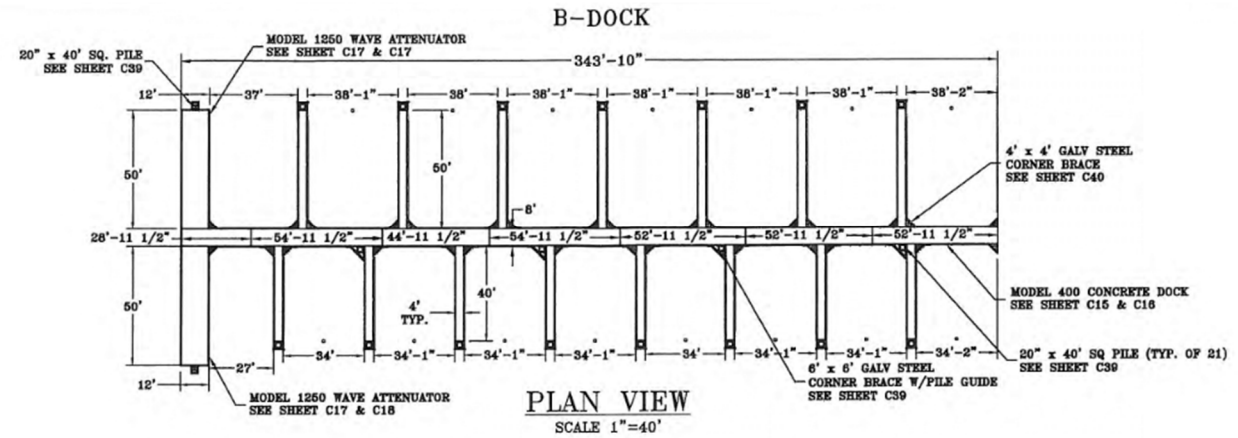
Figure 5: Planview of B-Dock

The wave attenuators at the end of B-Dock are in **Serious** condition due to nearly 50% flotation loss, the walkway and rest of the finger piers are in poor condition due to more than 20% flotation loss.

The overall condition of B-Dock is considered **Poor to Serious**. There are areas that need the floatation replaced and others that need significant repair/replacement and are overstressed, while others can be repaired or maintained to remain in working order.

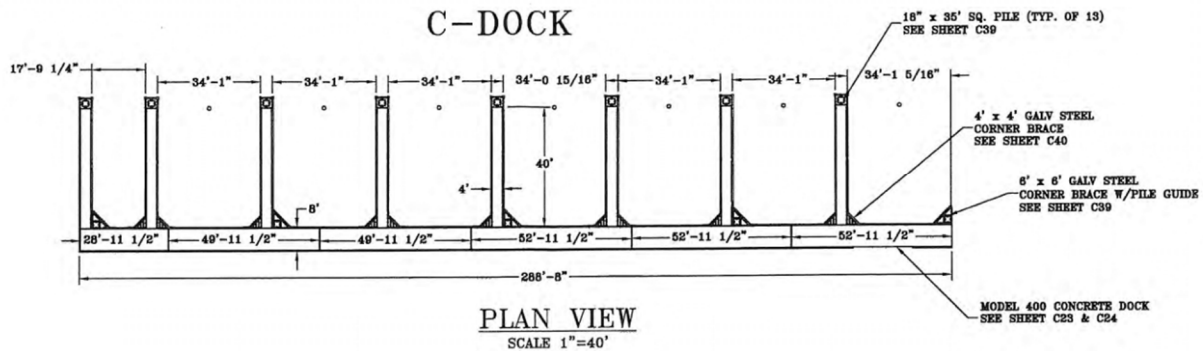
Figure 7: C-Dock Planview

C-Dock consists of an 8 feet wide walkway with 4 feet wide finger piers. The main C-Dock walkway is constructed similar to B-Dock, with one cable on each side of dock sections connecting the floats together. The plan view of the dock can be seen in Figure 7 and the cross-section of the walkway in Figure 6 under section 2.2. The floatation is designed to be throughout the entire length of the dock and sealed on the bottom with a polyurethane coating. It should be noted that at low tide, there is approximately 5 feet of water between the bottom edge of the float and the mudline. During the underwater assessment, it was discovered that the polyurethane coating has failed in most areas with more than 20% of the floatation exposed to the elements or large holes have been created.

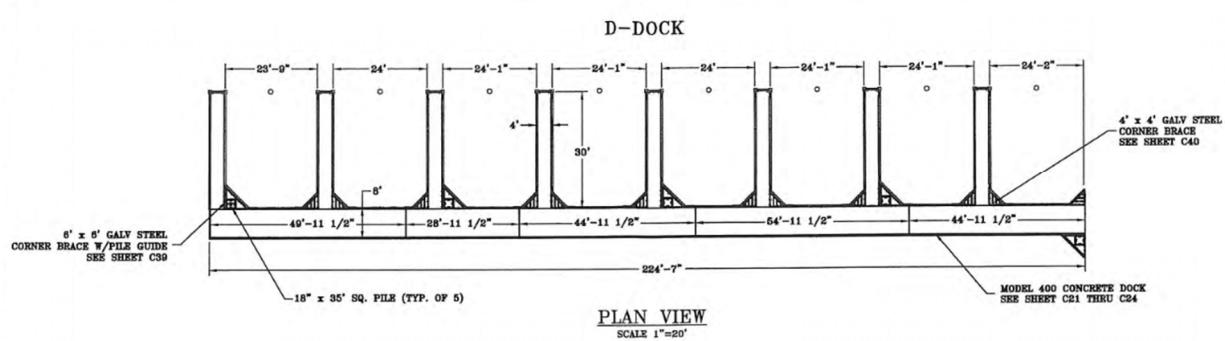
**Figure 8: D-Dock Planview**

D-Dock consists of an 8 feet wide walkway with 4 feet wide finger piers. The main D-dock walkway is constructed similar to C-dock, with one cable on each side of dock sections connecting the floats together. The plan view of the dock can be seen in Figure 8 and the cross-section of the walkway in Figure 6 under section 2.2. The floatation is designed to be throughout the entire length of the dock and sealed on the bottom with a polyurethane coating, but there was not enough water for the divers to safely get under the floating dock to check the condition of the coating and floatation. At low tide, there is approximately 6 inches of water between the bottom edge of the float and the mudline, with several areas of the dock resting on the mudline. This could cause undue stress on the internal cables.

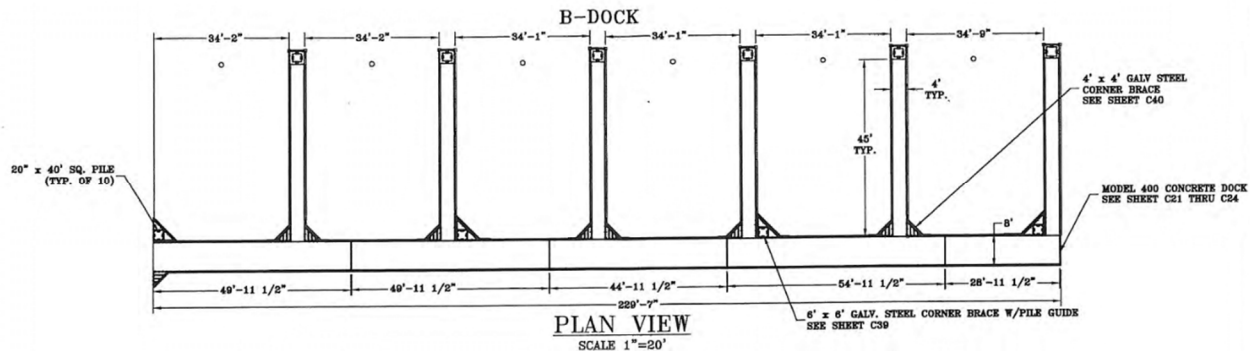
**Figure 11: North Basin B-Dock Planview**

The other main dock in the north marina basin is B-Dock, which is an 8 feet wide concrete floating dock similar to B-Dock in the South Marina with 4 feet wide finger piers. The main B-Dock walkway is constructed similar to A-Dock, but with only one cable on each side of the 8 feet wide dock section connecting the floats, as well as on each side on the finger piers connecting them to the main dock. As stated in the description for A-Dock, the floatation is designed to be throughout the entire length of the dock and sealed on the bottom with a polyurethane coating. During the underwater assessment, it was discovered that the polyurethane coating has failed in most areas with more than 30% of the floatation exposed to the elements or large holes have been created.
