DRC Lee Residence Report -Comments Responses

Case #: **FLD2025-07018 -- 1035 BAY ESPLANADE**

Request: Flexible Development approval for a detached dwelling in the Low Medium Density Residential (LMDR) District as a Residential Infill Project for the property located at 1035 Bay Esplanade. The building will not exceed 30 feet in height and includes two off-street parking spaces. Requested is flexibility from front setback requirements. (Community Development Code Section 2-204.E)

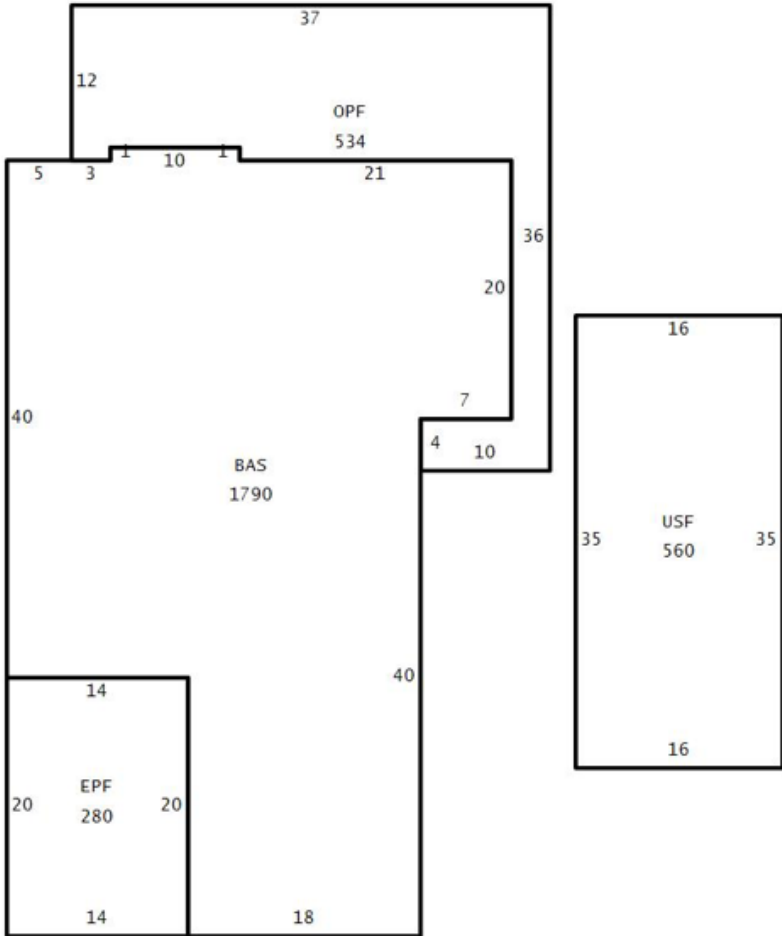
2024 Building 1 Structural Elements and Sub Area Information

Structural Elements		Sub Area	Living Area SF	Gross Area SF
Foundation	Continuous Footing Poured	Base (BAS)	1,790	1,790
Floor System	Wood	Upper Story (USF)	560	560
Exterior Walls	Frame Siding	Enclosed Porch (EPF)	0	280
Unit Stories	2	Open Porch (OPF)	0	534
Living Units	1	Total Area SF	2,350	3,164
Roof Frame	Gable Or Hip
