Alan Mayberry Tree Consulting

Tree Inventory 405 Coronado Drive Clearwater Beach, Florida

405 Coronado TRAFFIC IMPACT STUDY

Clearwater, Florida

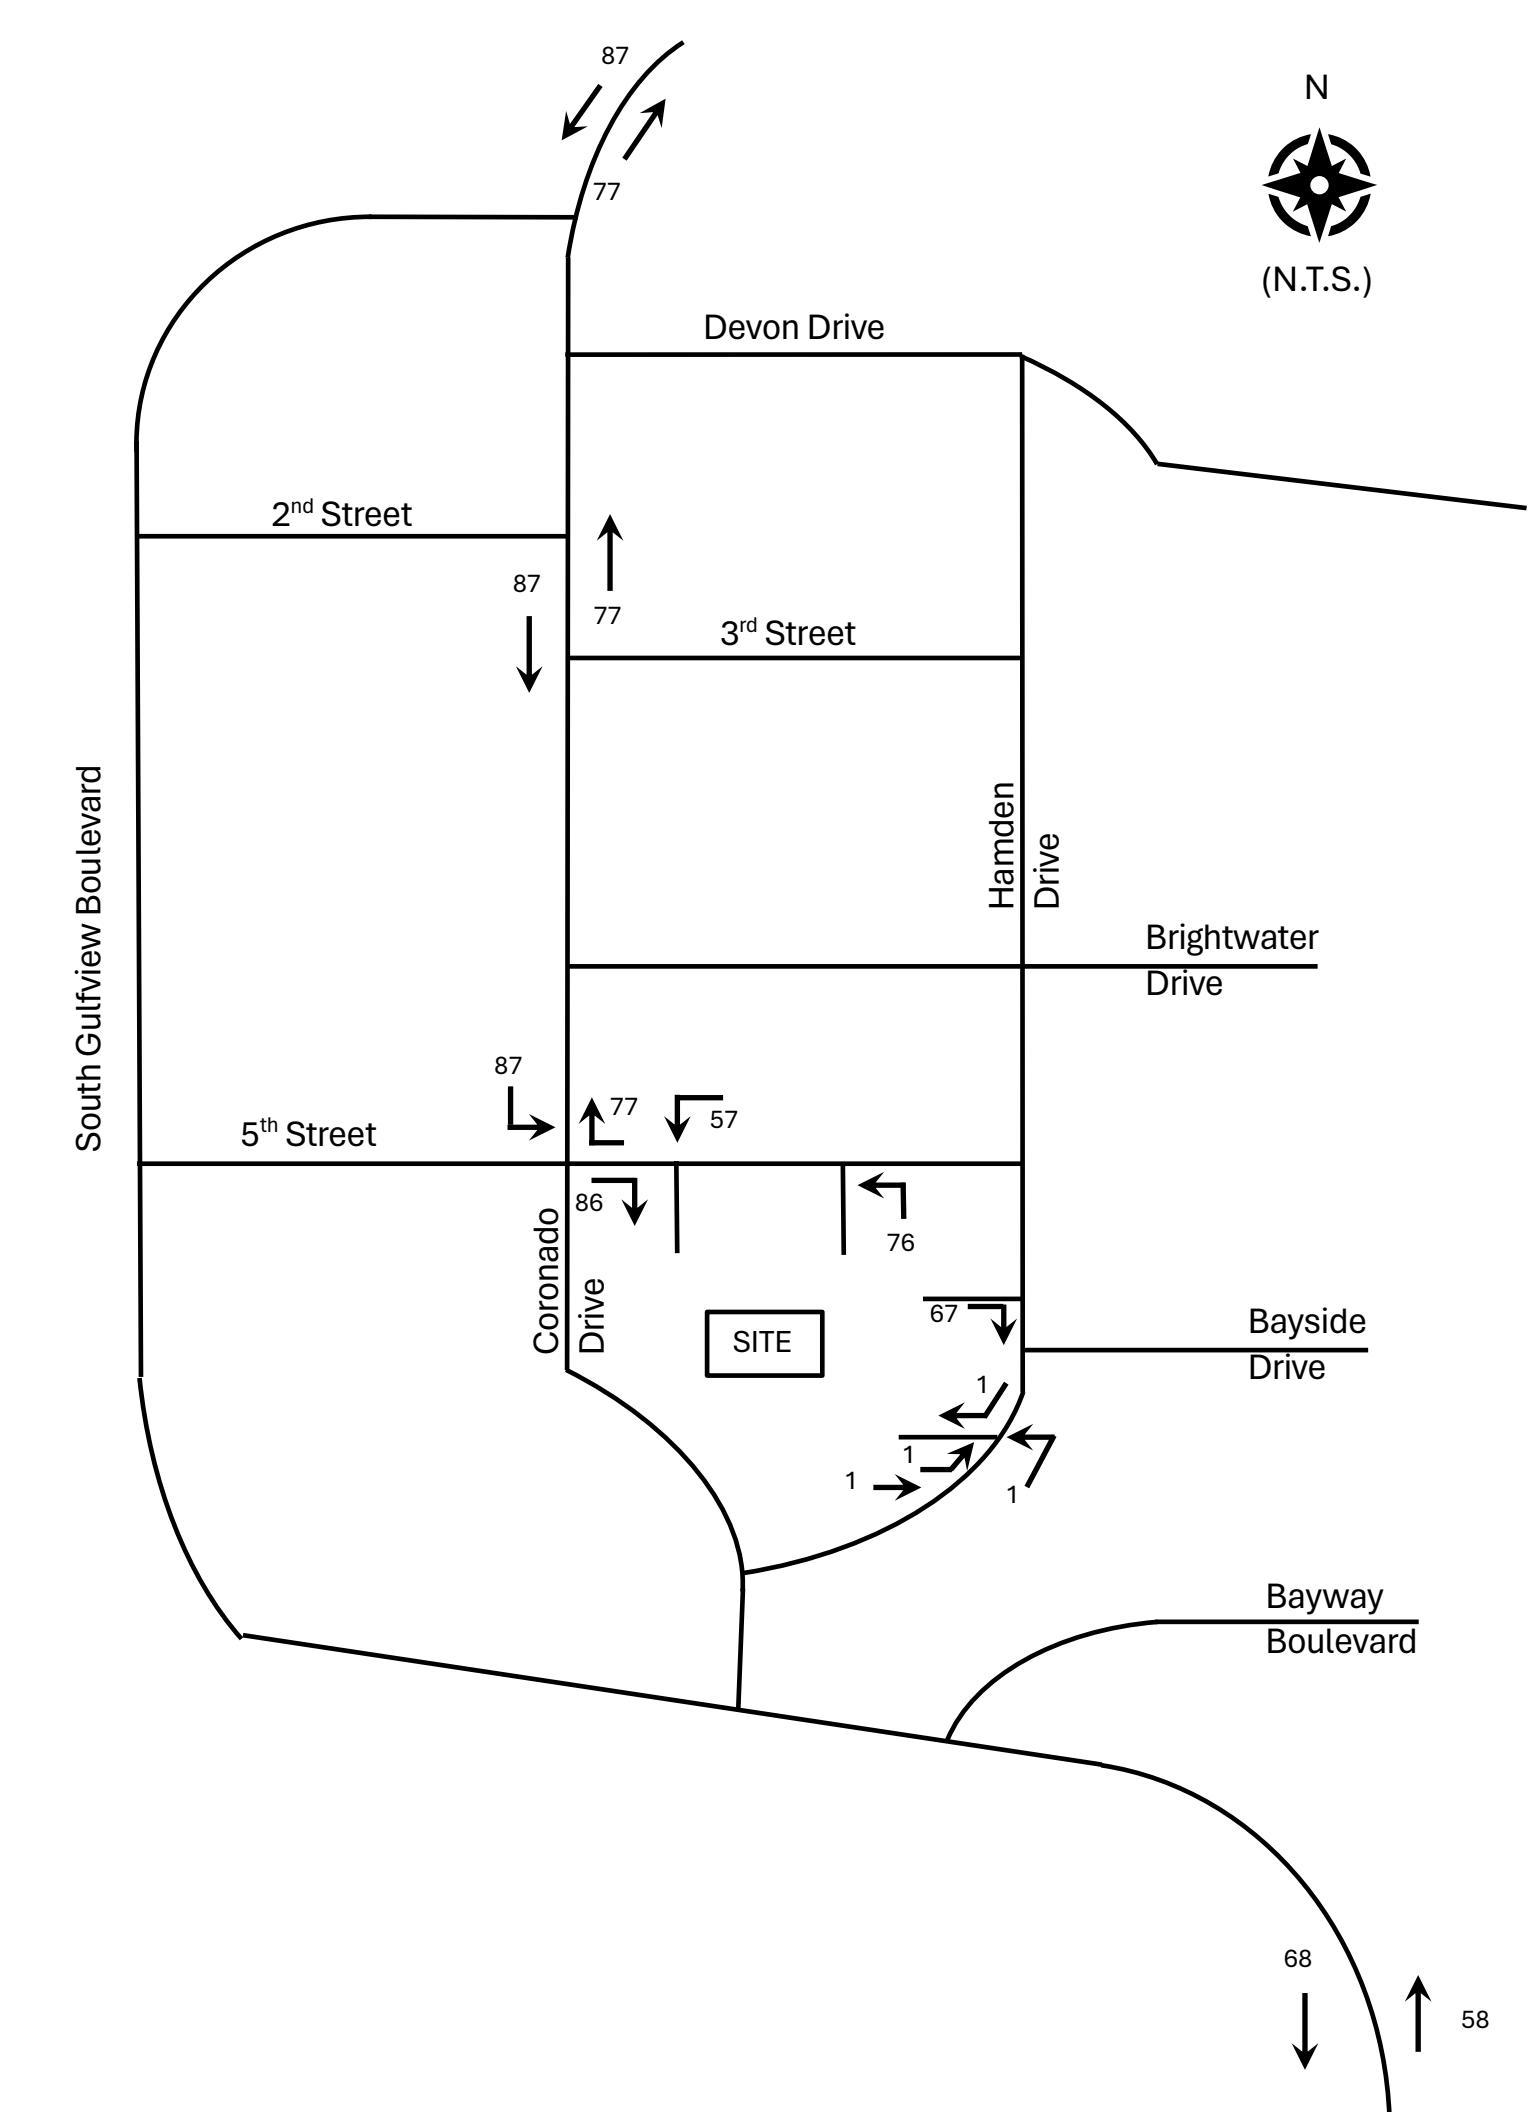
Updated project traffic distribution and assignment and study area are illustrated on the following page.

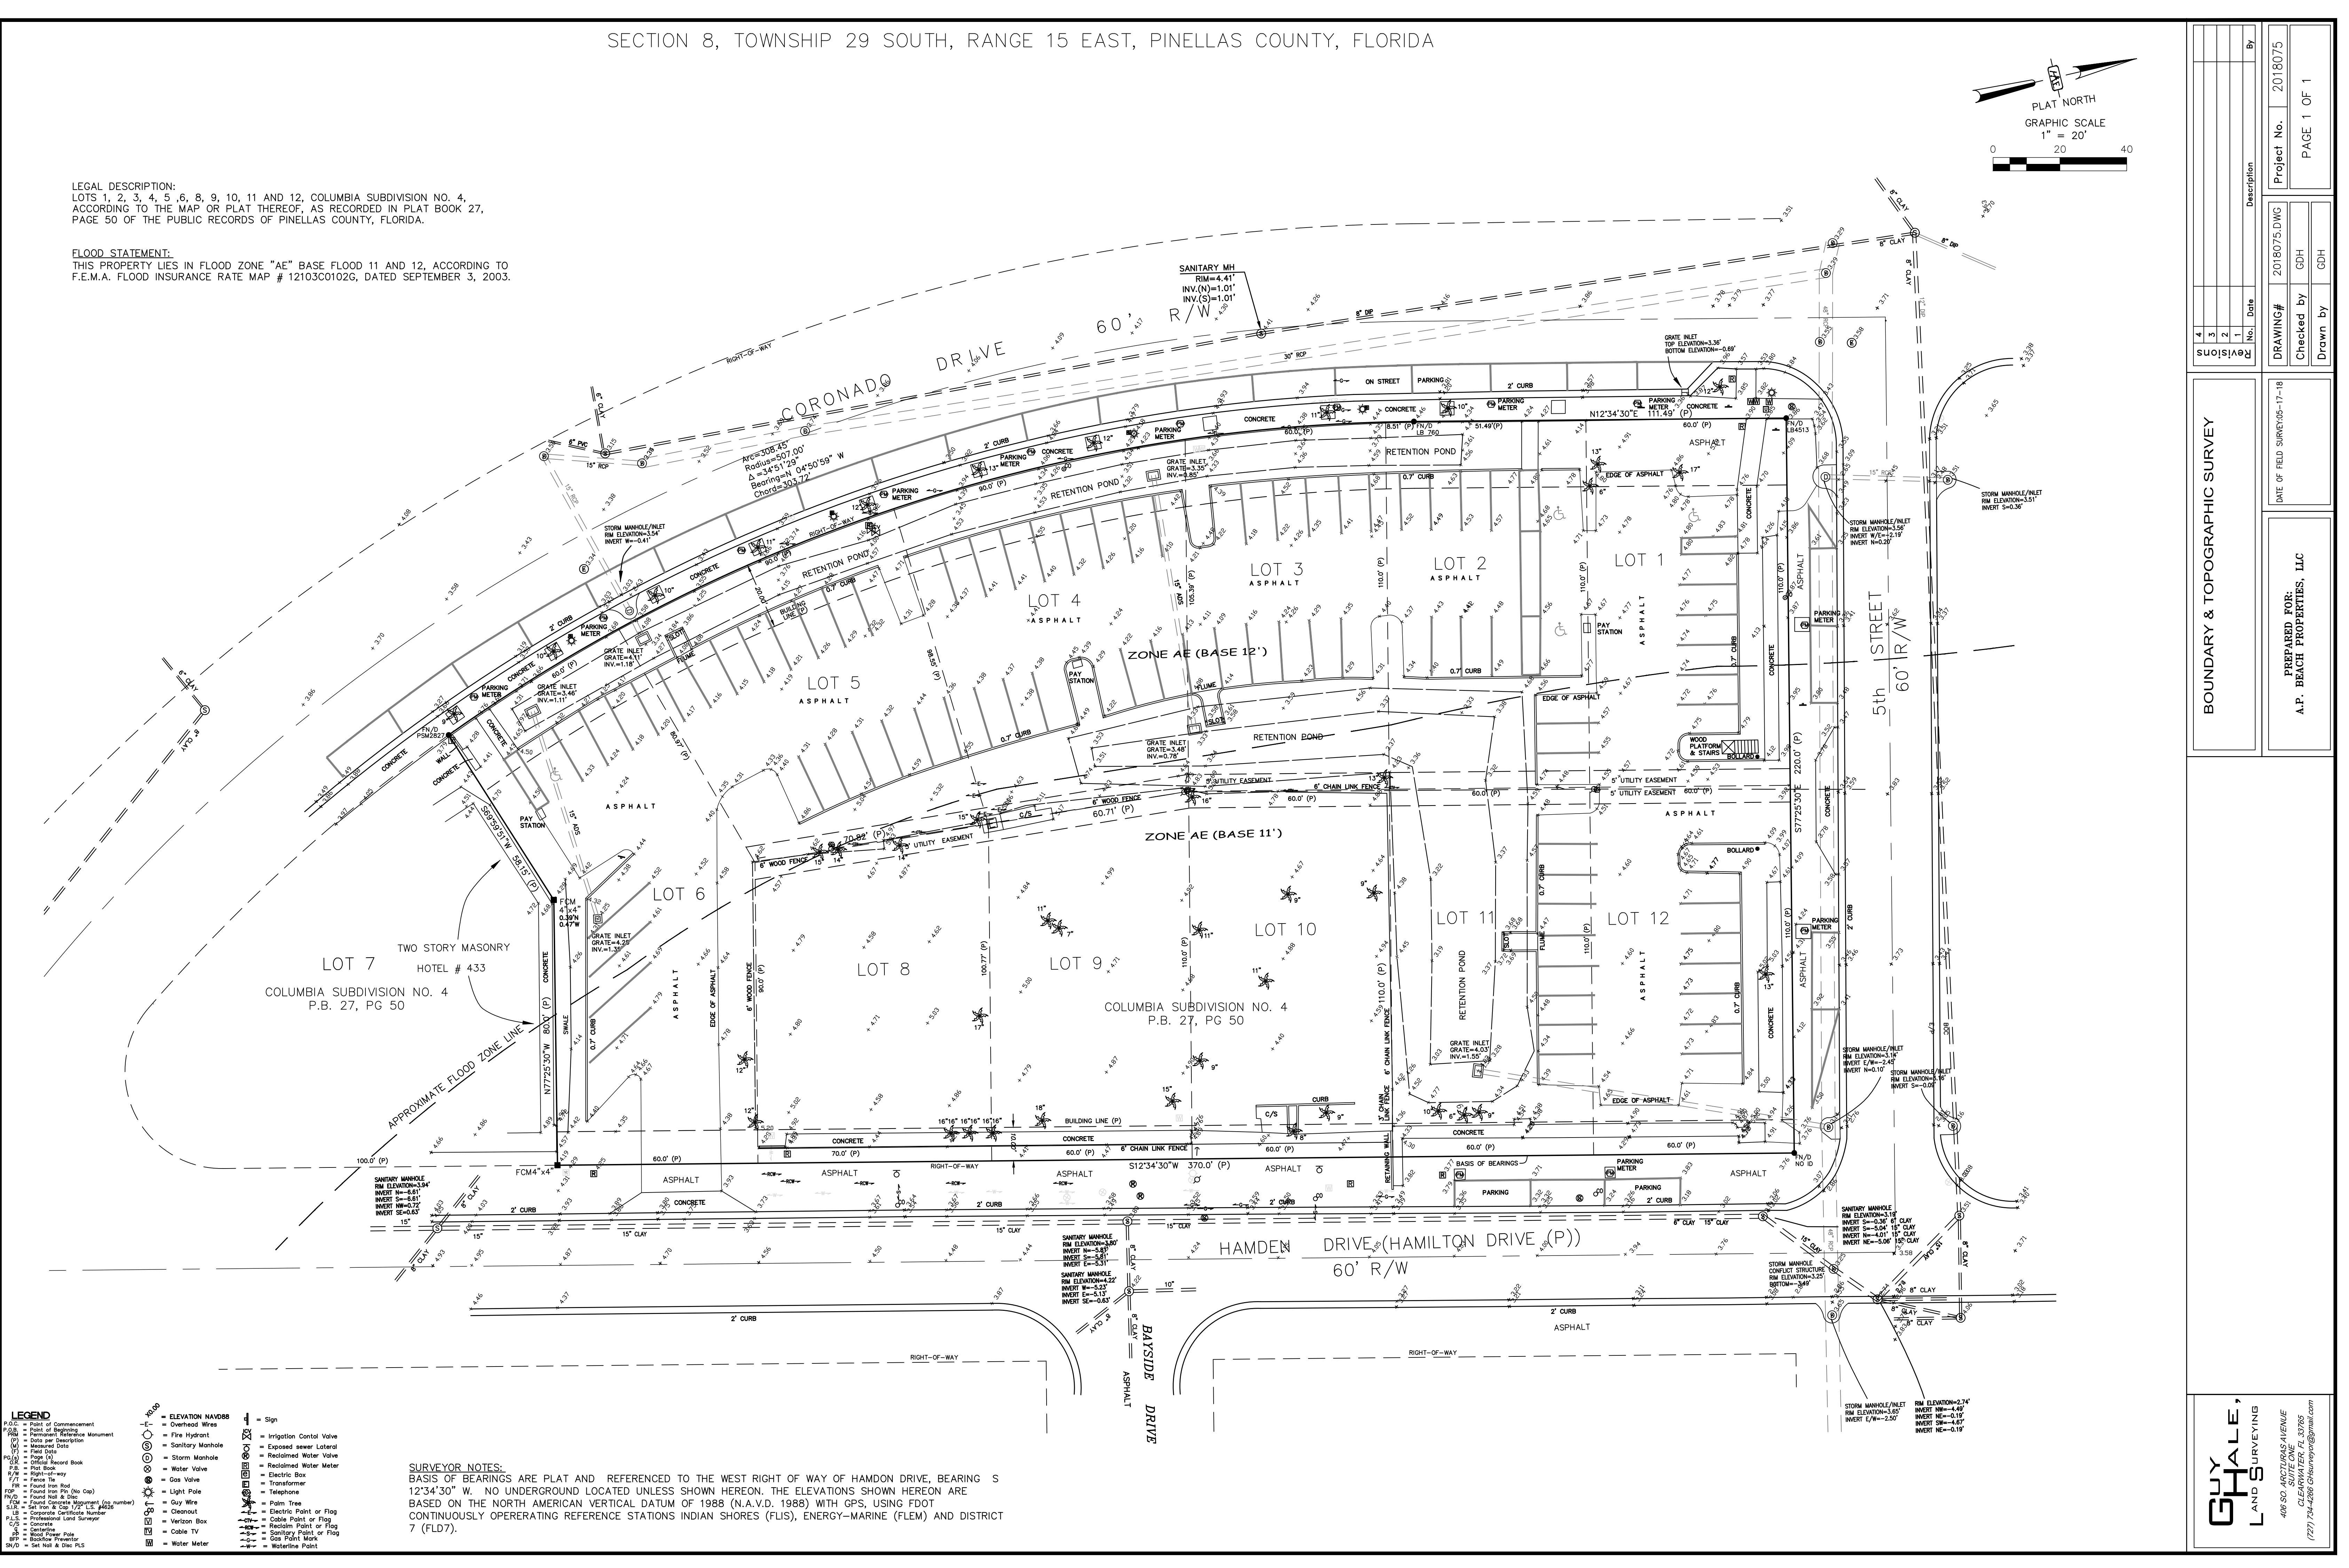
APPENDIX A Site Plan Detailed Trip Generation Information

The 405 Coronado Project is a proposed hotel and commercial development. As is shown on the **Site Plan (Appendix A)** and **Location Map** on the following page, the 405 Coronado project is located at 405 Coronado Drive in Clearwater, Florida.

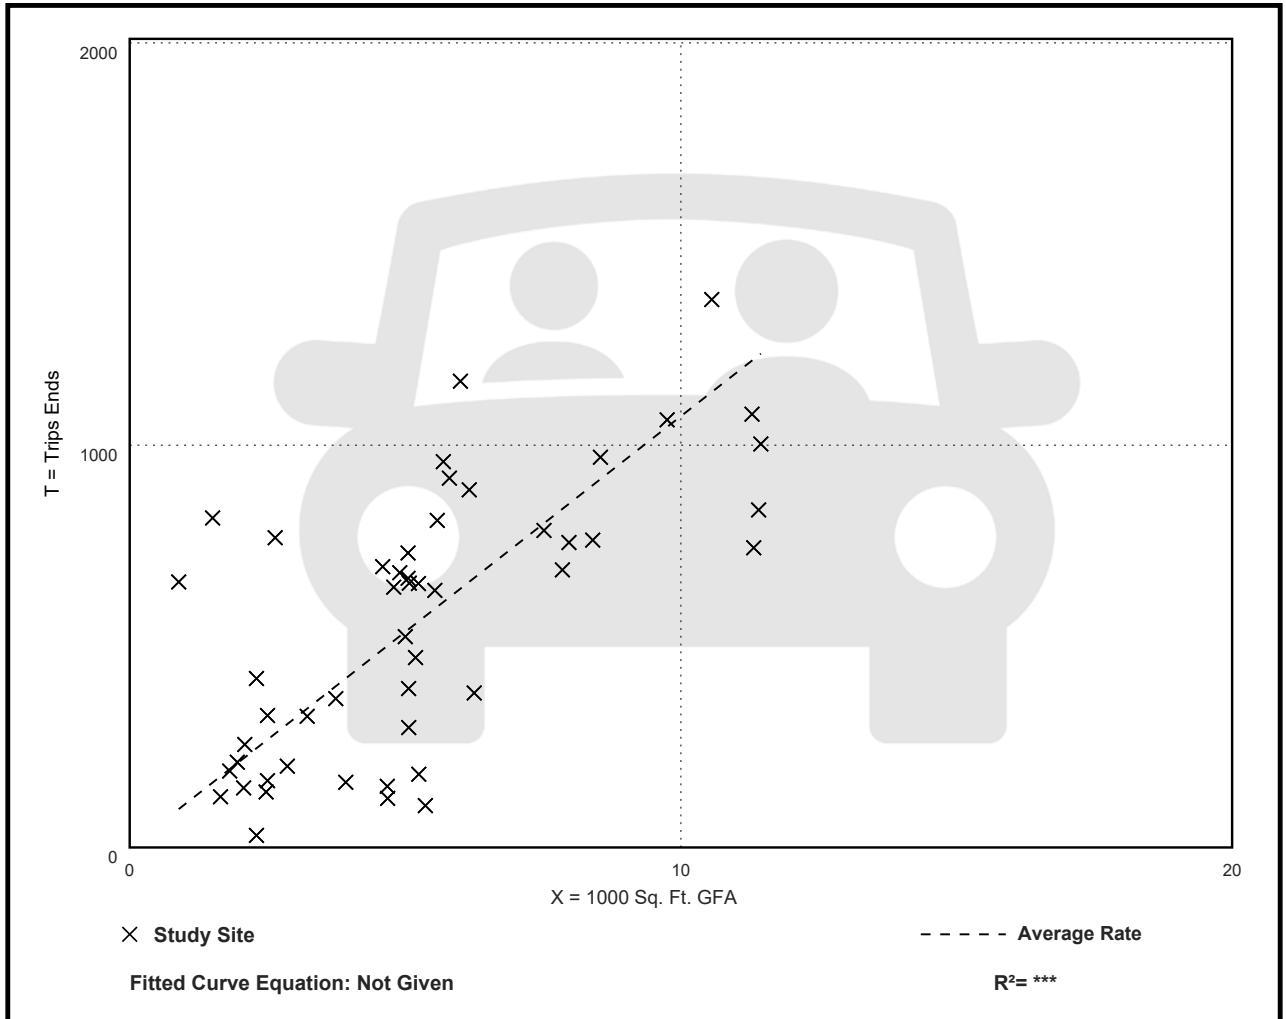
High-Turnover (Sit-Down) Restaurant (932)

Vehicle Trip Ends vs: 1000 Sq. Ft. GFA

On a: Weekday

Setting/Location: General Urban/Suburban

Number of Studies: 50 Avg. 1000 Sq. Ft. GFA: 5 Directional Distribution: 50% entering, 50% exiting

Vehicle Trip Generation per 1000 Sq. Ft. GFA

Average Rate	Range of Rates	Standard Deviation
107.20	13.04 - 742.41	66.72

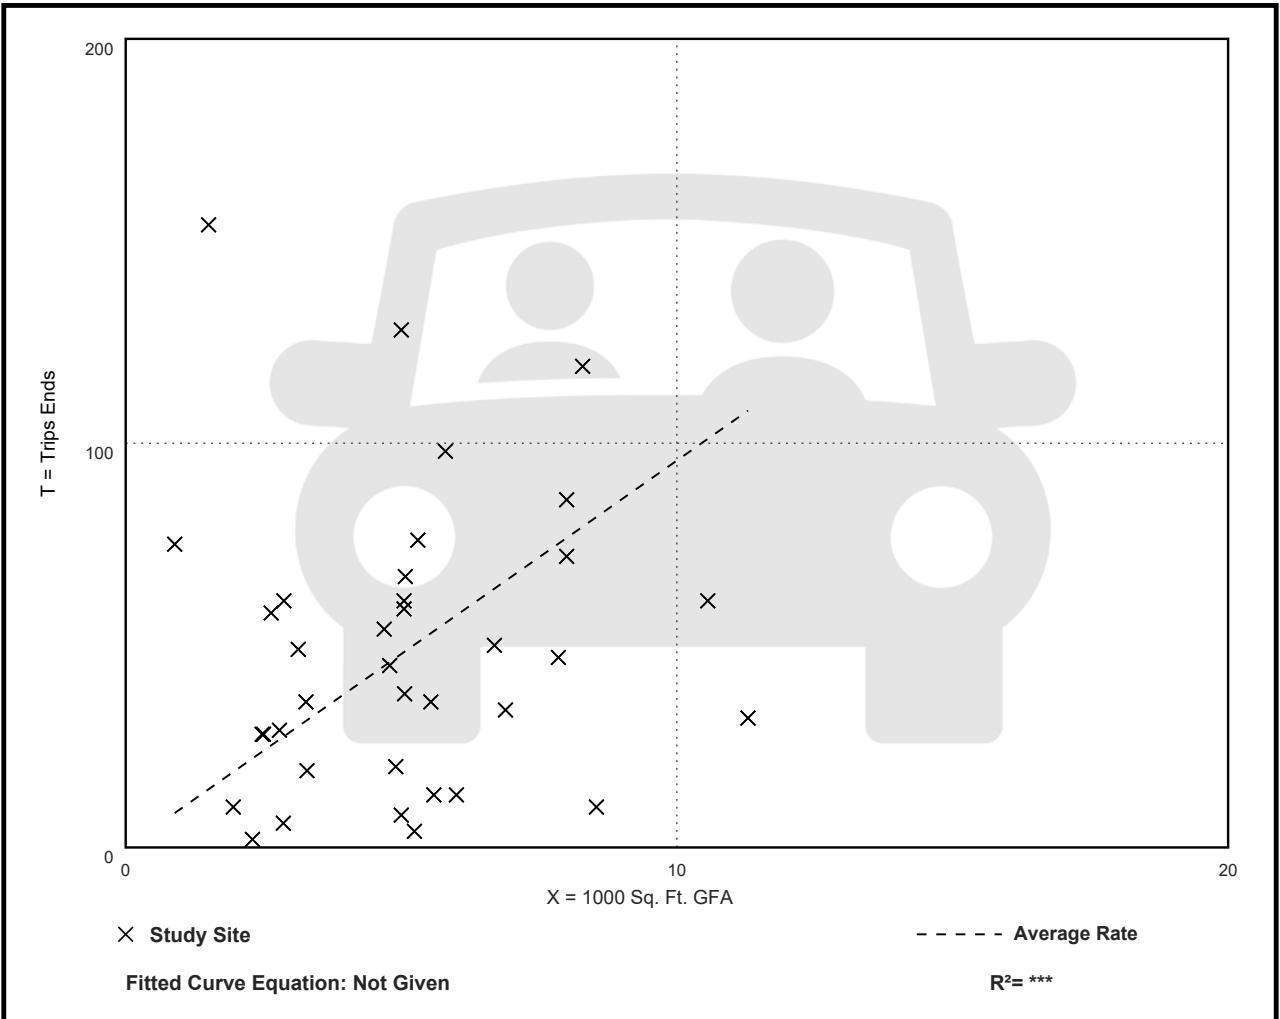
High-Turnover (Sit-Down) Restaurant (932)

Vehicle Trip Ends vs: 1000 Sq. Ft. GFA

On a: Weekday,

Peak Hour of Adjacent Street Traffic,

One Hour Between 7 and 9 a.m.

Directional Distribution: 55% entering, 45% exiting

Average Rate	Range of Rates	Standard Deviation
9.57	0.76 - 102.39	11.61

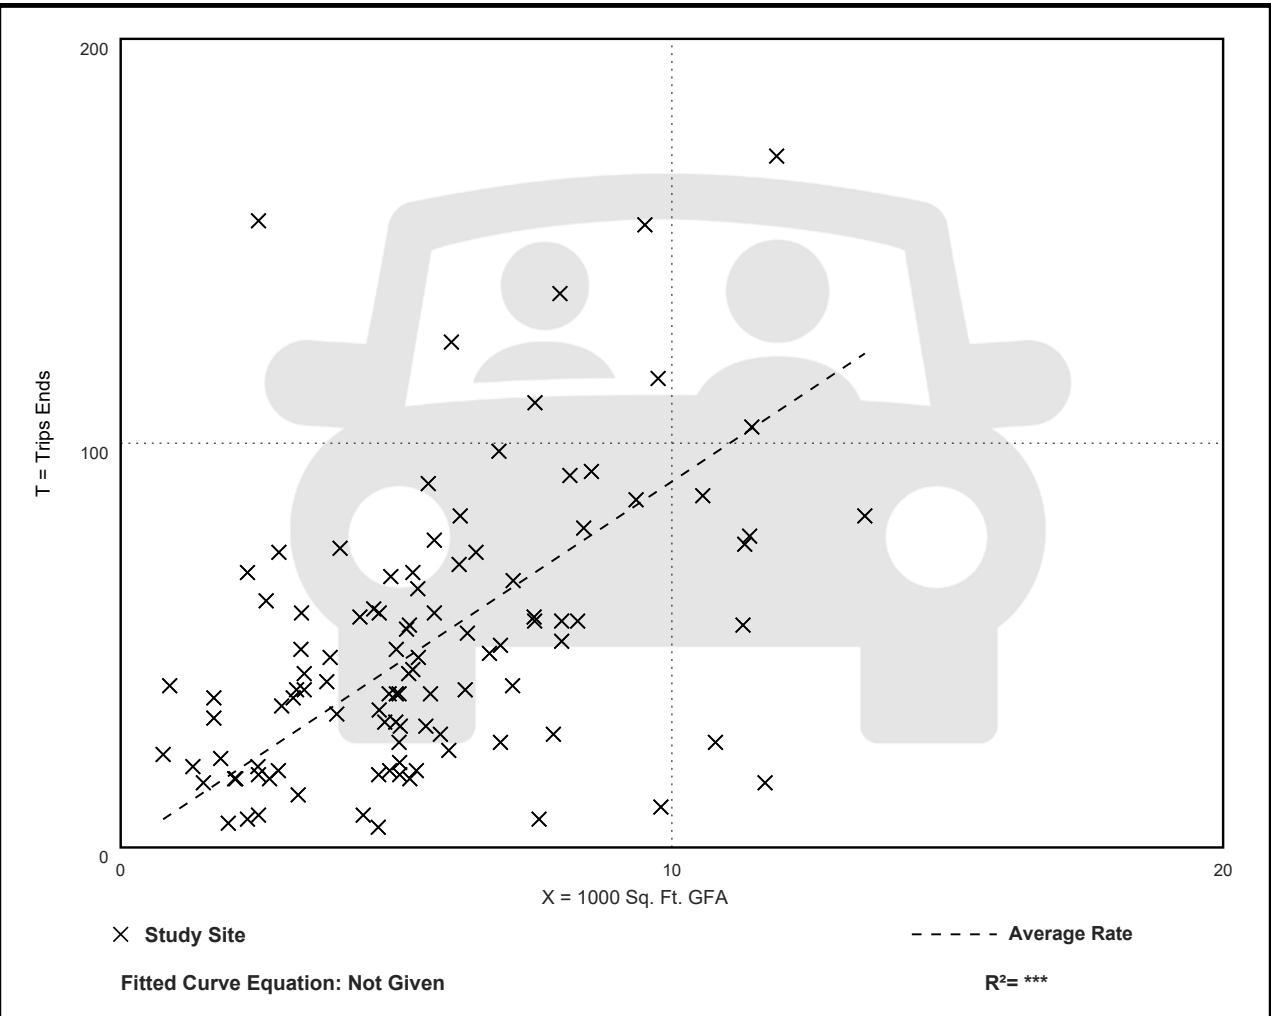
High-Turnover (Sit-Down) Restaurant (932)

Vehicle Trip Ends vs: 1000 Sq. Ft. GFA

On a: Weekday,

Peak Hour of Adjacent Street Traffic,

One Hour Between 4 and 6 p.m.

Average Rate	Range of Rates	Standard Deviation
9.05	0.92 - 62.00	6.18

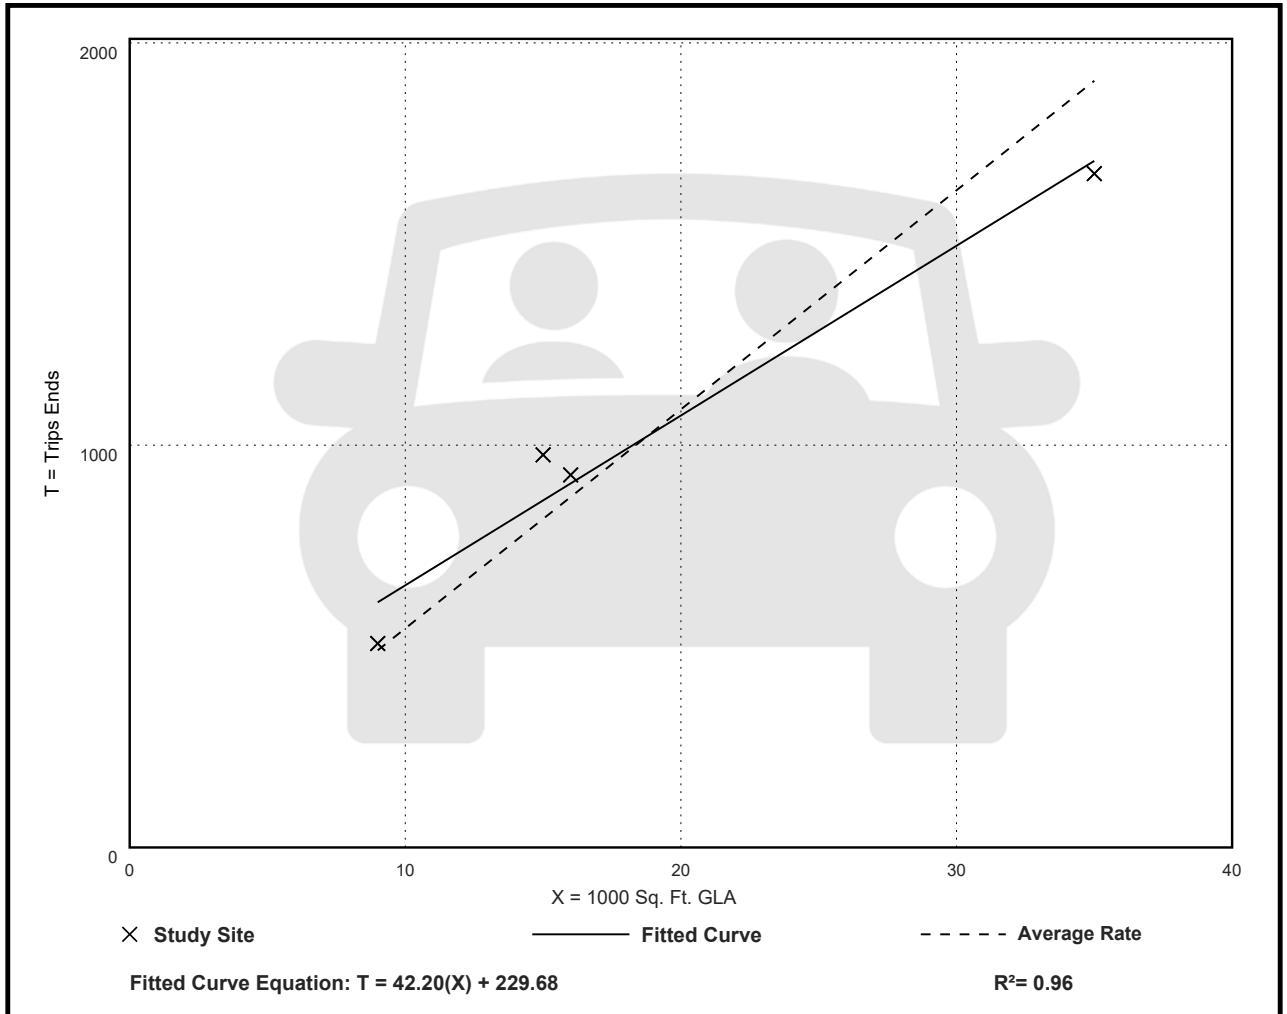
Strip Retail Plaza (<40k) (822)

Vehicle Trip Ends vs: 1000 Sq. Ft. GLA On a: Weekday

Vehicle Trip Generation per 1000 Sq. Ft. GLA

Average Rate	Range of Rates	Standard Deviation
54.45	47.86 - 65.07	7.81

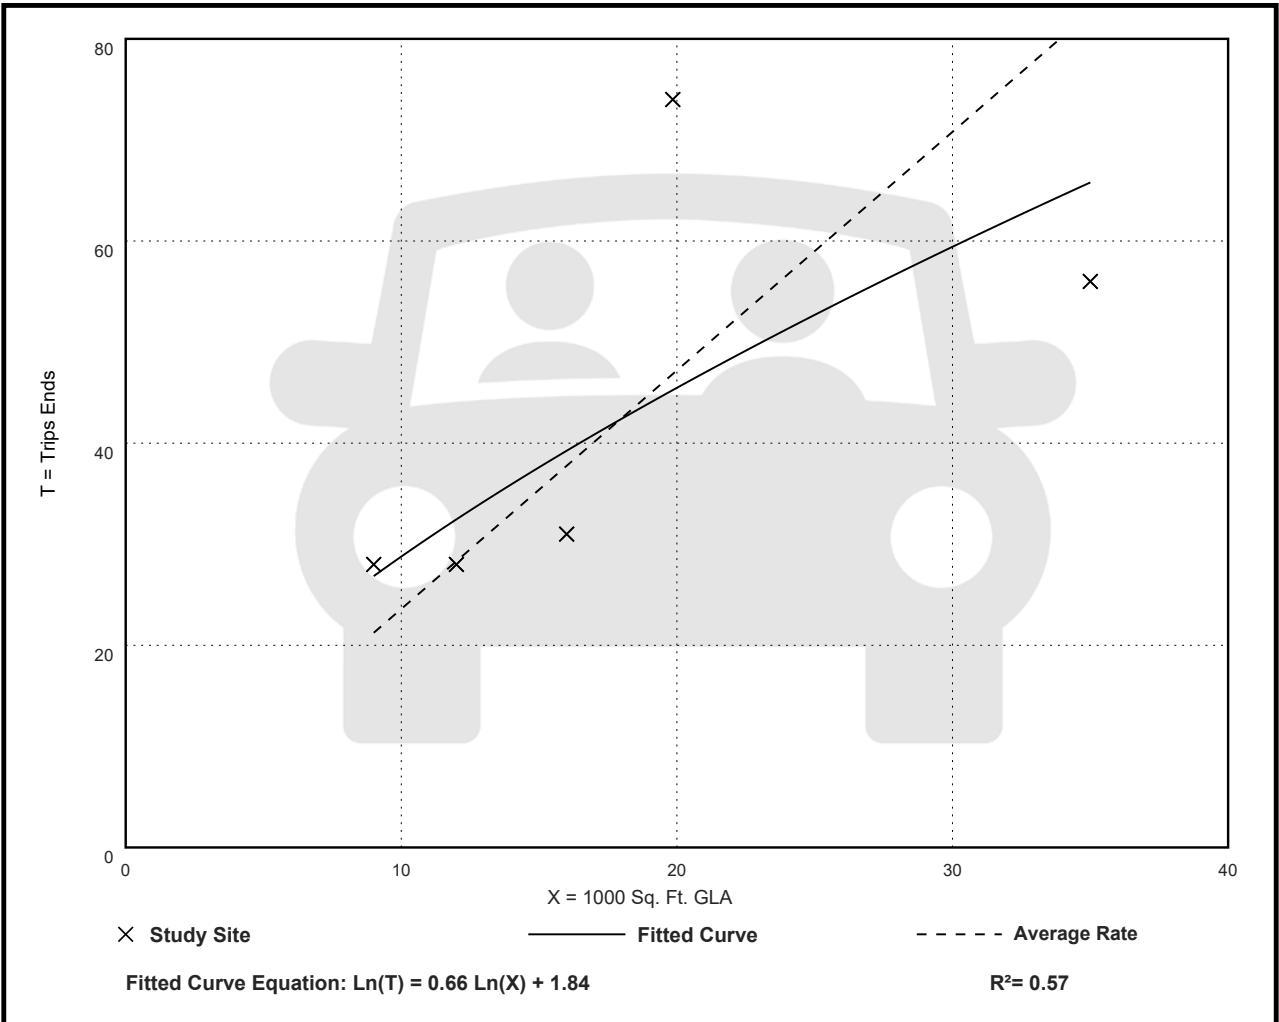
Strip Retail Plaza (<40k) (822)

Vehicle Trip Ends vs: 1000 Sq. Ft. GLA

Vehicle Trip Generation per 1000 Sq. Ft. GLA

Average Rate	Range of Rates	Standard Deviation
2.36	1.60 - 3.73	0.94

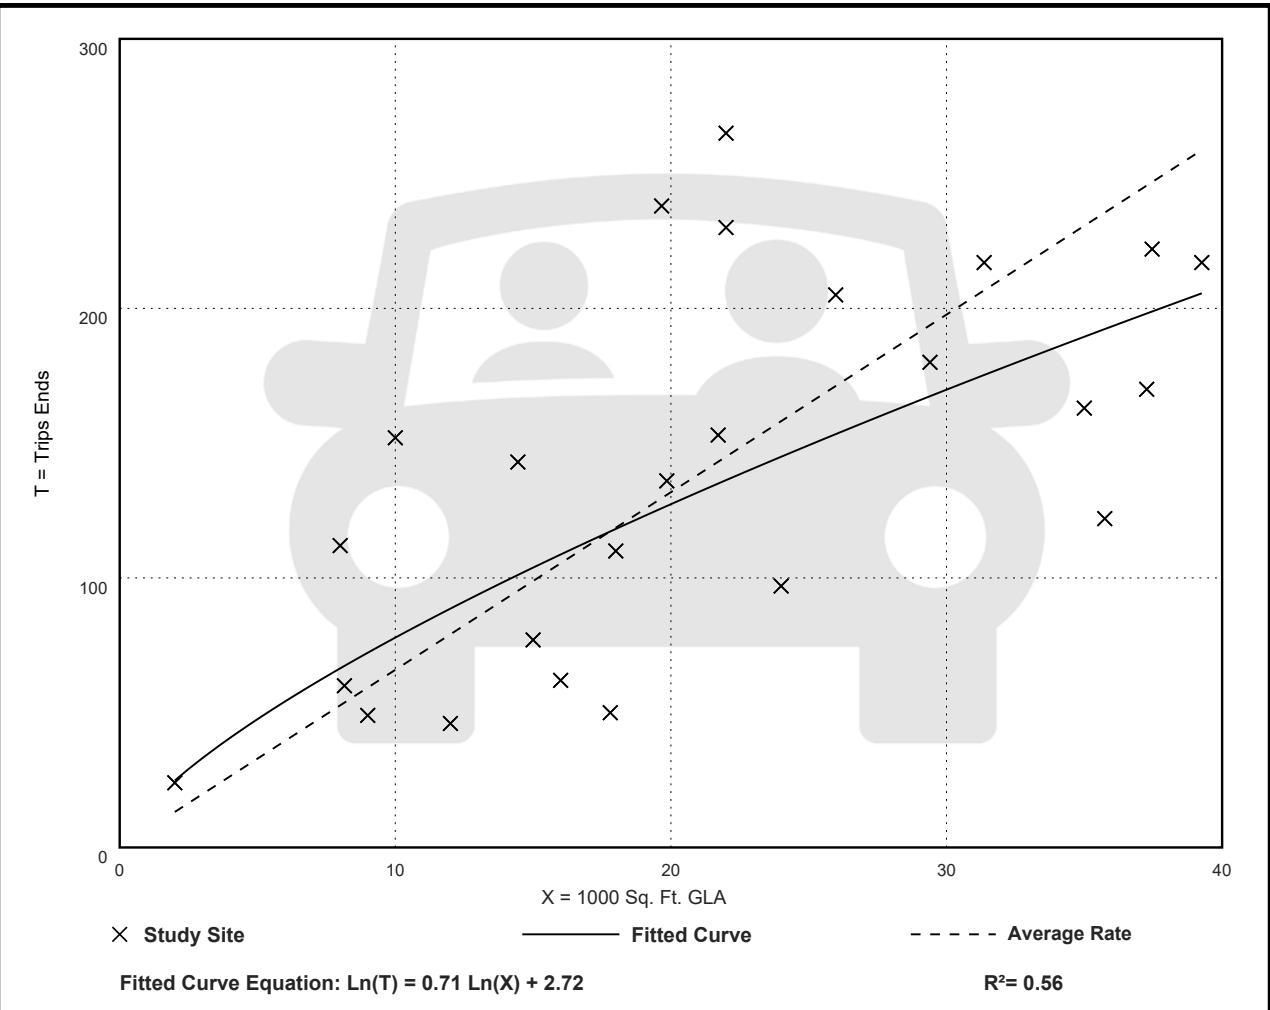
Strip Retail Plaza (<40k) (822)

Vehicle Trip Ends vs: 1000 Sq. Ft. GLA

Vehicle Trip Generation per 1000 Sq. Ft. GLA

Average Rate	Range of Rates	Standard Deviation
6.59	2.81 - 15.20	2.94

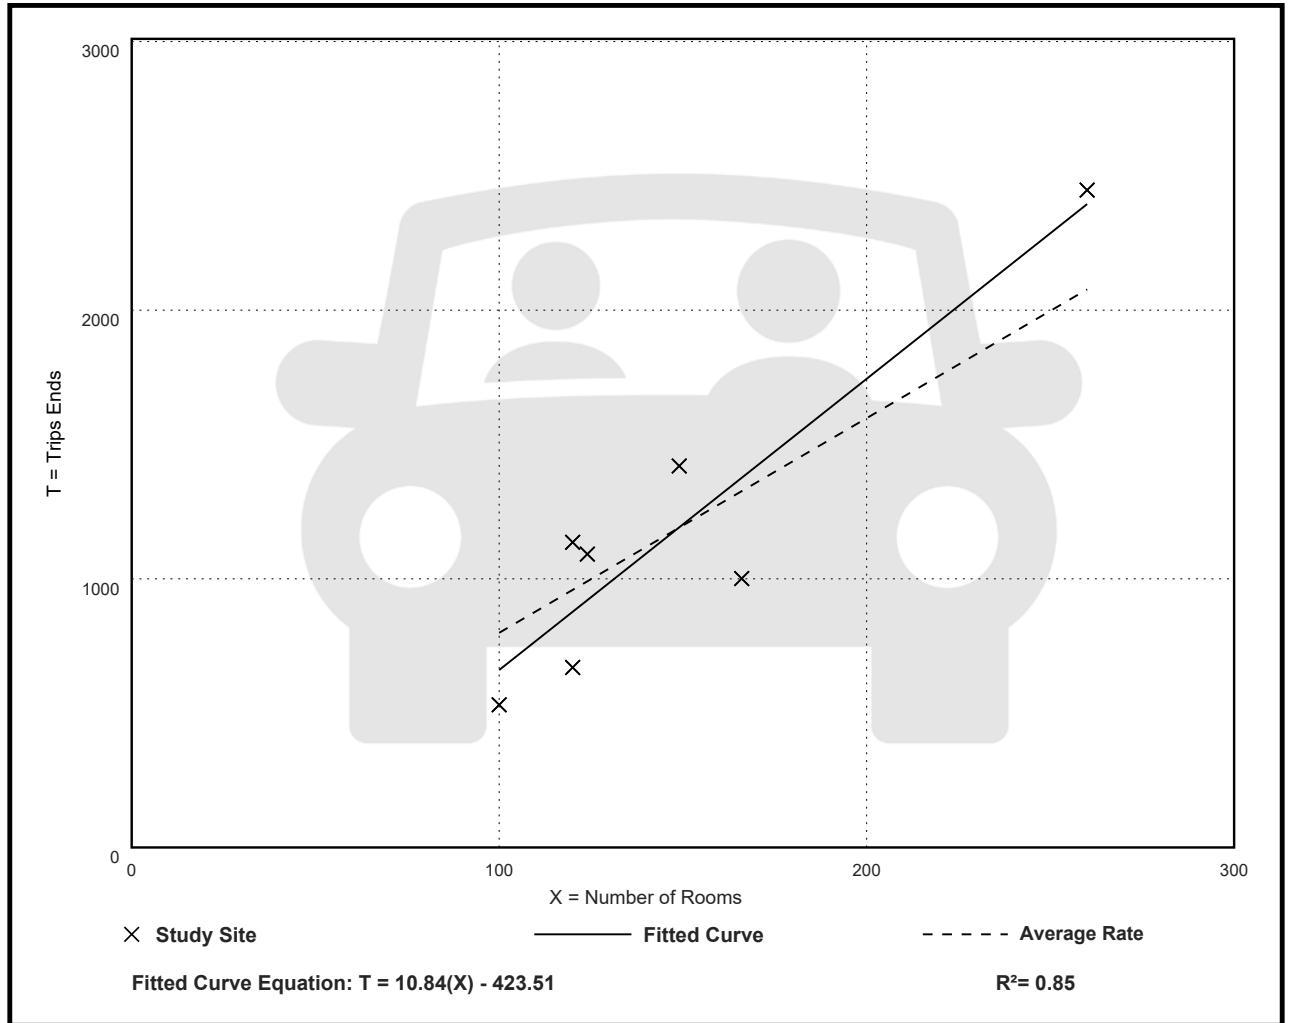
Hotel (310)

Vehicle Trip Ends vs: Rooms

Vehicle Trip Generation per Room

Average Rate	Range of Rates	Standard Deviation
7.99	5.31 - 9.53	1.92

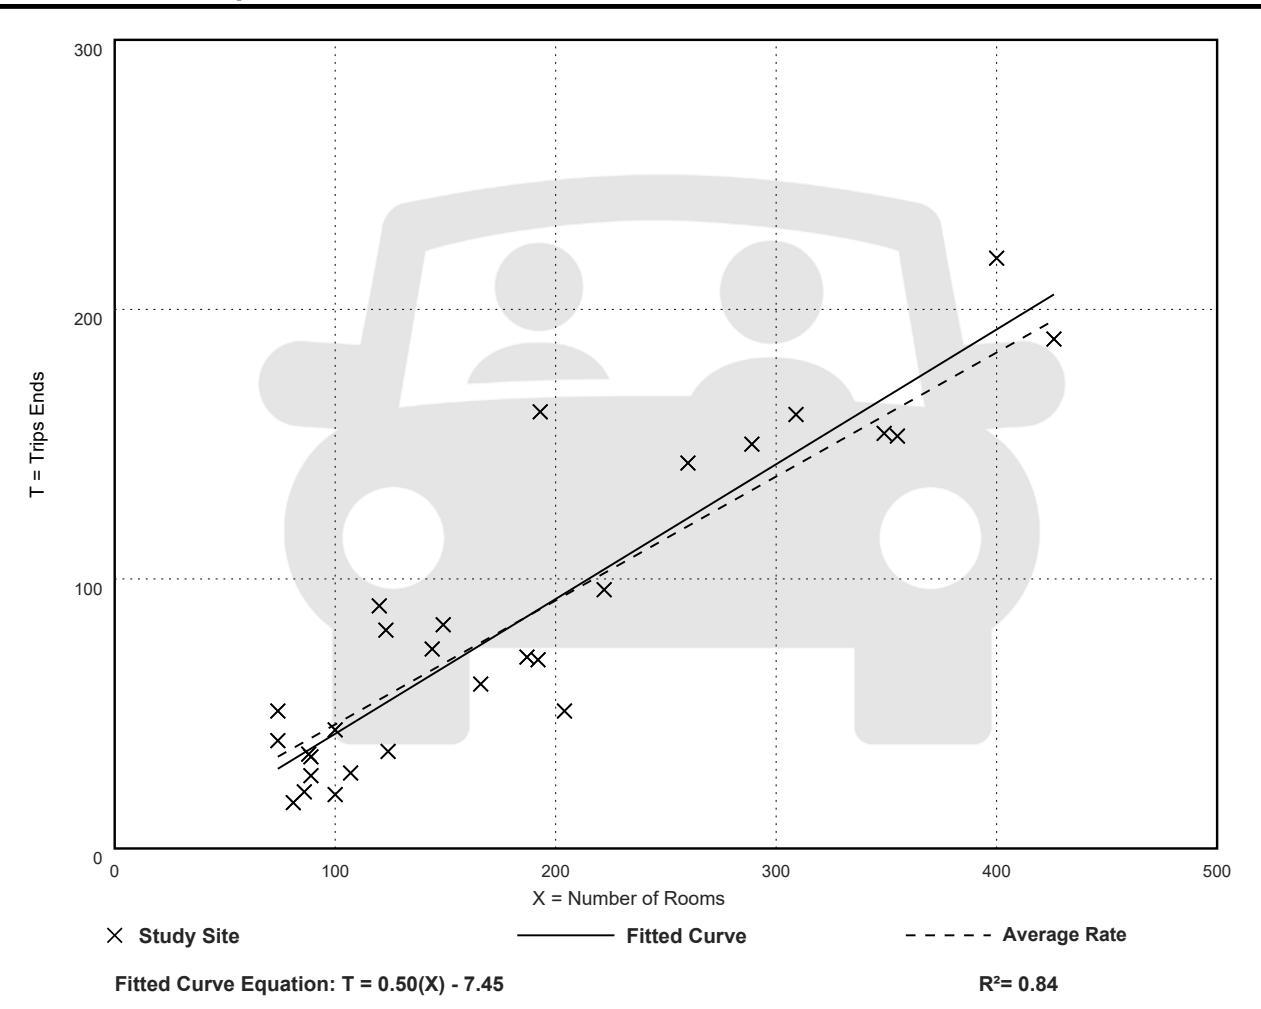
Hotel (310) Vehicle Trip Ends vs: Rooms On a: Weekday, Peak Hour of Adjacent Street Traffic, One Hour Between 7 and 9 a.m. Setting/Location: General Urban/Suburban Number of Studies: 28 Avg. Num. of Rooms: 182 Directional Distribution: 56% entering, 44% exiting

Vehicle Trip Generation per Room

Average Rate	Range of Rates	Standard Deviation
0.46	0.20 - 0.84	0.14

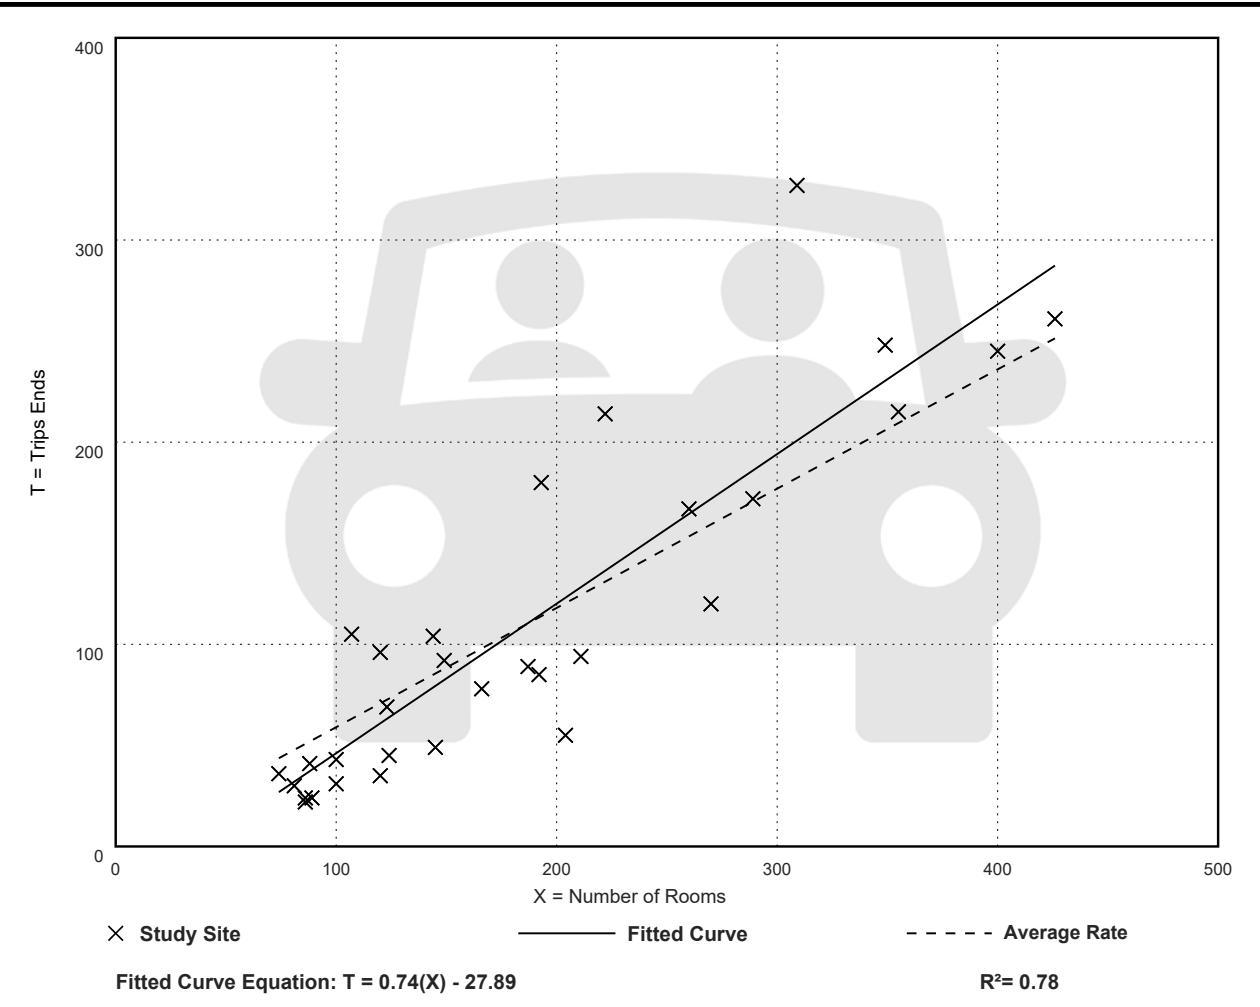
Hotel (310) Vehicle Trip Ends vs: Rooms On a: Weekday, Peak Hour of Adjacent Street Traffic, One Hour Between 4 and 6 p.m. Setting/Location: General Urban/Suburban Number of Studies: 31 Avg. Num. of Rooms: 186 Directional Distribution: 51% entering, 49% exiting

Vehicle Trip Generation per Room

Average Rate	Range of Rates	Standard Deviation
0.59	0.26 - 1.06	0.22

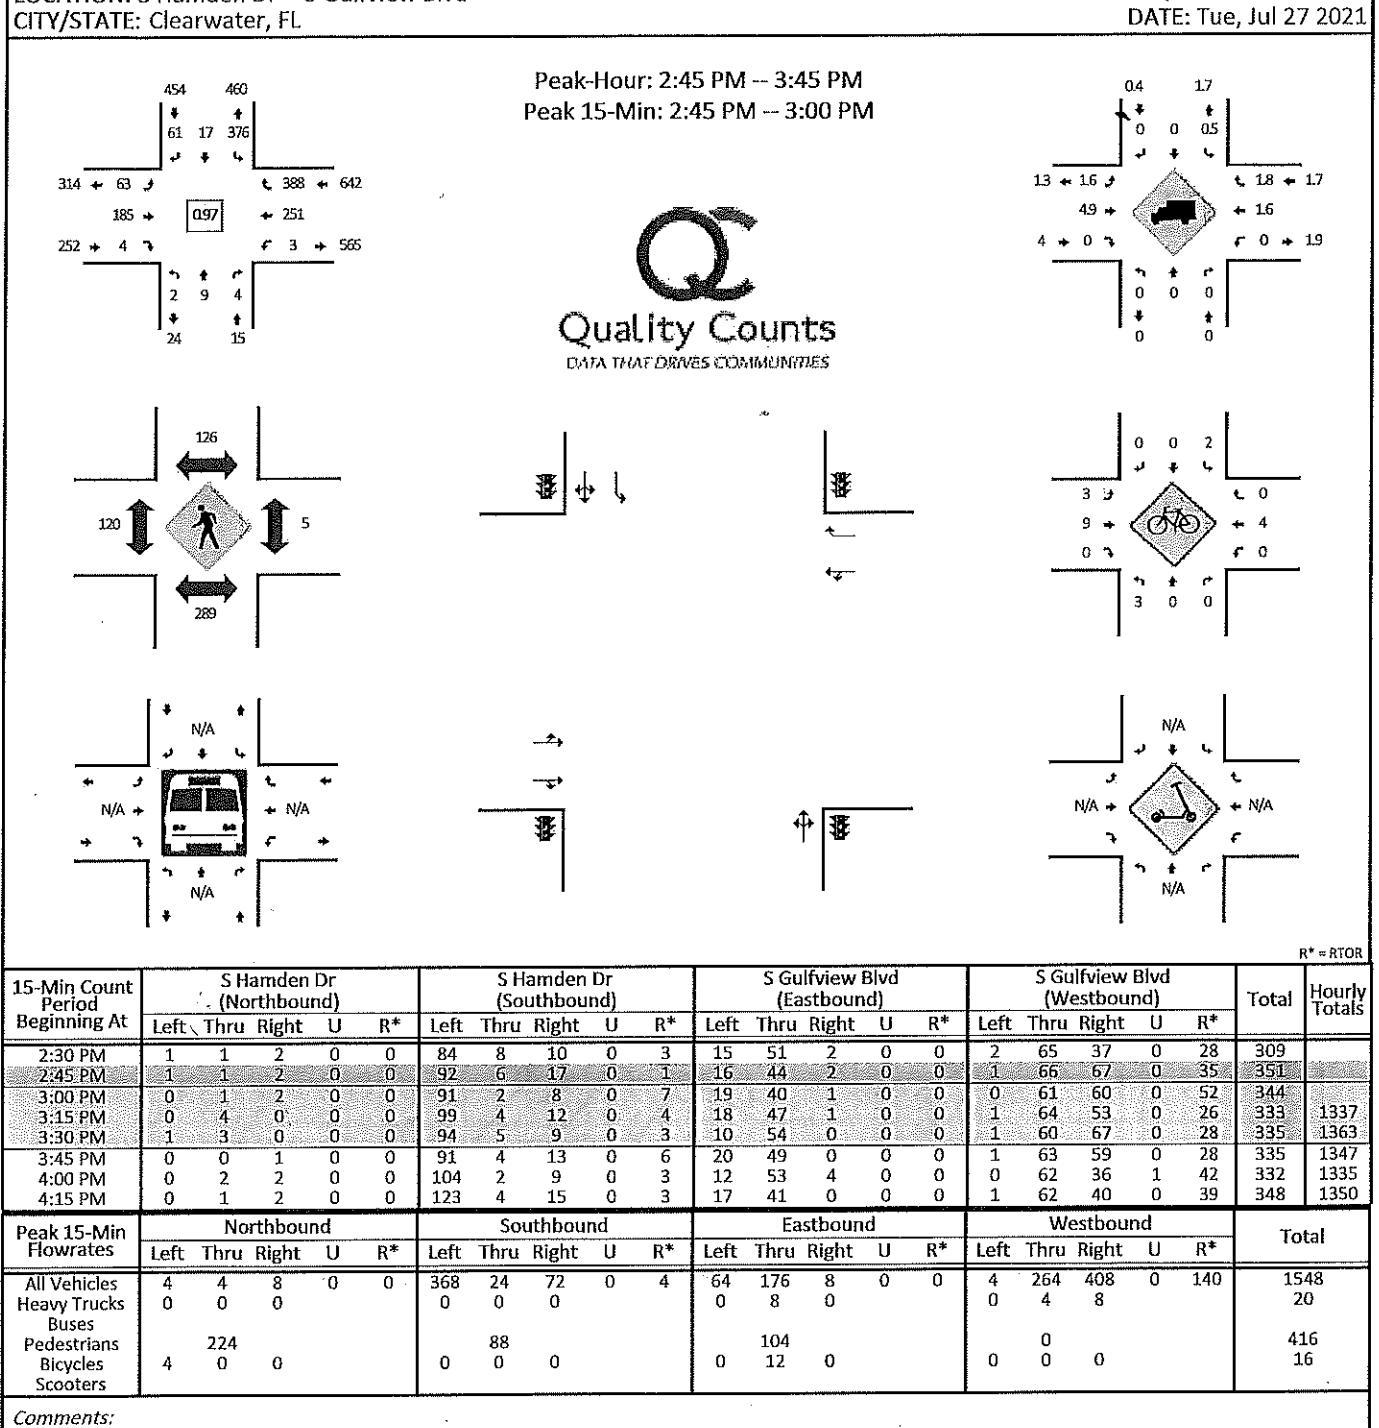
LOCATION: S Hamden Dr --- S Gulfview Blvd

Method for determining peak hour: Total Entering Volume

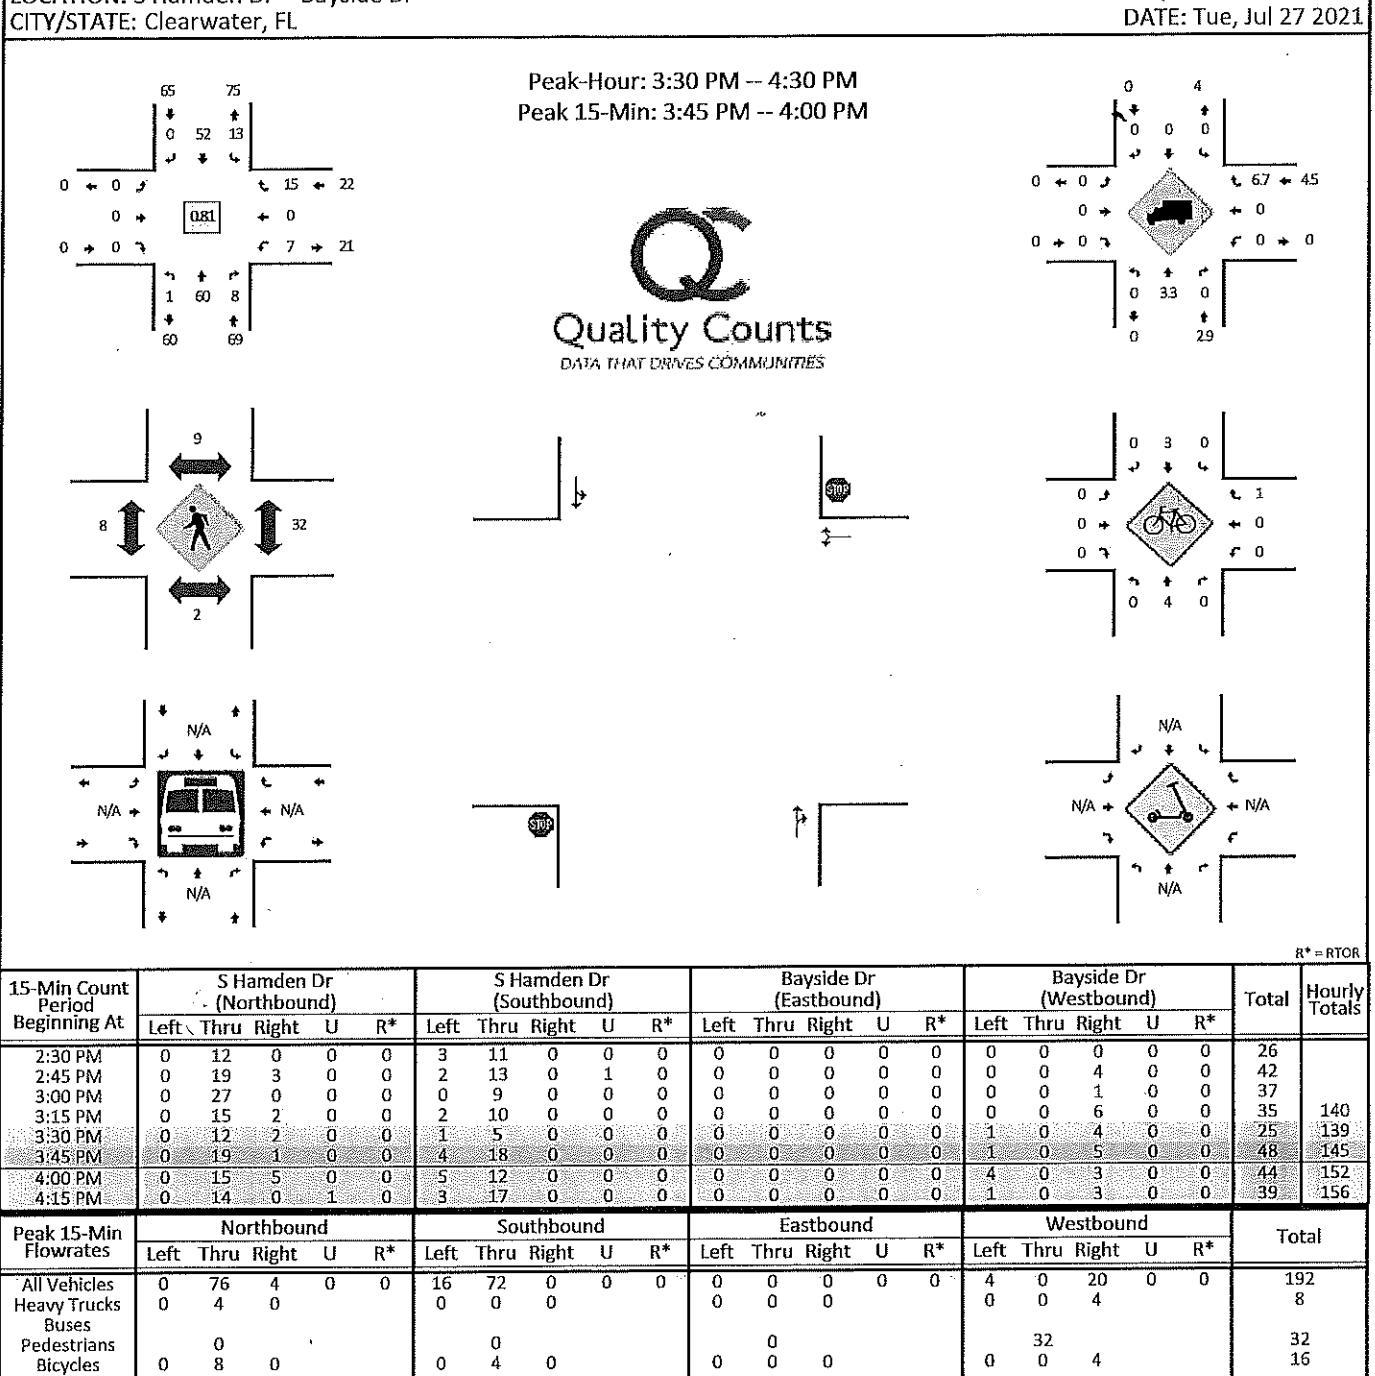
LOCATION: S Hamden Dr -- Bayside Dr CITY/STATE: Clearwater, Fl

Method for determining peak hour: Total Entering Volume
